Ord River power station
Planned Outage case study

PPA Annual Conference, July/August 2018

PROJECT DETAILS

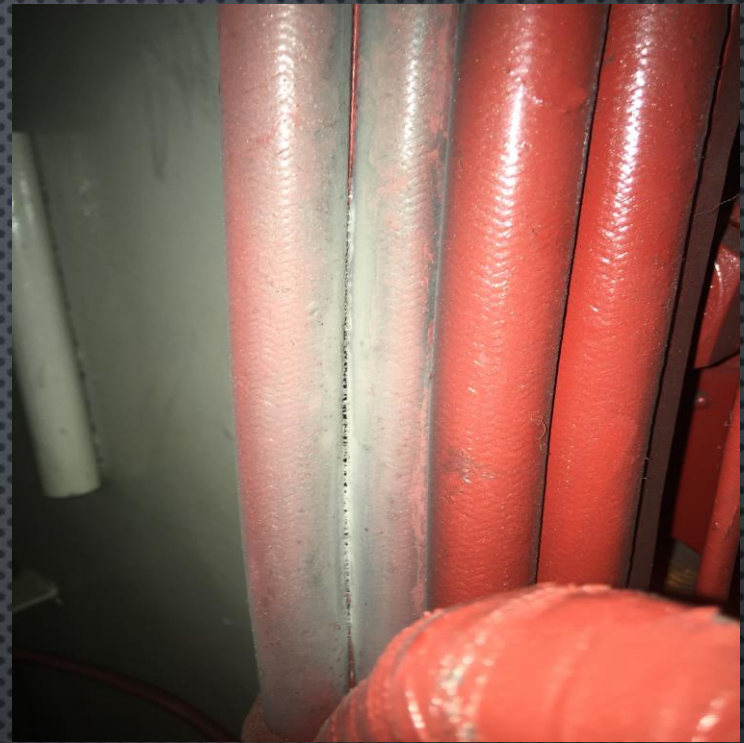
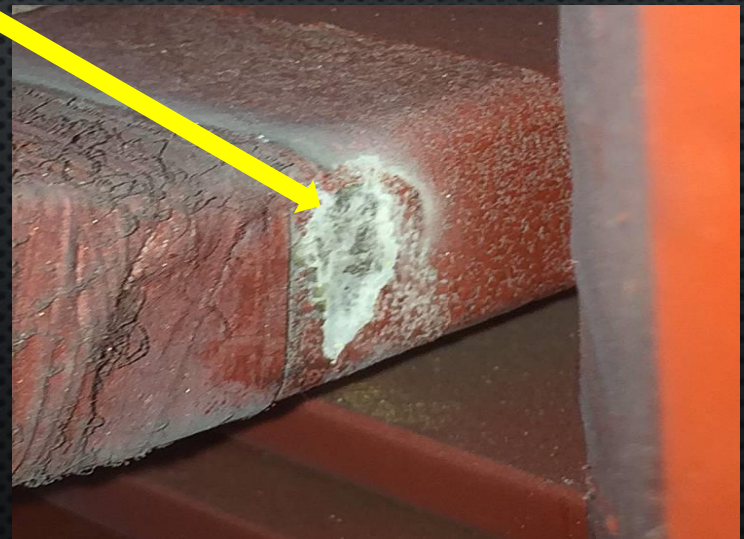
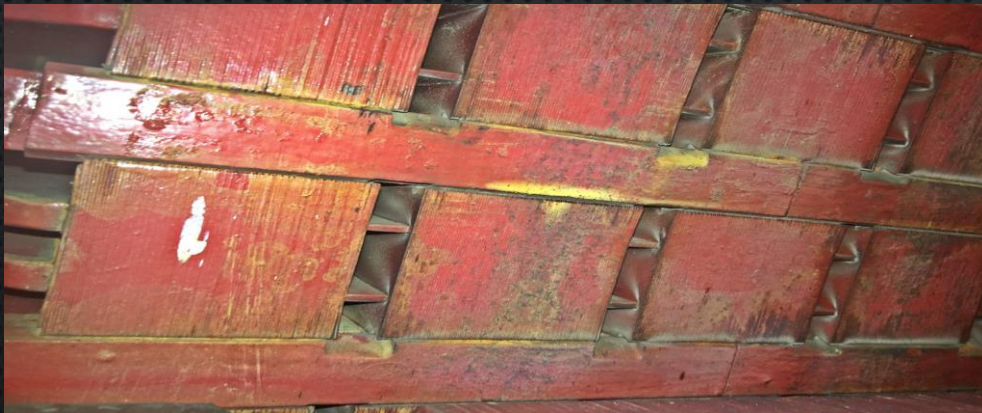
MAINTENANCE ISSUES

- VISUAL INSPECTIONS OF THE STATOR WINDINGS WERE PERFORMED BY AN EXPERIENCED WINDER, SHOWING LARGE AMOUNTS OF **PARTIAL DISCHARGE (PD)** IN THE BUNDLED CABLE CONNECTION RINGS AND COILS.
- PARTICULAR CONCERN WAS FOR INSULATION DAMAGE NEAR THE END OF THE SLOT
- ALSO, SLOT WEDGES WERE LOOSE AND FRETTING IN MANY PLACES
- IR READINGS WERE GOOD

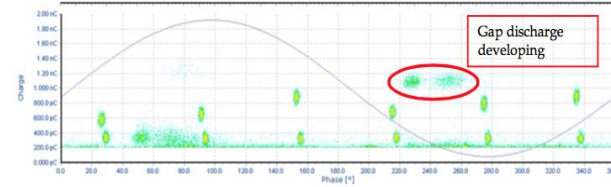
- OFFLINE PD TESTING SHOWED THE FOLLOWING TREND
- THE PD LEVEL AT RATED VOLTAGE IS BEGINNING TO APPROACH A DETERIORATED CONDITION (IEC STANDARD 10nC)
- THE PD LEVEL AT 7.6kV VARIED BETWEEN 15.9nC AND 24.2nC WITH TWO TEST RUNS.
- THIS QU PLOT SHOWS THIS LARGE INCREASE IN ACTIVITY AROUND THE 7.6kV SETTING VIA A VERTICAL LINE.
- THIS INDICATES THE 7.6kV VOLTAGE IS ON THE BORDER OF SIGNIFICANTLY INCREASED PD ACTIVITY.

W Phase - PD Pattern at 3.8kV with IEC Filter (100-500kHz) over 30seconds

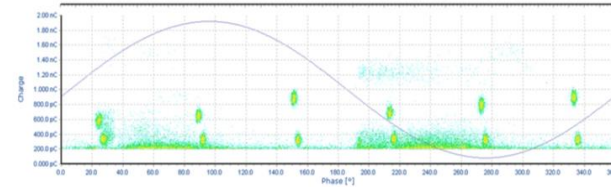
W Phase - PD Pattern at 5.1kV with IEC Filter (100-500kHz) over 30seconds

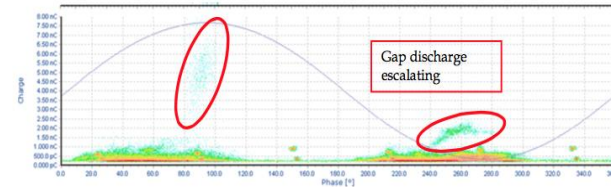
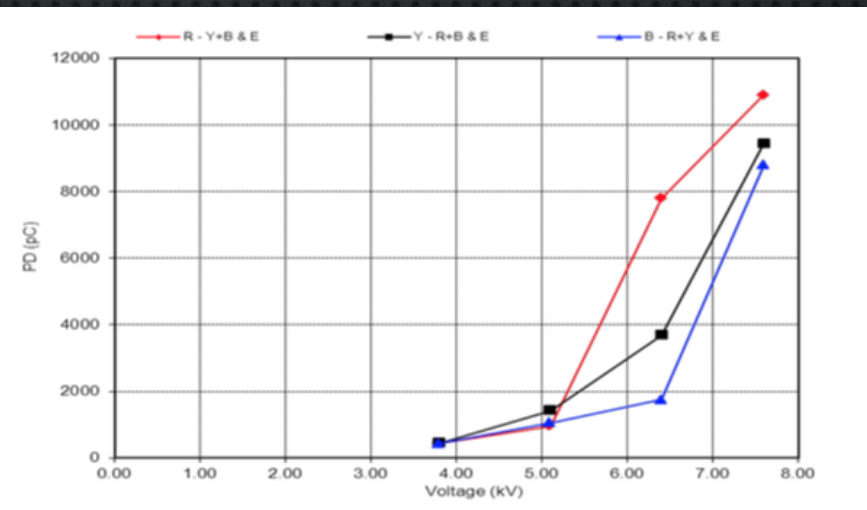
W Phase - PD Pattern at 6.4kV with IEC Filter (100-500kHz) over 30seconds

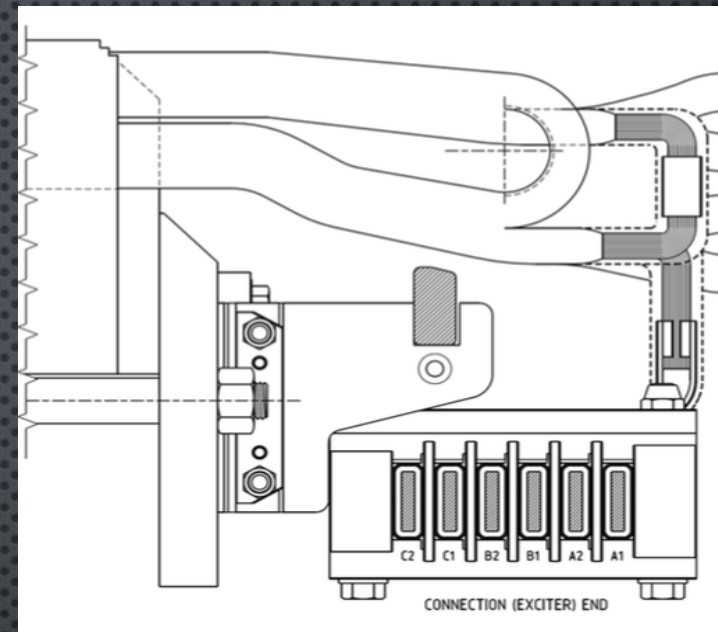
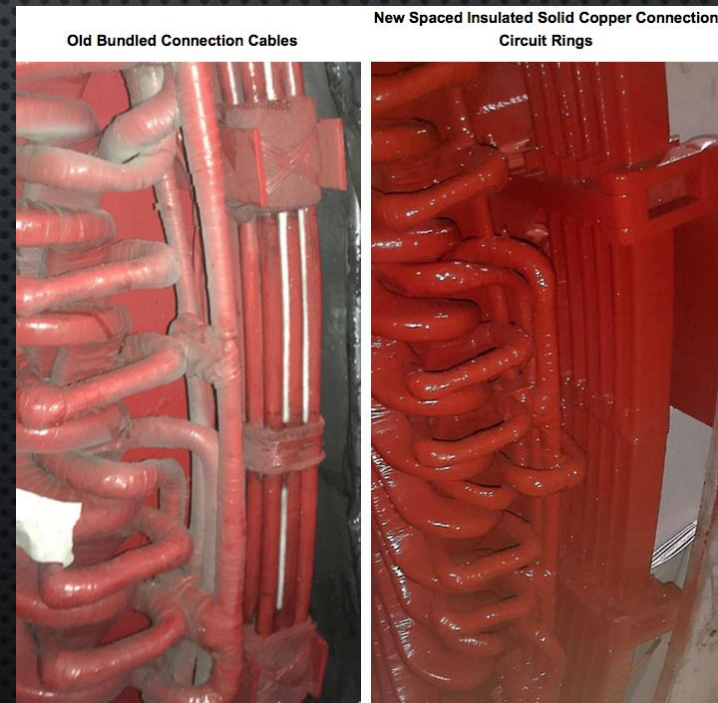
REPAIR OPTION-1 CIRCUIT RING REPLACEMENT

- THE HV END CABLES HAVING FULL LINE TO LINE VOLTAGES BETWEEN THEM ARE CLOSELY BUNCHED TOGETHER WITHOUT REQUIRED AIR GAP WHICH IS THE PRIMARY CAUSE OF PARTIAL DISCHARGES BETWEEN CABLES.
- COMPLETE REDESIGN OF STATOR BUS CONNECTIONS TO APPROPRIATELY SIZED, INSULATED AND SPACED SOLID COPPER CIRCUIT RINGS AS DEPICTED IN THE DRAWING ABOVE
- THIS OPTION IS THE PROPER ENGINEERING SOLUTION, AND WOULD POSITIVELY ELIMINATE ALL CURRENTLY EXPERIENCED PD PROBLEMS WITH STATOR CABLES.

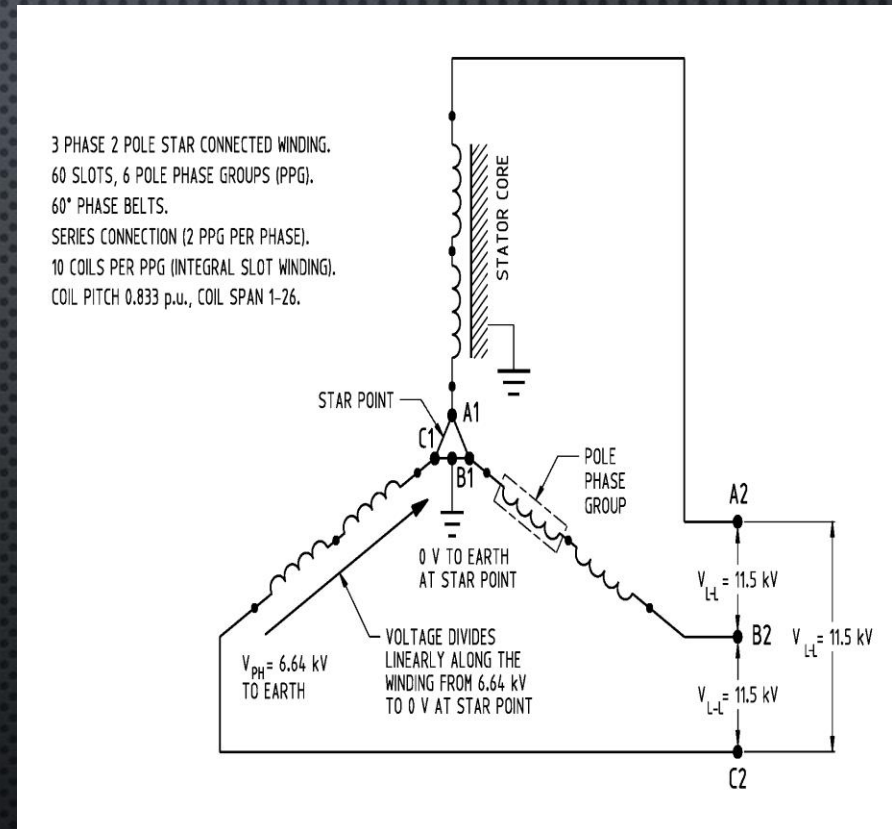
REPAIR OPTION-2 STATOR WINDING LEADS INVERSION

- THE HIGHEST GRADIENT ACROSS THE STATOR GROUND WALL INSULATION (LINE TO GROUND VOLTAGE) IS AT THE MAIN OUTPUT HIGH VOLTAGE (HV) LEAD END. THUS THE HV WINDING SIDE INCURS THE HIGHEST IN-SERVICE PD DEGRADATION (INTERNALLY AND EXTERNALLY)
- THE LOWEST DIELECTRIC GRADIENT ACROSS THE STATOR GROUND WALL INSULATION OCCURS AT THE NEUTRAL END OF THE WINDING. THE NEUTRAL WINDING END IS UNAFFECTED BY THE PD DAMAGE
- BY REVERSING/INVERTING STATOR LEADS (ACTIVE SIDE AND NEUTRAL SIDE), THE NEUTRAL SIDE WHICH IS NOT AFFECTED BY PD EROSION IS NOW CONNECTED TO THE HV OUTPUT SIDE. THE BARS THAT WERE PREVIOUSLY CONNECTED TO THE HV SIDE ARE NOW EXPOSED TO VERY LOW VOLTAGE STRESSES AND ARE NOT EXPECTED TO INCUR FURTHER PD DEGRADATION
- BY STATOR WINDING LEADS INVERSION IT IS POSSIBLE TO APPRECIABLY EXTEND THE WINDING LIFE BY SHIFTING WEAKER DEGRADED COILS NEAR THE NEUTRAL END UNDER LOWER DIELECTRIC STRESS

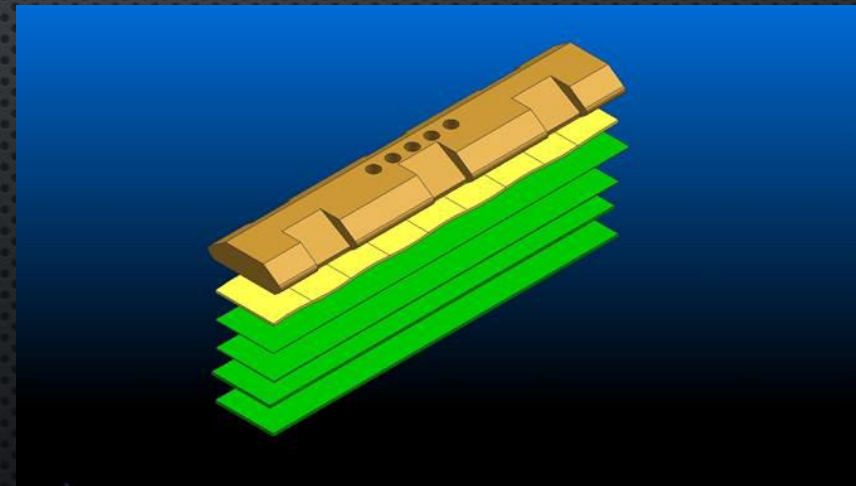
REPAIR OPTION-3 REWEDGE

- DUE TO THE MAJORITY OF WEDGES BEING LOOSE OR HOLLOW, A REWEDGE WAS PERFORMED DURING THE SAME OUTAGE.
- THE WEDGE DESIGN SYSTEM USED WAS A FLAT WEDGE WITH TOP RIPPLE SPRING
- THE WEDGE KIT WAS MANUFACTURED AND SUPPLIED BY AUSTRALIAN WINDERS

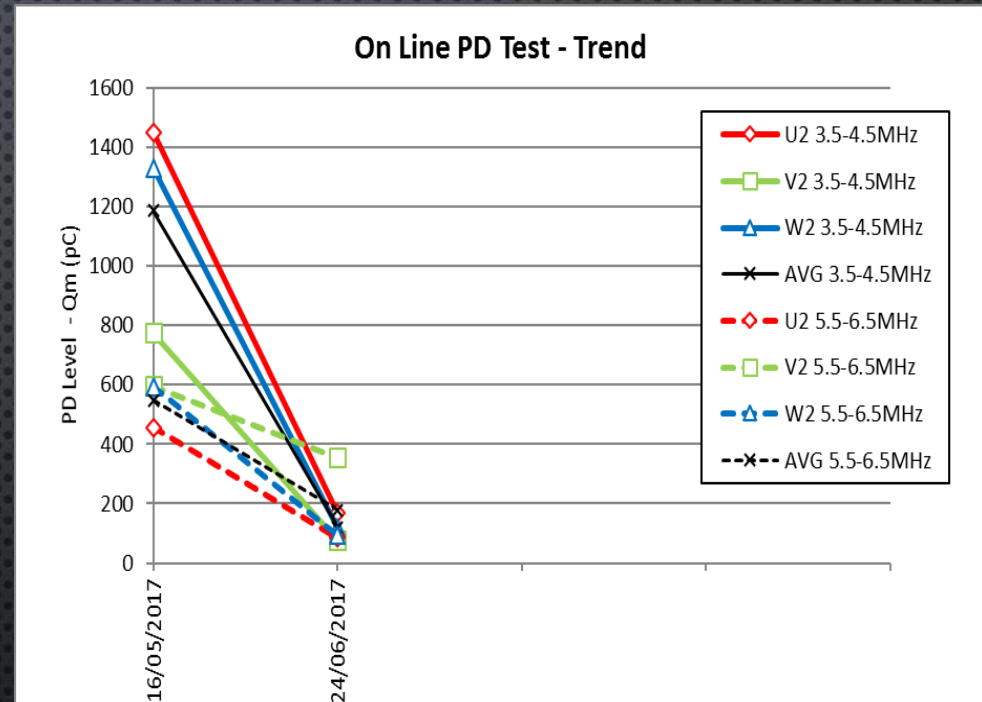
DRAMATIC PD REDUCTION

- THERE WAS A DRAMATIC REDUCTION OF PARTIAL DISCHARGE AT THE CONCLUSION OF THE REPAIR WORKS
- THE REPORT AS WRITTEN BY THE TESTING ENGINEER: *THE ON-LINE PD TESTS FOLLOWING RE-COMMISSIONING INDICATED DRAMATIC REDUCTION IN PD ACTIVITY, BOTH DUE TO TOTAL ELIMINATION OF PD DISCHARGES IN CABLE BUNDLE AND DUE TO INVERSION OF THE STATOR LEADS, THEREFORE THE PROJECT HAS ACHIEVED ITS MAIN GOAL OF SIGNIFICANTLY REDUCING ON-LINE OPERATIONAL PD ACTIVITY AND EXTENSION OF THE WINDING OPERATIONAL LIFE .*
