WAI-CUN-A002

Wailoa-Cunningham	
Work Scope Assessment Report - September 2017

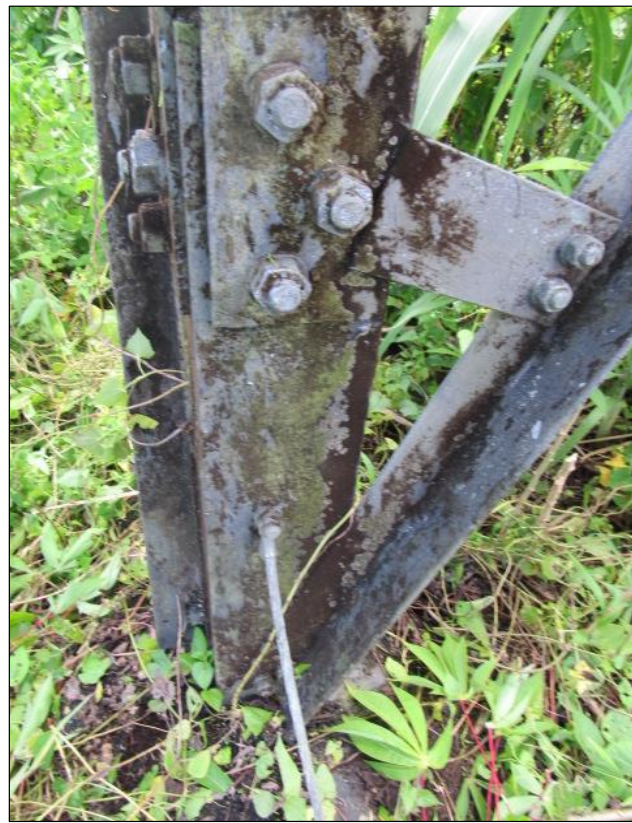
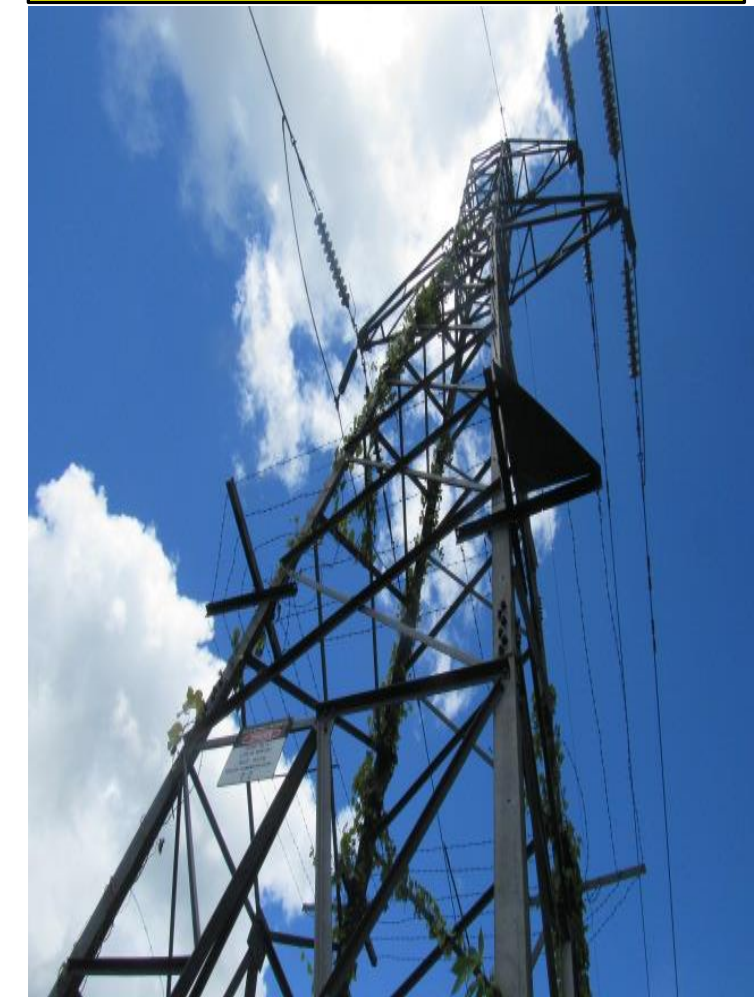
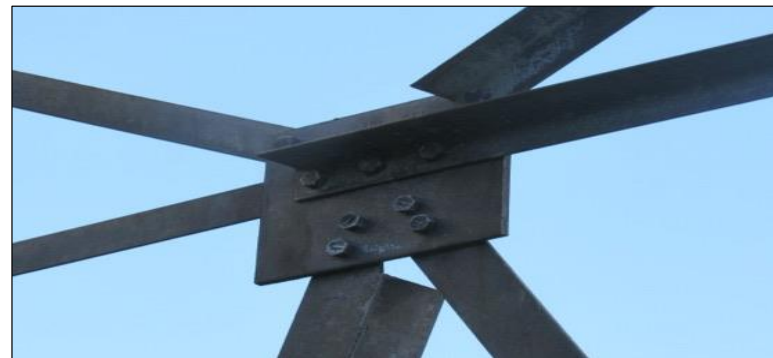
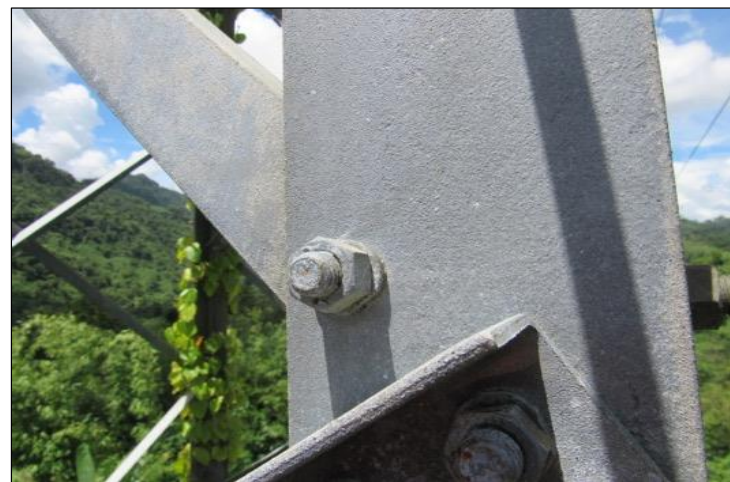
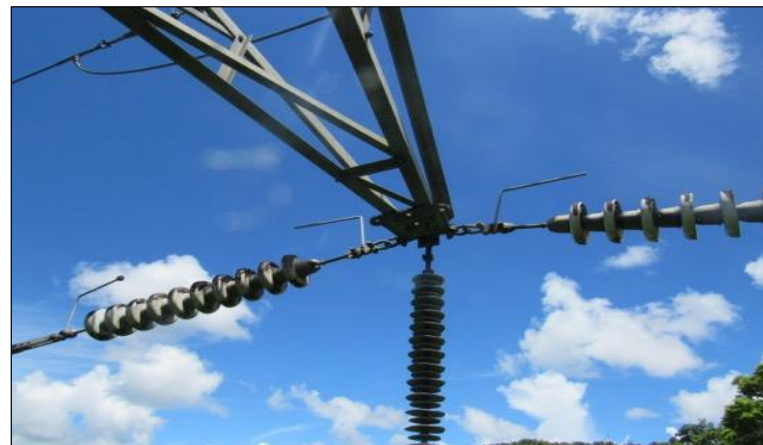
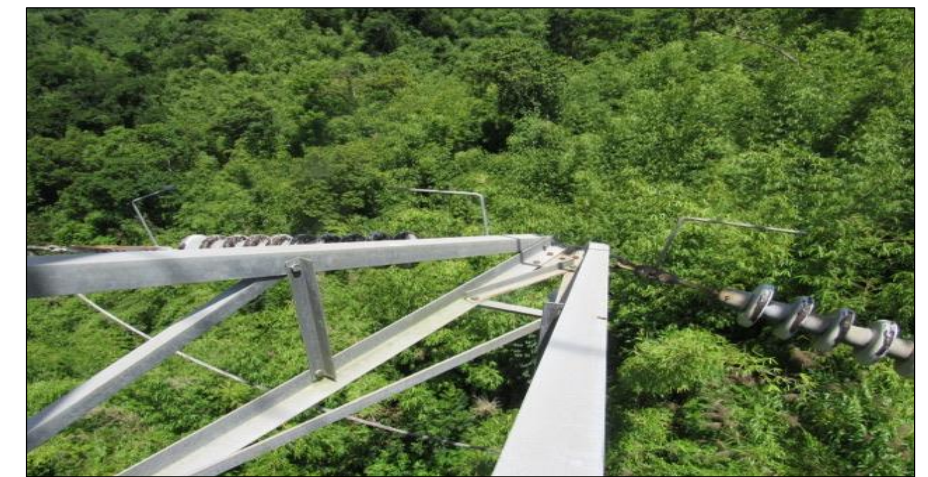
- Havy Moss and mold on lower leg sections.
- Gey Paint 1 meter above ground Level on Legs
- Vines Growing Up structue into the Upper Body
- CA Data
- Heavy Moss on Insulators

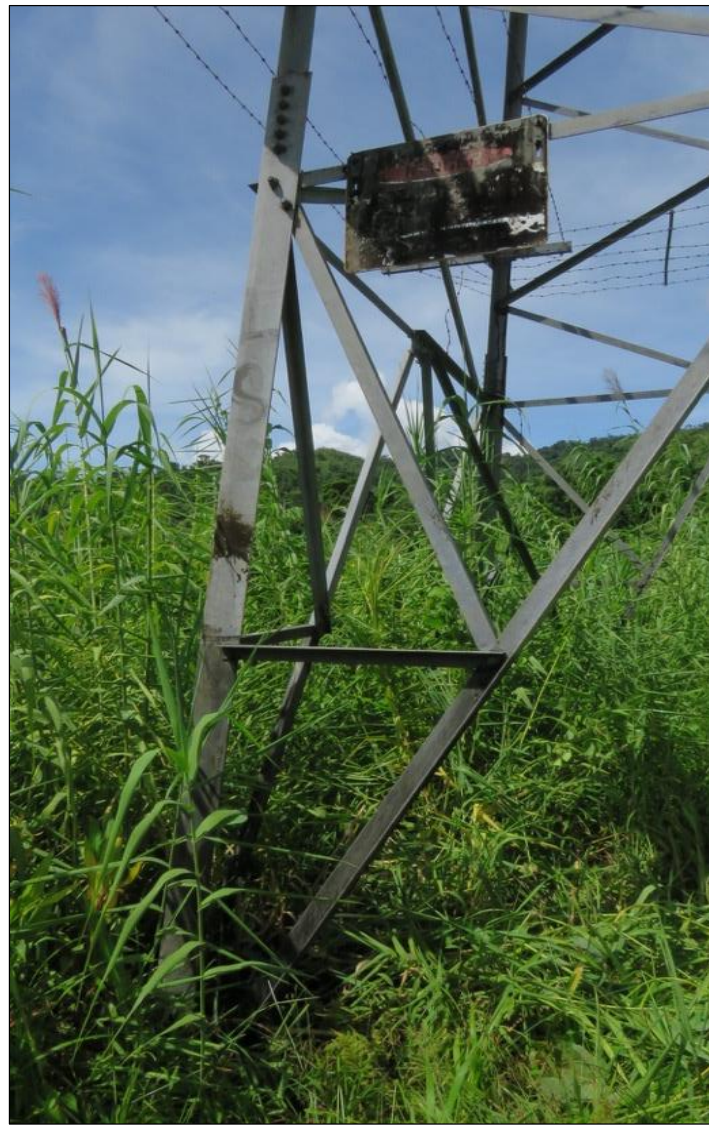
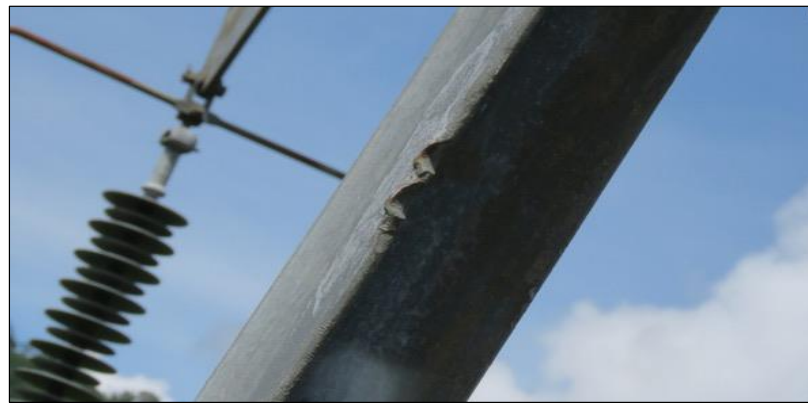
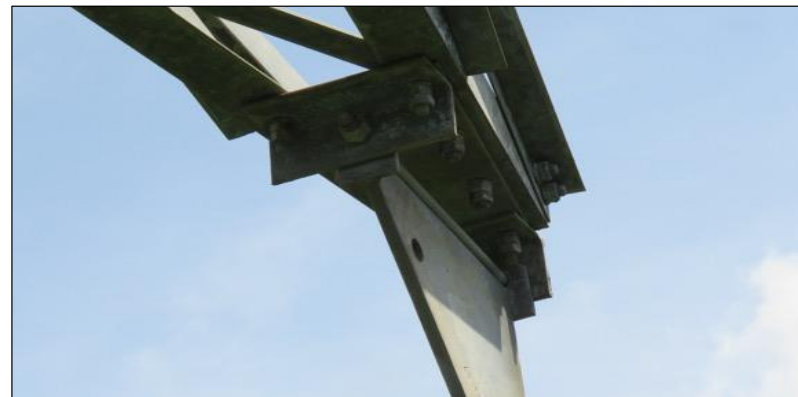
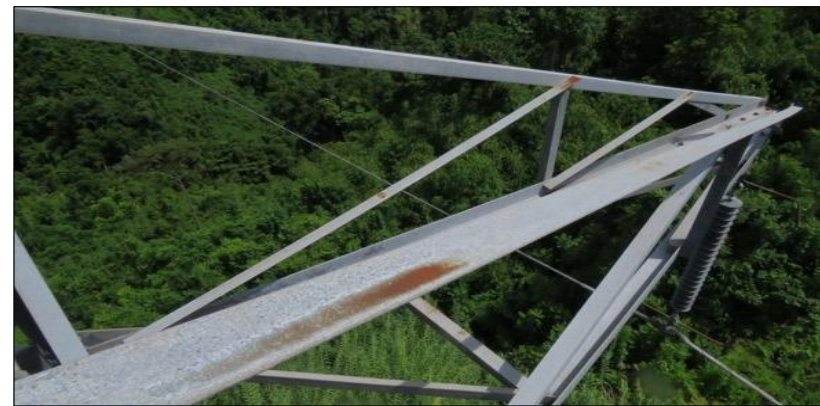
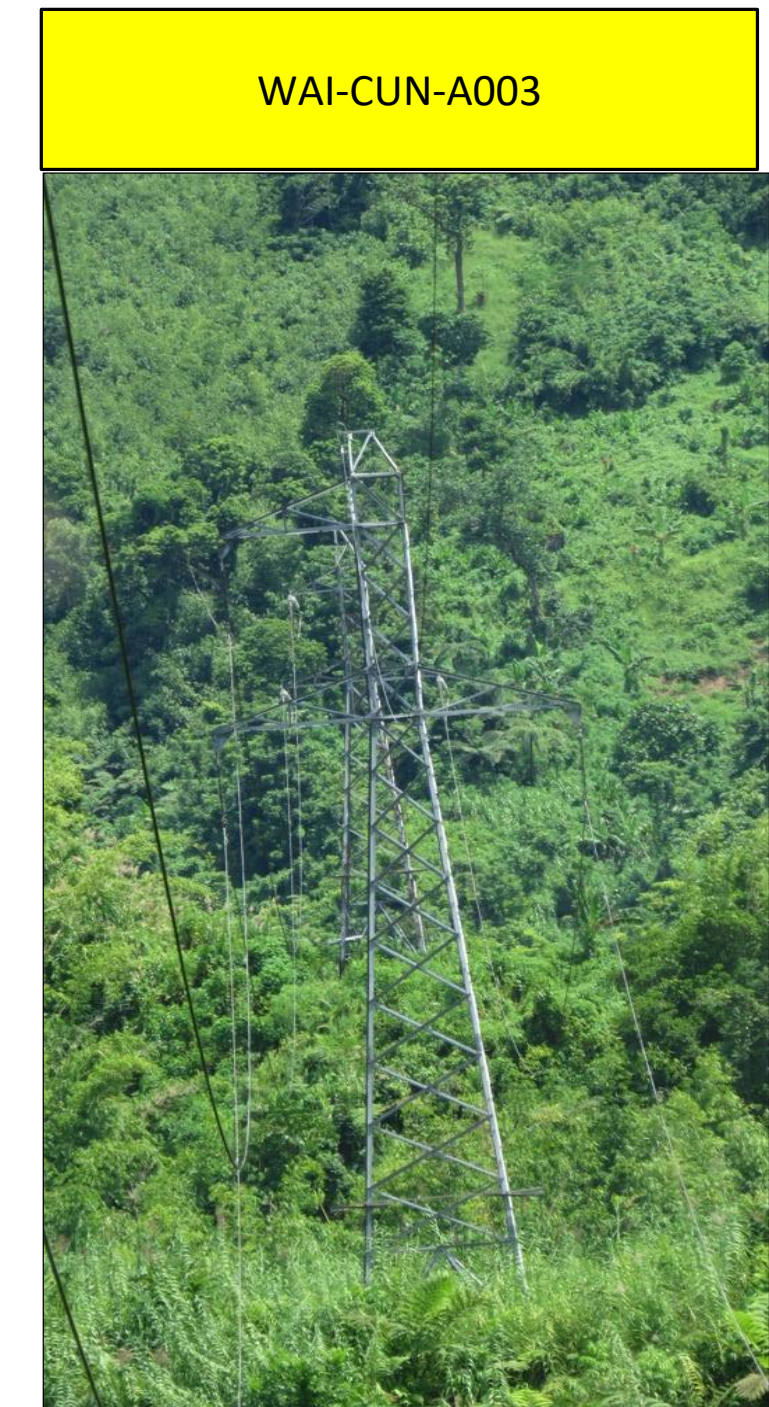
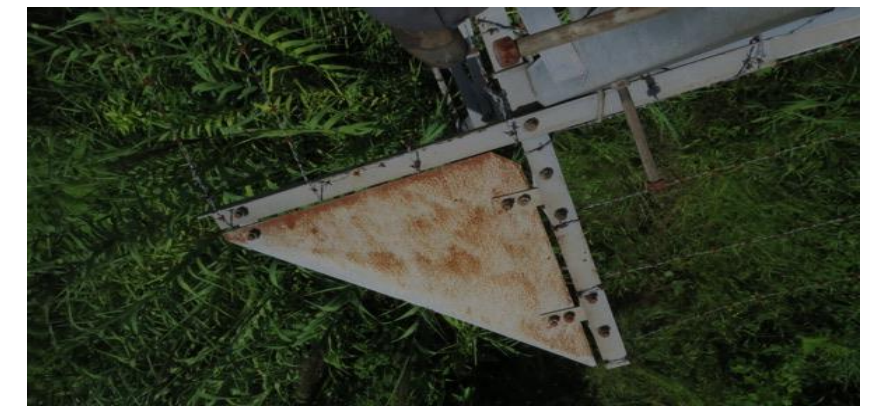
- Heavy Moss and Mold on Lower Sections of the Structure
- Missing Step bolt in the Upper Body

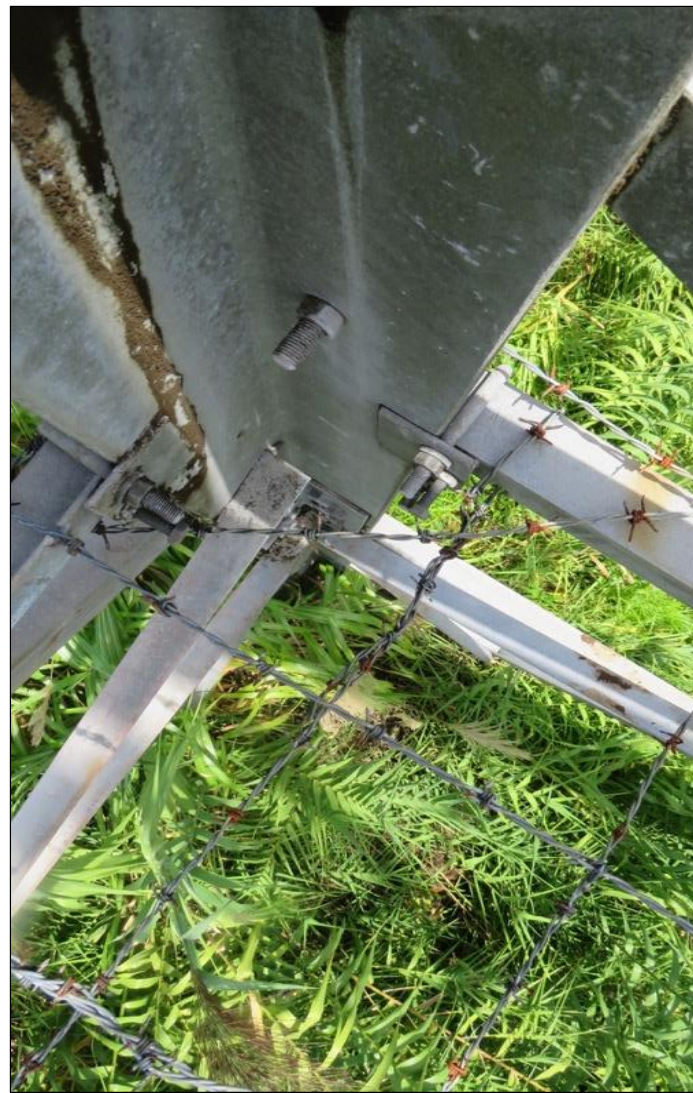
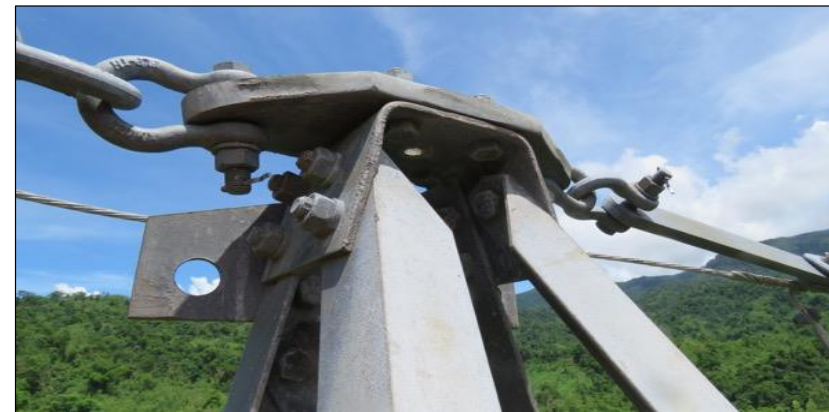
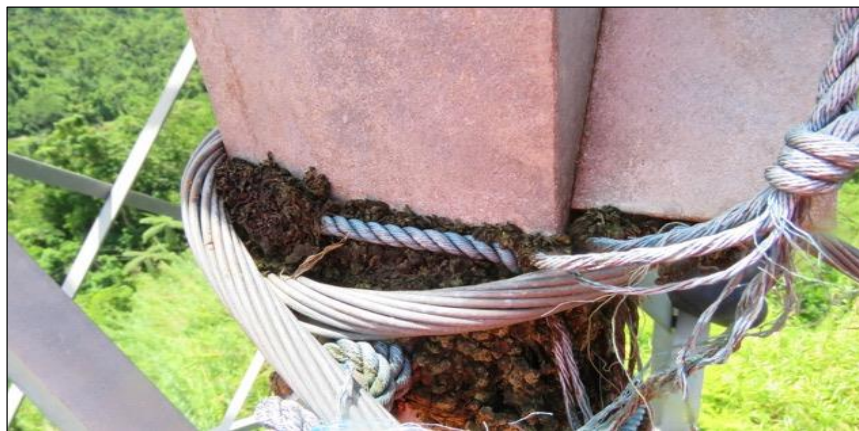
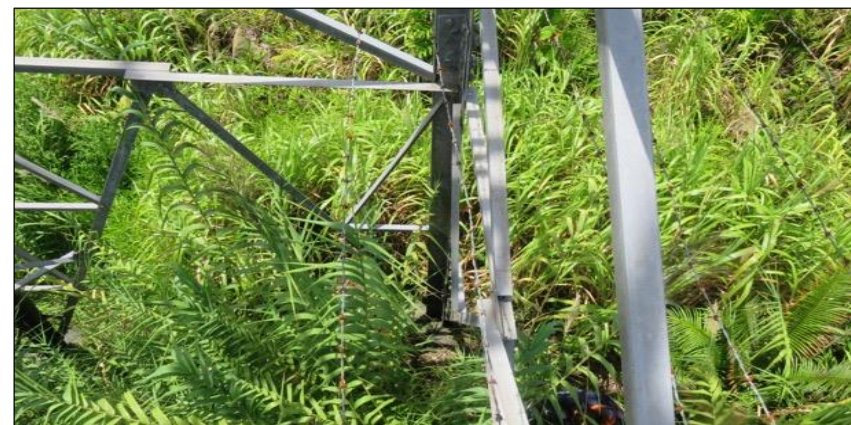
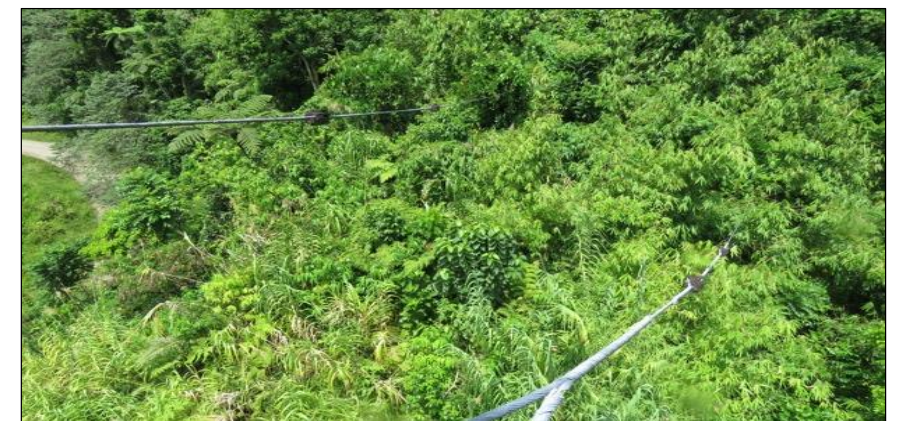
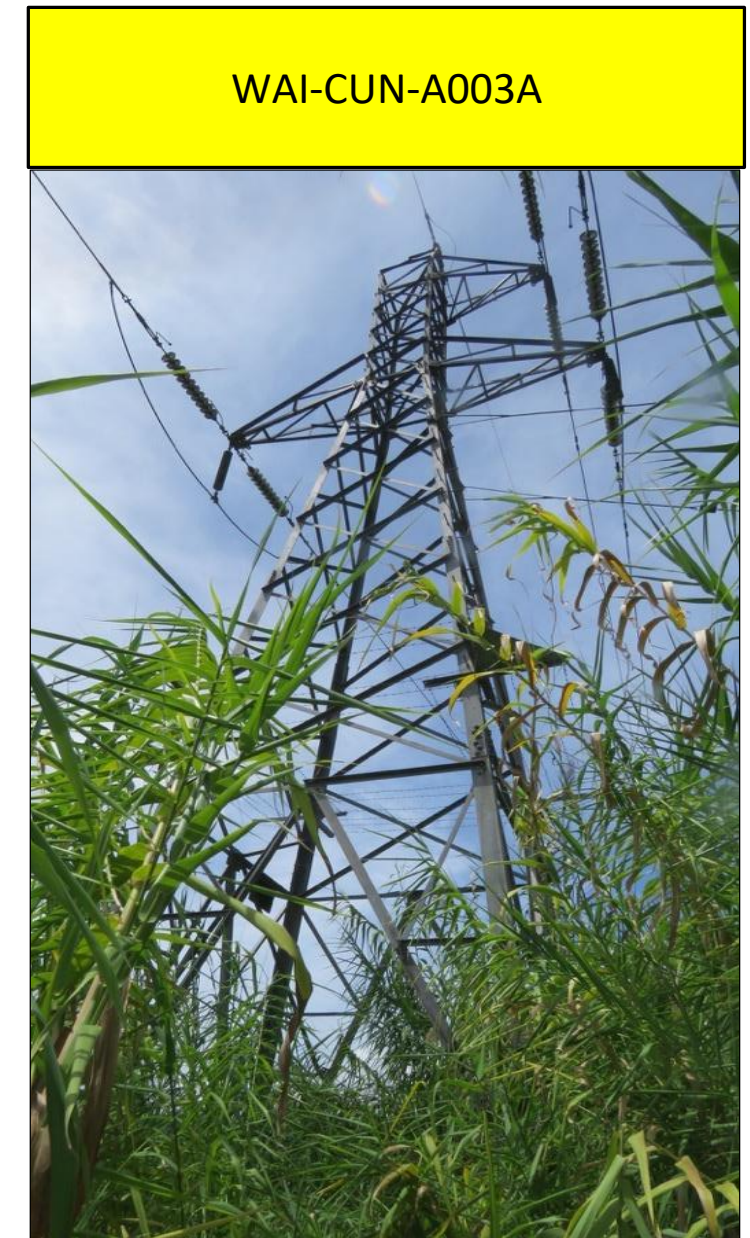
WAI-CUN-A003A

- Guy Wire Attached in the Body on B and C leg
- Heavy Moss and Mold on lower section of Structure.

- **CA Data**
- Heavy Surface Corrosion on Sag links
- Insulators Heavy Moss and Mold
- Old Style dampers Installed

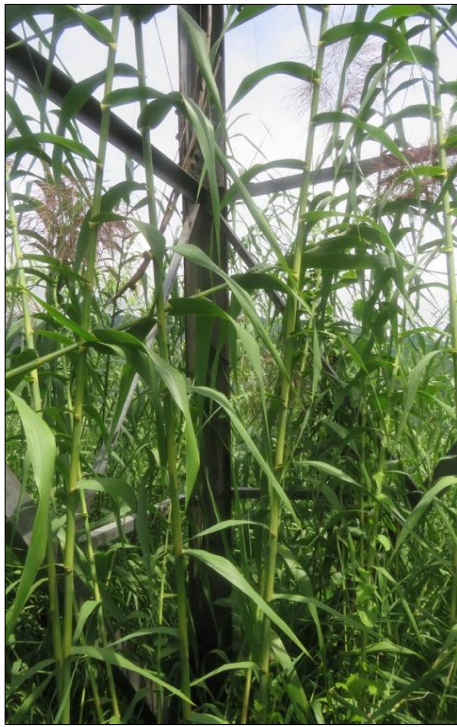
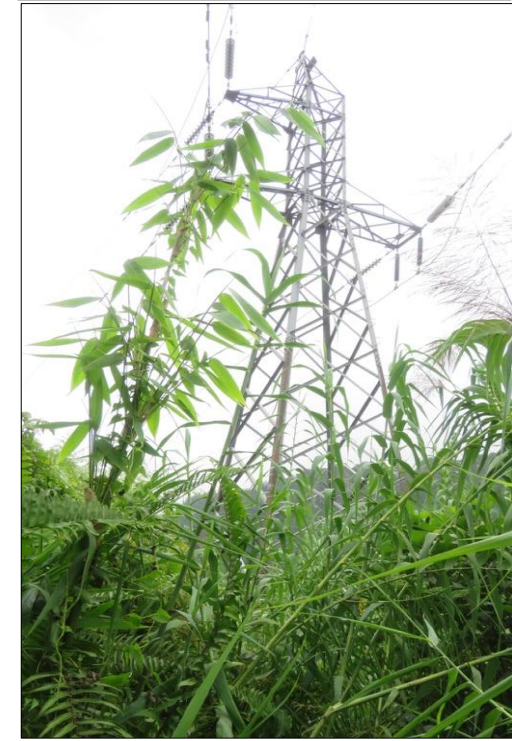
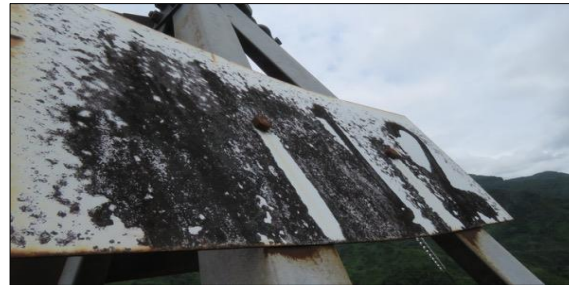
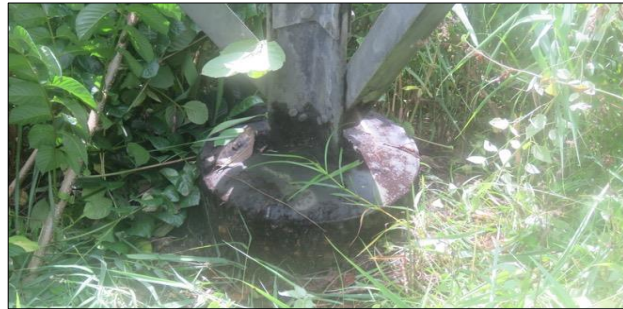
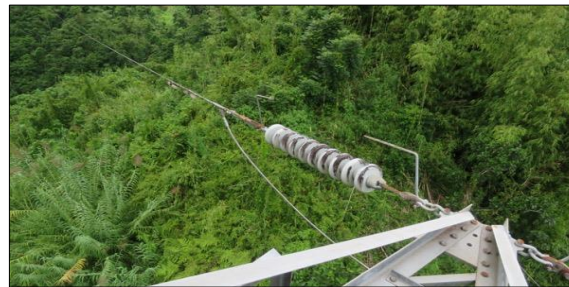
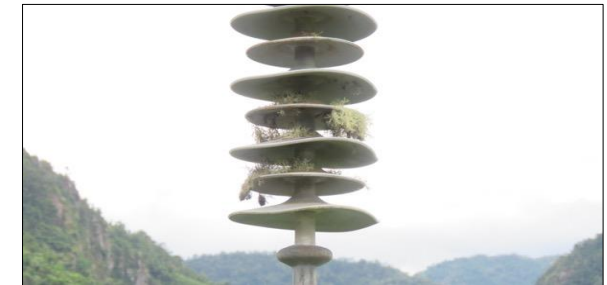
## WAI-CUN-A004

- Aerial Id Installed on Structure
- 40 M16 Tower Bolts R/C
- Tower Requires Vegetation Control
- **CA Data**
- Heavy Moss and mold on Insulators
- Heavy Surface Corrosion on Sag links
- Holding Plate Bolts R/C all Phases (6 Each Phase)

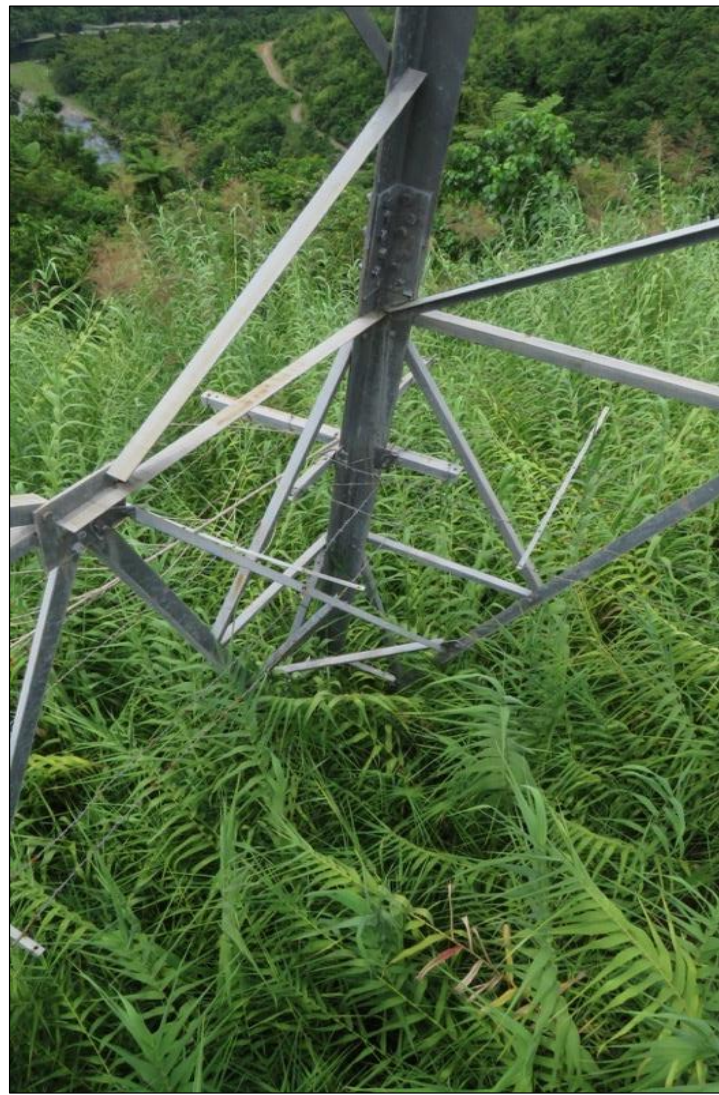
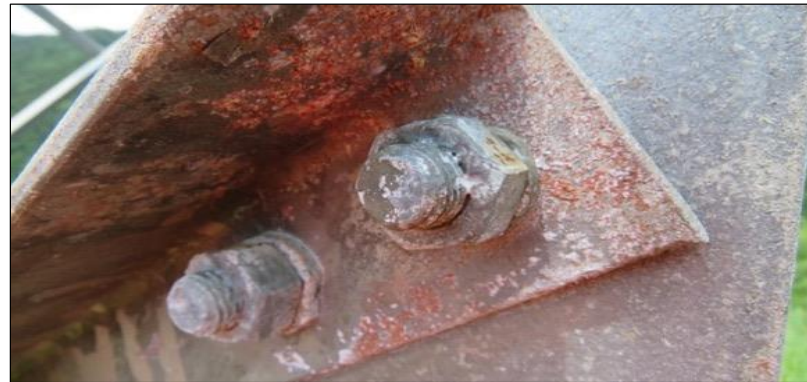
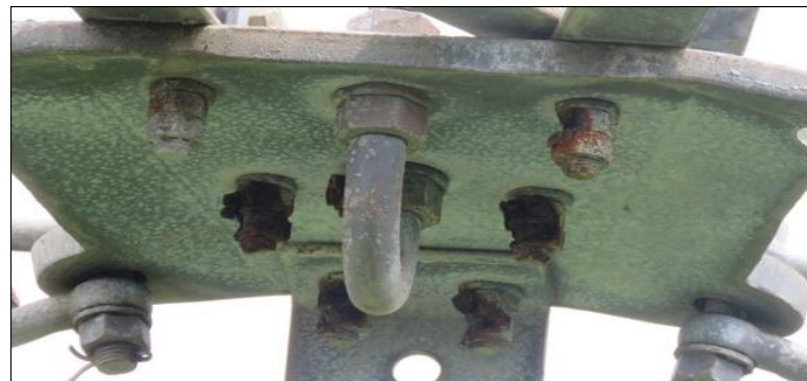
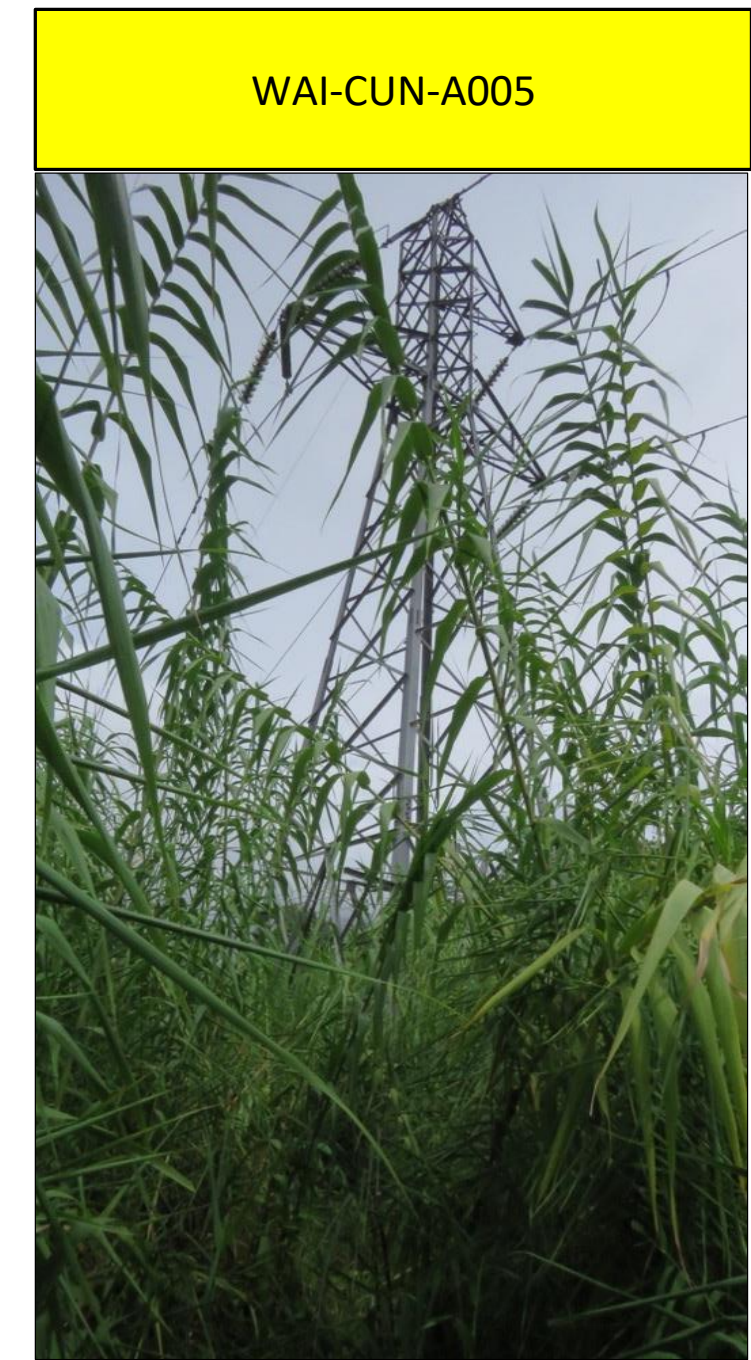
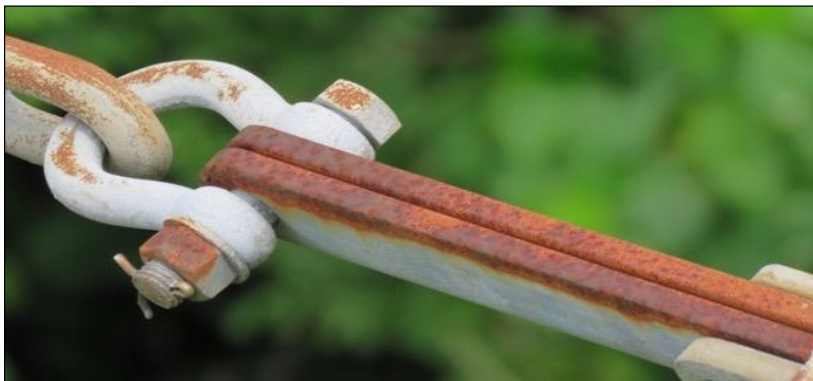
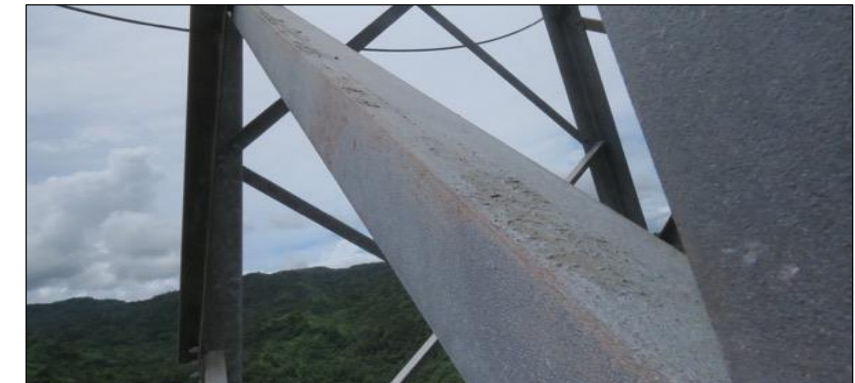
- 15 M16 Tower Bolts R/C
- Needs Vegetation Control
- CA Data
- Heavy Surface Corrosion on Sag links.
- Holding Plate Bolts R/C (5 on Yellow Phase)
- Holding Plate Bolts R/C (2 on Red and Blue Phase)

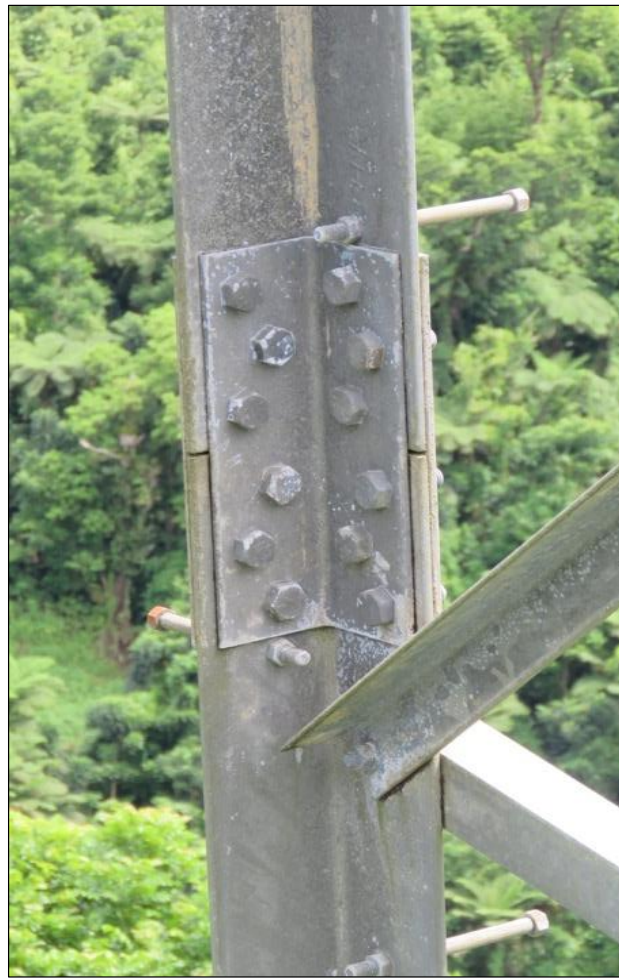
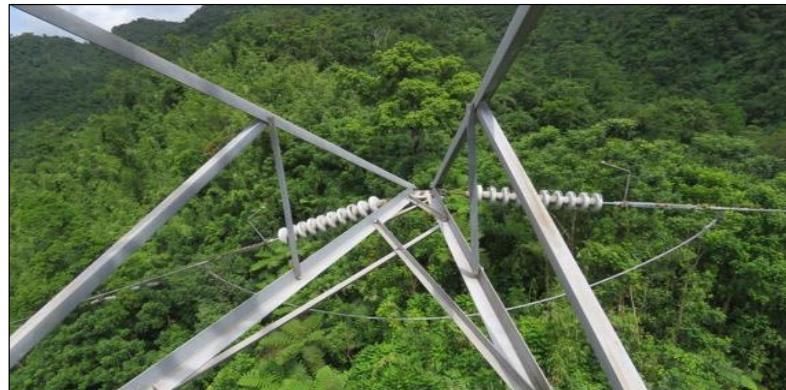
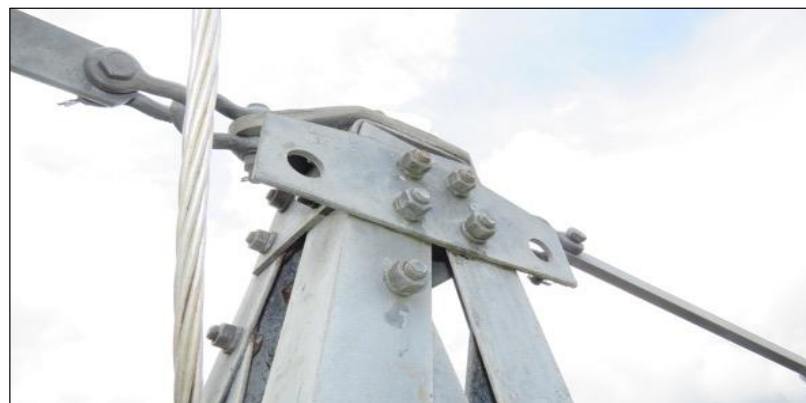
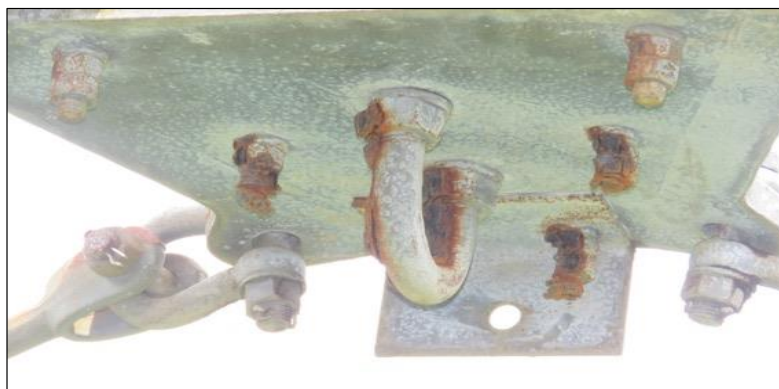
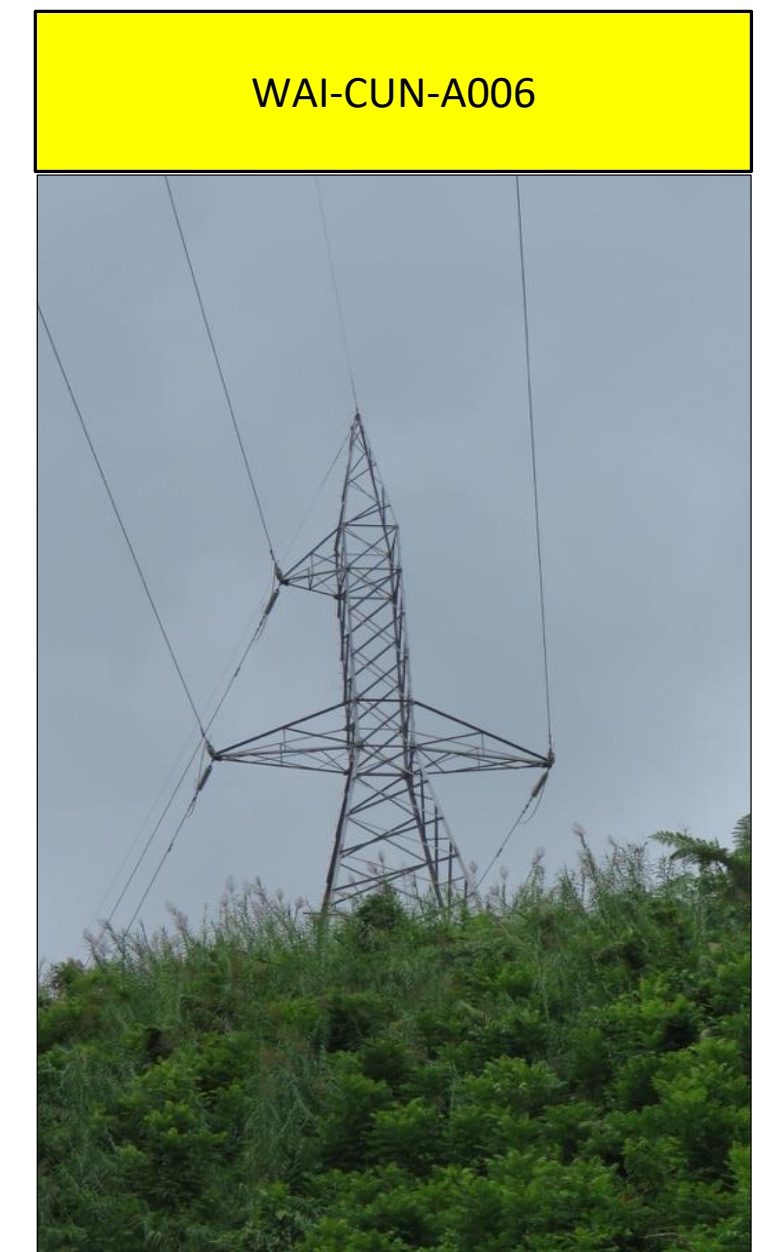
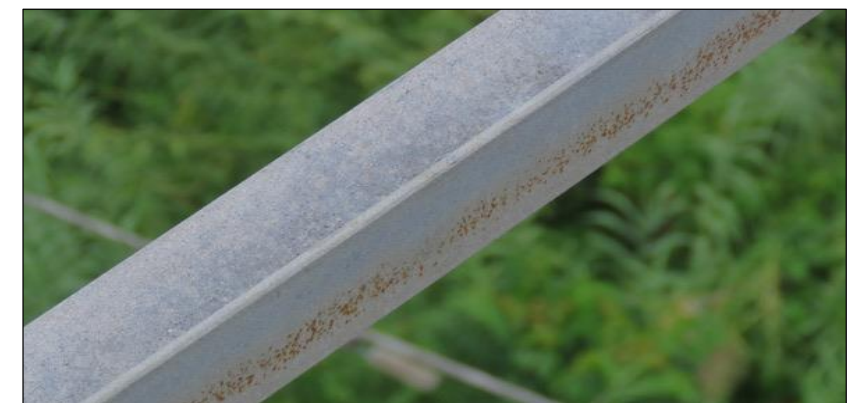
- Heavy Moss and Mold on the Base on the Structure
- 60 M16 Tower Bolts R/C.
- CA Data
- Surface Rust on Sag Links
- Heavy Moss and Mold on Insulators
- Holding Plate Bolts R/C on all Phases

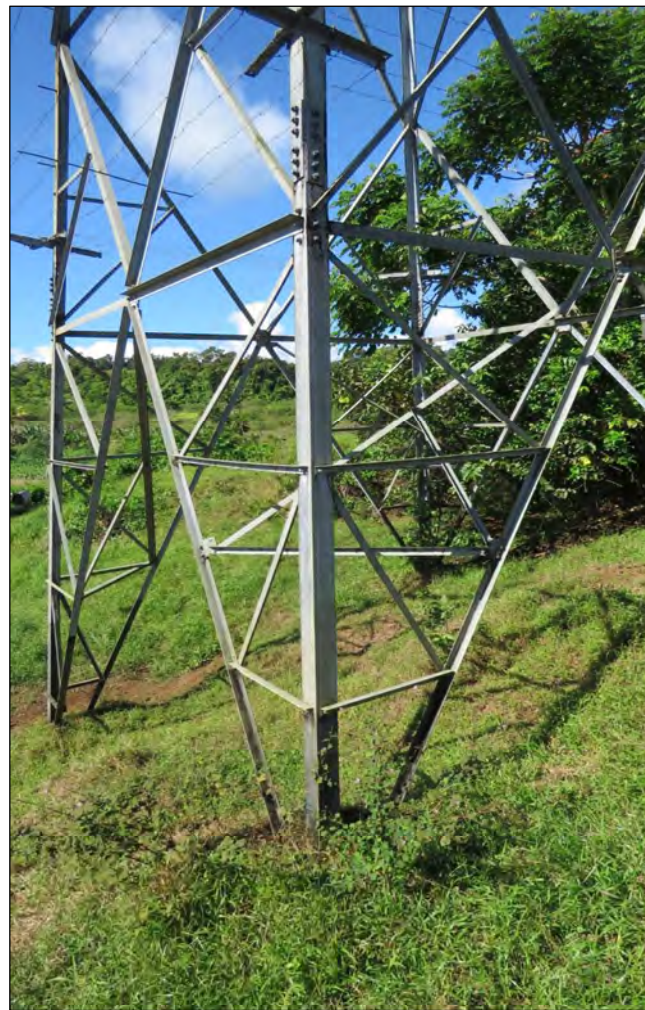
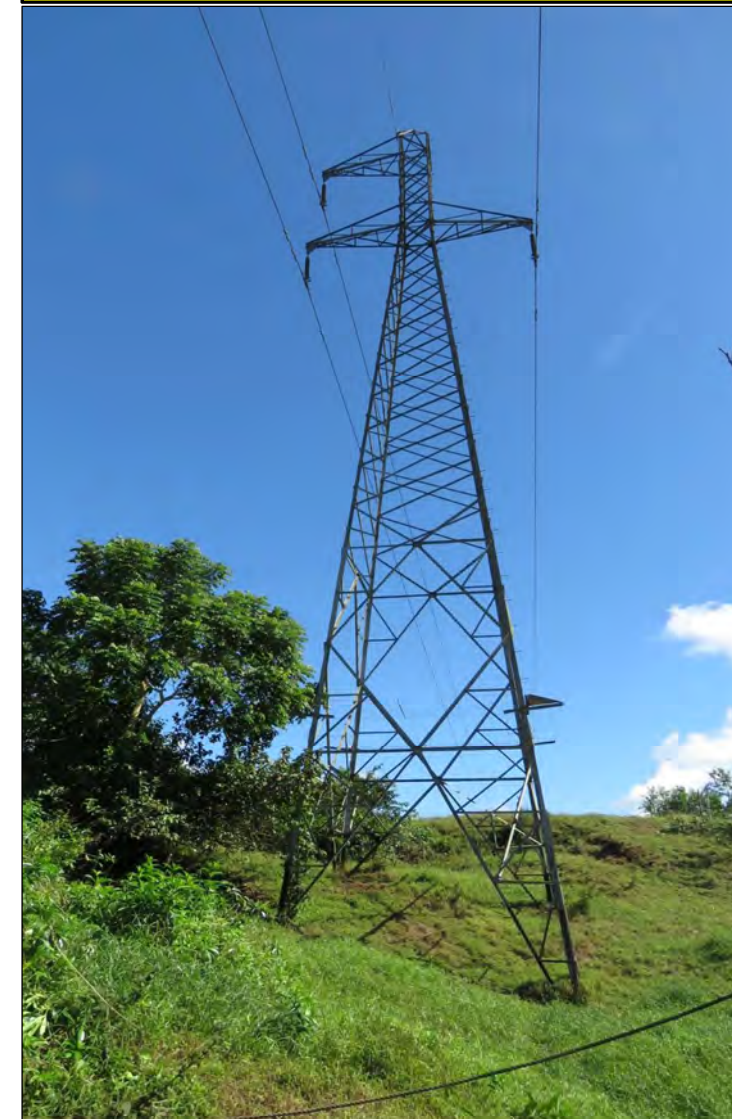
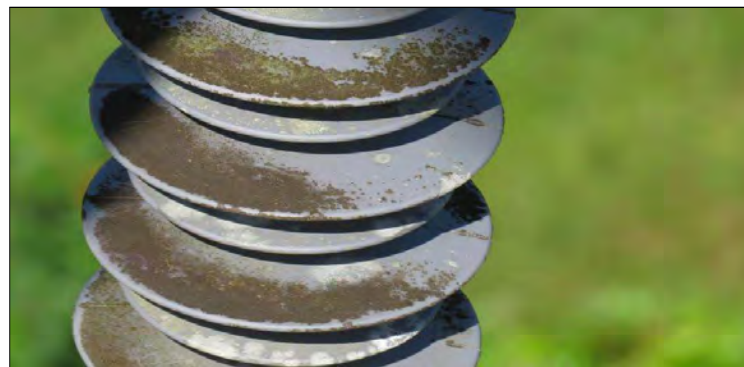
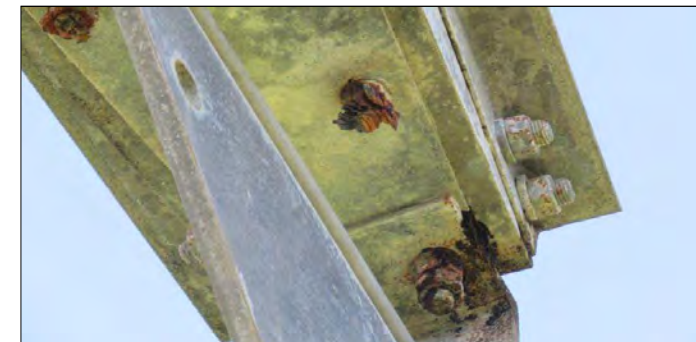
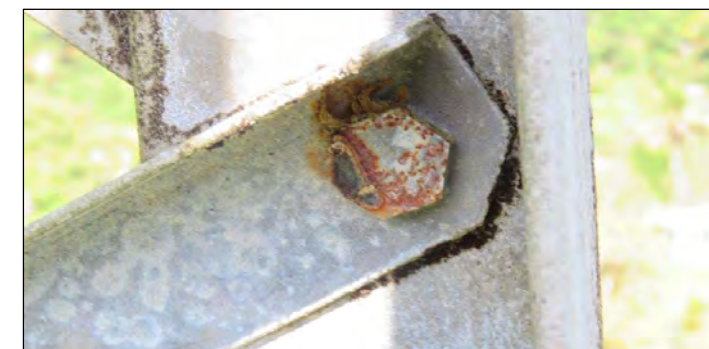
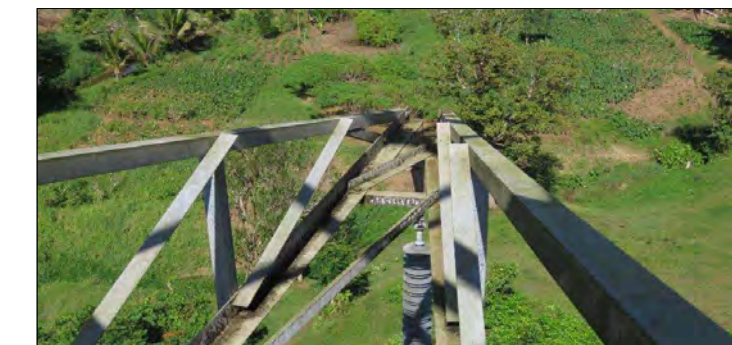
WAI-CUN-A086

- Grey paint on legs 1-2m above ground level and on random bolts on tower
- Moss and mould on tower
- Anti-climb wire broken
- House 150m from B/C face
- Crops 100m from A-B face
- River 100m from A leg
- **CA Data**
- Holding plate bolts all phases R/C (24 in total)
- Through bolts not standard need a lock nut fitted
- Old style dampers R/C x 6
- M16 tower bolt R/C x 100
- Minor moss and mould on insulator
