Wailoa- Vuda

WAI-VUD A Paint Towers 19/20		DRG. SIZE	SCALE	FOLDER	
				7/07/2023				A3	N/A	CAP18365			
LandOwner	Refer To Efl	Inspector-Tower	Karl Formo		LATITUDE	17°42'38.52"S		Work Scope Assessment Report - Jun-2023	WID	MR57-2021	SHEET	REVISION	
TowerAccess	Second Turen Left After Fulton College Off Sabeto Rd	Inspector-Ground	Karl Formo		LONGITUDE	177°30'38.52"E					1	2	
ContactName	Refer To Efl	Draft Report	R. Glover	24/04/2023					WAI-VUD-A0023				
ContactPhone	Refer To Efl	Report Review

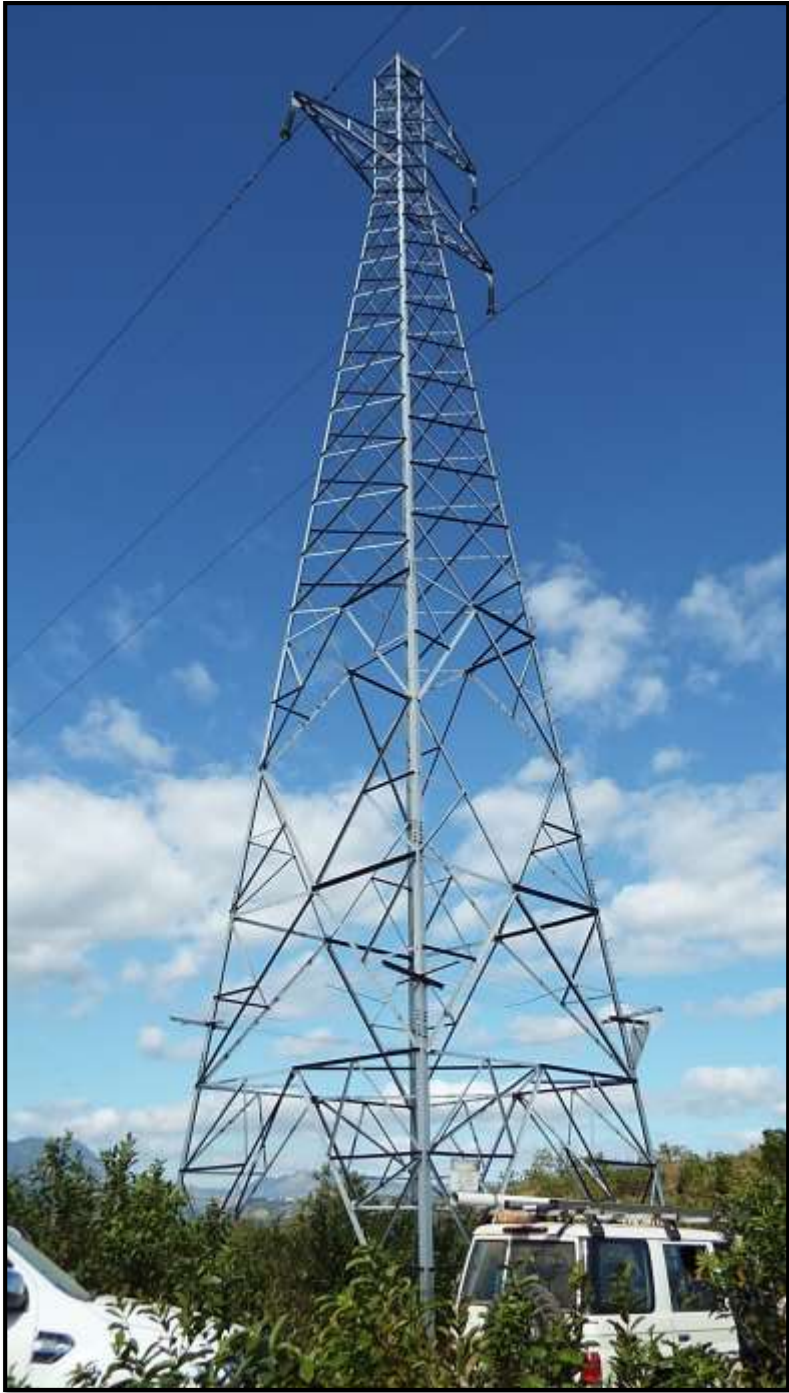
Structure looking towards CD Face

Comments
Track access maintenance required prior to entry
LSD - faded
no CPI - Fiji
Minor vegetation managennt needed around base of structure
Coal tar epoxy painted 1m up each leg
Light ZCP throughout structure
Dross throughout structure steel
There is a River ford on the way to the structure, exercise caution during wet season
Bird excrement on members throughout structure
2 x aerial id's on tower
Minor bend on A-Leg K-brace DA phase
