WAI-VUD-A0021

_			
WAI-VUD A Paint Towers 19/20		SCALE FO		LDER			
WAI-VOD A Paint Towers 19/20	A3	N/A	CAP18365				
	WID	MR57-2021	SHEET	REVISION			
Mark Carra Assessment Daniel Ive 2002	WID	IVIN 37-202 I	1	2			
Work Scope Assessment Report - Jun-2023		WAI-VUD-A0021

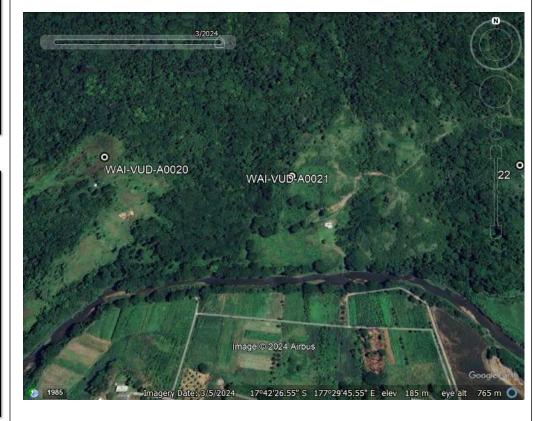
Tower base needs clearing Legs painted with CTE about 400mm above ground level

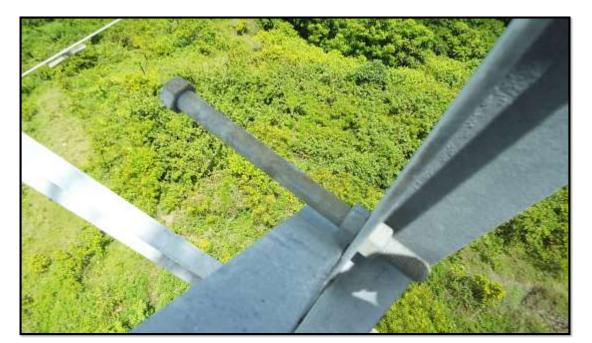
Minor construction damage to steel member main horizontal coming of B-Leg

Top chord coming off B-Leg minor construction damage, top cross arm.

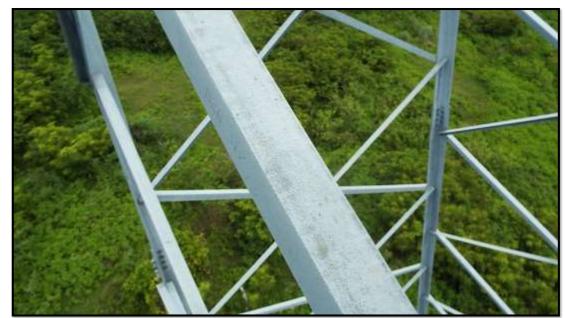
Minor galv flaw on top cross arm floor steel, at end of cross arm, diagonal.

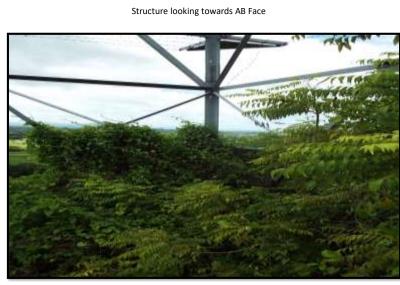
Light ZCP through out tower

Dross noted throughout tower
