| Device Position Description | WAI-VUD-A0027 | |

Wailoa- Vuda

| LANDOWNER DETAILS | | INSPECTION TEAM<br>LUMEN | | Date | GPS COORDINATES (WGS84) | | | WAI-VUD A Paint Towers 19/20 | | DRG. SIZE | SCALE | FOLDER | |
|---|---|---|---|---|---|---|---|---|---|---|---|---|--|
| LandOwner | Refer To Efl | Inspector-Tower | Karl Formo | | LATITUDE | 17°42'39.24"S | | Work Scope Assessment Report - Jun-2023 | WID | MR57-2021 | SHEET | REVISION | |

VUDA - WAILOA LINE  
TOWER 67-1(27) OUTLINE

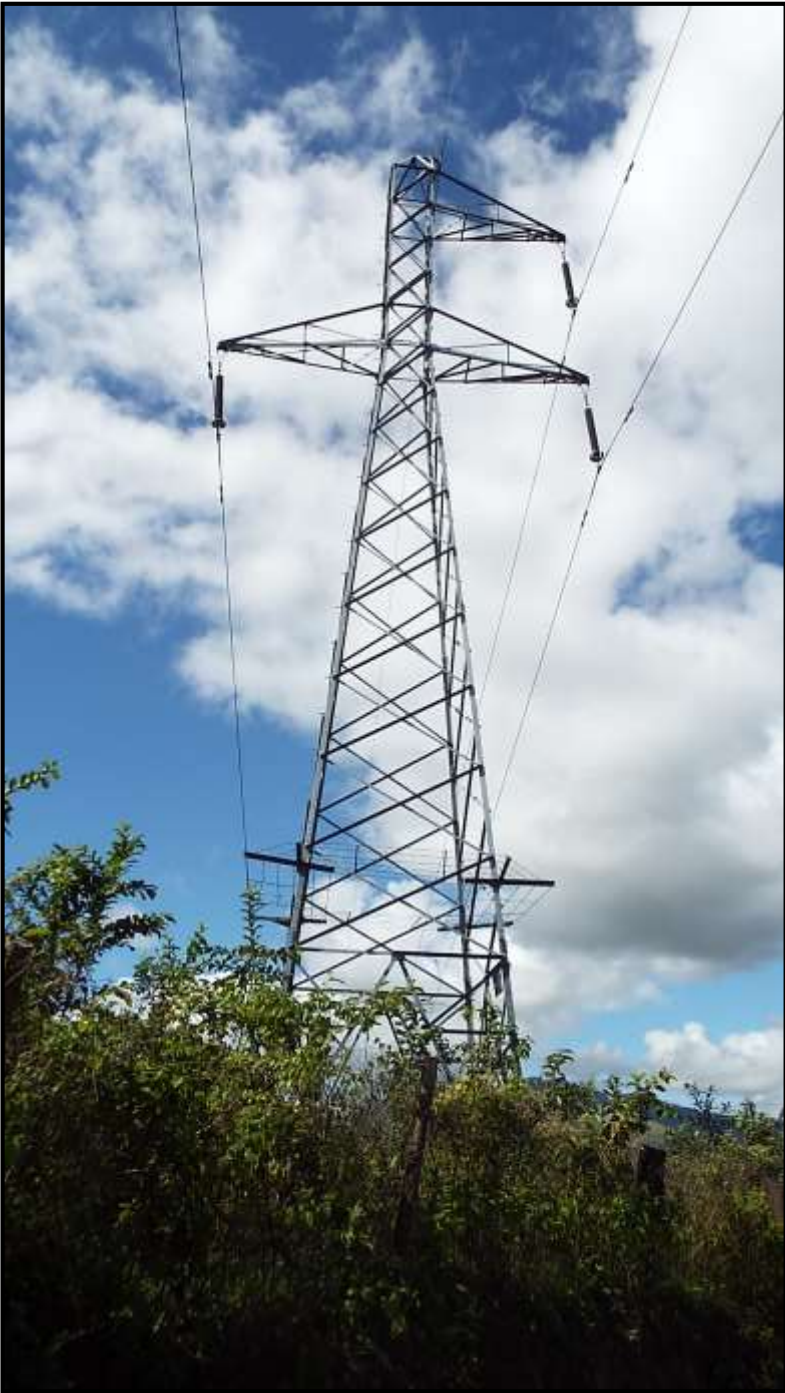
Structure looking towards CD Face

| Device Position Description | WAI-VUD-A0027 | |
|---|---|---|
| Rust m² | 6 | 6% |
| Sweep m² | 77 | 73% |

| Major vegetation management needed around base of structure. | | |
| CTE painted 1m up each Leg | | |
| Light ZCP through out structure | | |
| Dross throughout structure on steel | | |
| Bird excrement on members throughout structure | | |
| LSD - faded | | |
| TVHZ, 4 wire fence withing 5m of C-Leg | | |

| Track access maintenance required prior to entry | | |
