WAI-VUD-A		
				19/02/2025				DRG. SIZE	SCALE	FOLDER
LandOwner	Efl To Sort Out	Inspector-Tower	Karl Formo		LATITUDE	17°42'45.72"S		A3	N/A	CAP20477
TowerAccess	Sabeto Road/Zip Line	Inspector-Ground	Karl Formo		LONGITUDE	177°35'11.76"E				
ContactName	Efl To Sort Out	Draft Report	R Glover	12/02/2025						
ContactPhone	Efl To Sort Out	Report Review	M Boardman	12/02/2025				Work Scope Assessment Report - Feb-2025		
							WAI-VUD-A0032

STRUCTURE DESCRIPTION	
LINE:	WAI-VUD-A
STR No:	0032
BODY EXTN:	NIL
LEG A:	-2
LEG B:	+3
LEG C:	+/-0
LEG D:	-2
INSPECTED BY:	Karl Formo
COMPANY:	LUMEN
DATE:	19/02/2025

ENERGY FIJI LTD		SCALE N.T.S	
VUDA - WAILOA LINE TOWER 65-2(32) OUTLINE		VUD-WAI 65-2	ISS. -2

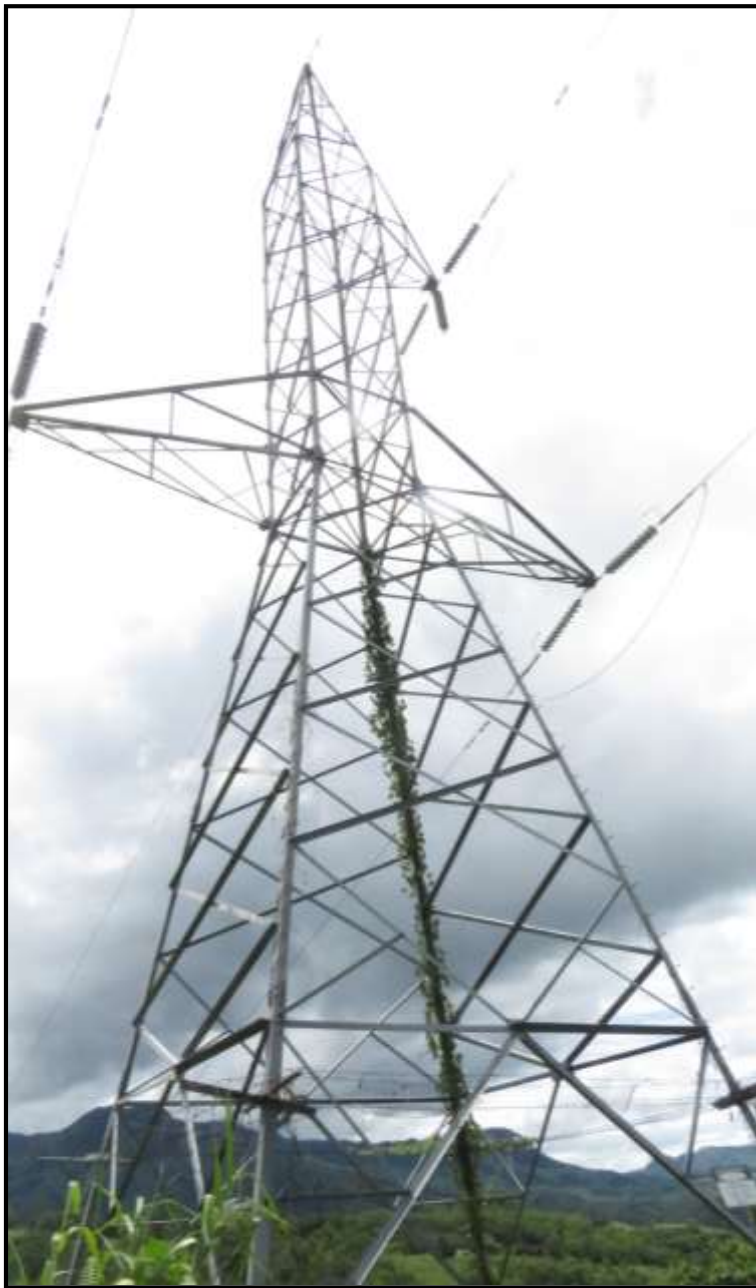
Structure looking towards CD Face
