Tower ID	WAI-VUD-A0045		
Contract number	\$2G+6		
Final No.	60-2		
Insulator Type/ Condition	COMPOSITE		
Туре	0		
Body Extn - size	0		
Legs - size	+1, -1, +/-0, +2		
Earth Wire	YES		
Tower Area m ²	122		
Rust m ²	11 9%		
Sweep m ²	89 74%

Work Scope Assessment Report - May-2025	WAI-VUD-A0045				
Work Coops Assessment Depart May 2025		U	1	2	
	WID	0	SHEET	REVISION	
WAI-VUD-A		N/A	CAP20477		
WAI-VUD-A		DRG. SIZE		TOLDER

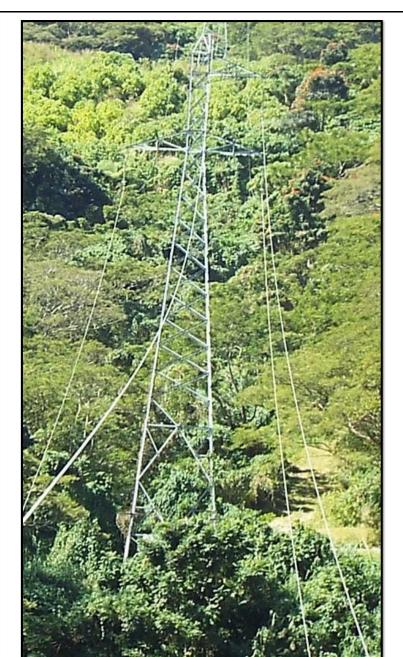
Structure	looking	towards	AB Face

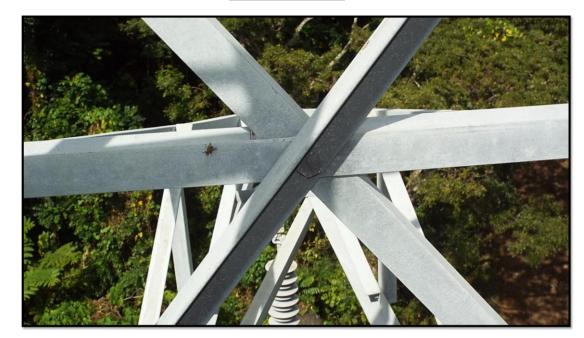
CPI on Face
