Wailoa- Vuda

| LANDOWNER DETAILS | | INSPECTION TEAM<br>LUMEN | | Date | GPS COORDINATES (WGS84) | | | WAI-VUD A Paint Towers 19/20 | | DRG. SIZE | SCALE | FOLDER | |
|---|---|---|---|---|---|---|---|---|---|---|---|---|---|
| | | | | | | | | Work Scope Assessment Report - Jun-2023 | | WID | MR57-2021 | SHEET<br>1 | REVISION<br>2 |
| WAI-VUD-A0183 | | | | | | | | | | | | | |

| ENERGY FIJI LTD | | SCALE N.T.S | |
|---|--|---|---|
| VUDA - WAILOA LINE<br>TOWER 3-1(183) OUTLINE | | VUD-WAI 3-1 | ISS. -1 |

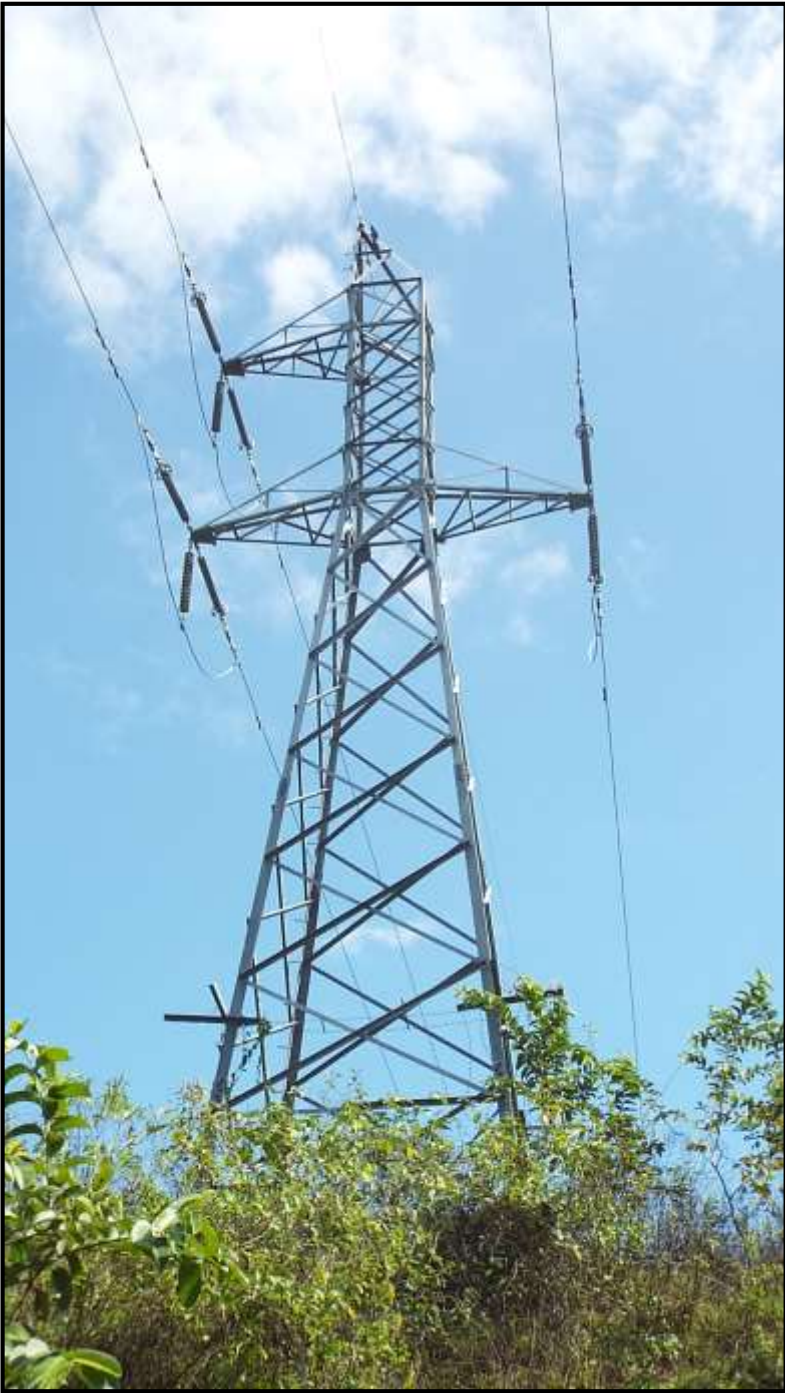
Structure looking towards CD Face
