# *Geotechnical investigation*

## Nauru Solar Panel Facility

for Elemental Group Power and Renewables

Rev 2 - 24/10/2017

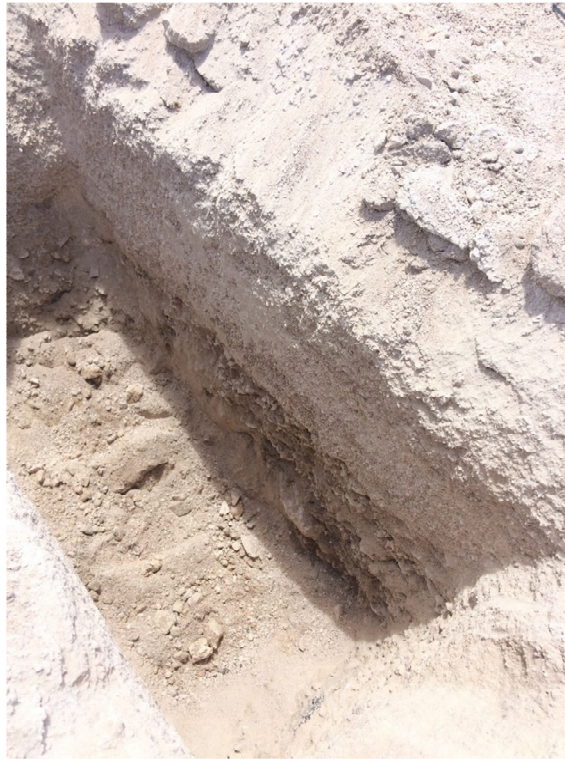
The sub-soil conditions of the flat areas consist of hard, granular/rock soil, well suited for the construction of shallow foundations. The ground will generally provide 300 kPa ultimate bearing capacity.

**Figure: Typical excavated ground conditions in test pits**

Foundations constructed by either excavation or driving piles will likely prove difficult and expensive due to the hard, granular ground conditions observed over the site extents. Therefore, a pre-cast foundation with minimal excavation into the existing soil would likely be easier to construct compared to an excavated, cast in-situ foundation.

The recommended foundation to support the solar panels (based on the geotechnical investigation findings) is pre-cast concrete ground beams spanning one-way between panel support posts, as discussed in Section 3 of this report. Driven piles/supports, like those used at the initial site on the island are likely to be not possible due to the more compact ground at the proposed site.

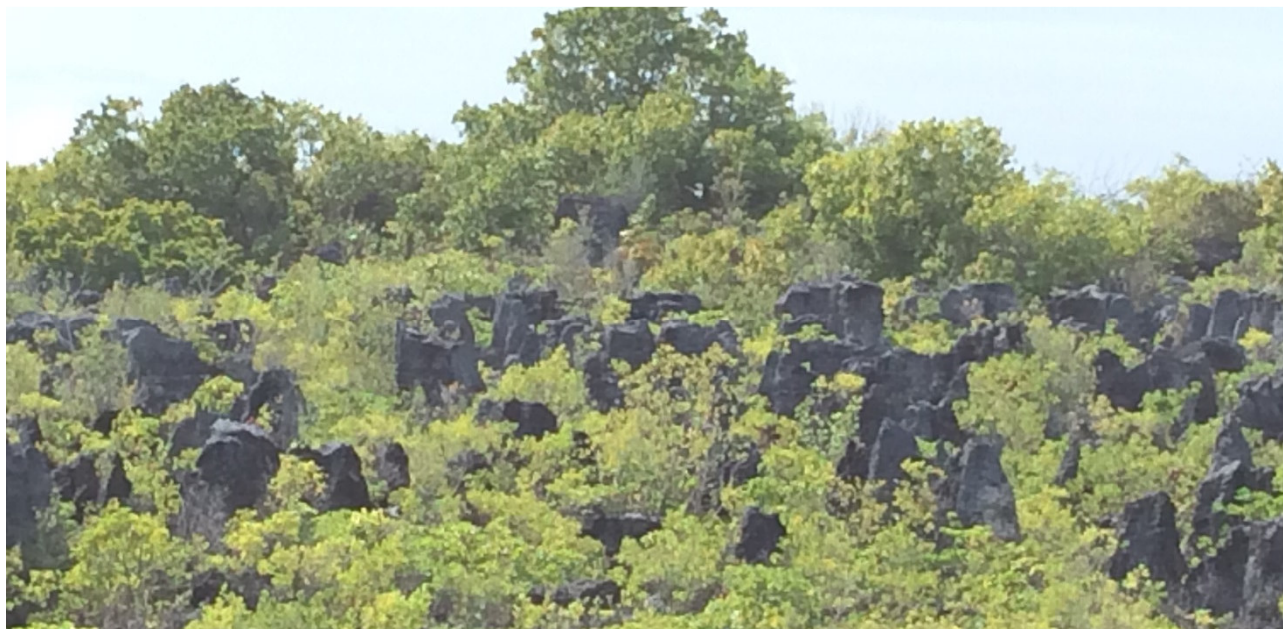
The island is primarily developed on the coastal perimeter and surrounding the inland 'Buda Lagoon'. The majority of the inland section of the island is relatively undeveloped, with terrain consisting of limestone pinnacles and large depressions with vegetation. Figure 1.2 displays typical inland terrain of the island. The proposed solar development site is located opposite the Nauru Australian Immigration Detention Centre.

Figure 1.2: Photo of typical inland terrain on Nauru

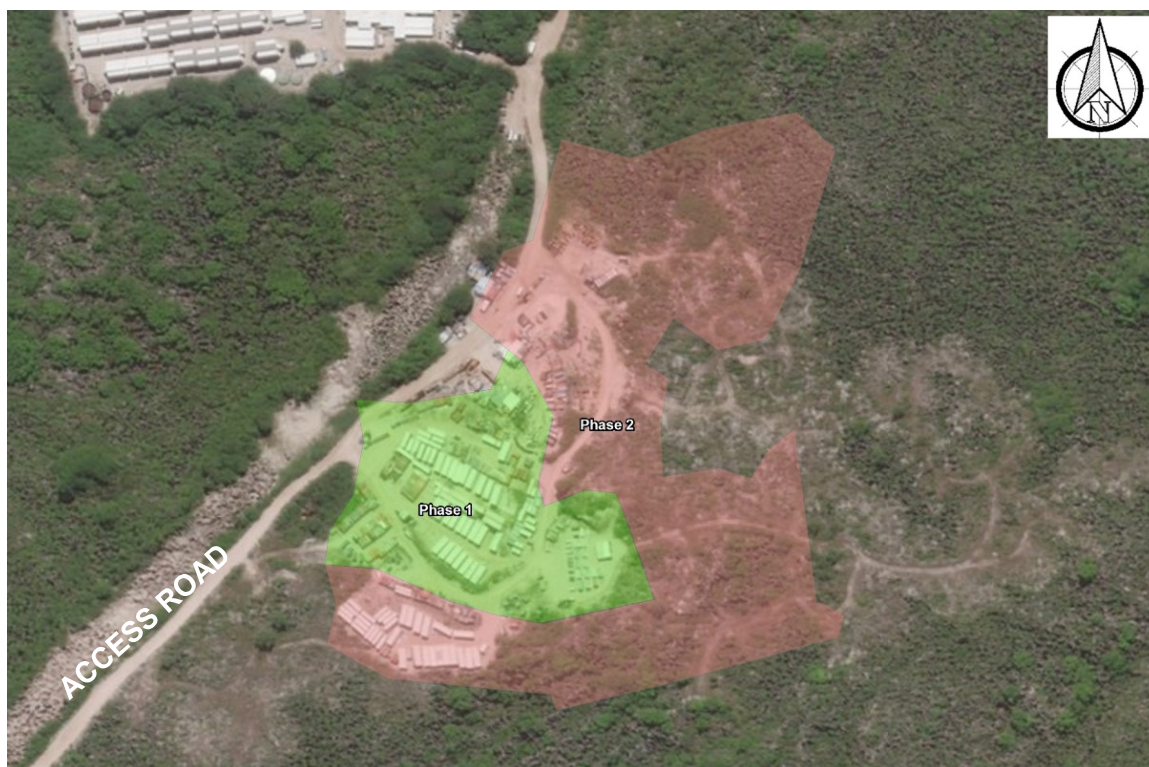
This investigation and report focuses on the 'Phase 1' area identified by the green hatching below in Figure 1.3. This area of the site has been remediated and flattened following phosphate mining, to form five relatively flat areas. The five flat areas located within the site are identified and labelled in Figure 1.4.

Phase 2 area of the site (identified by the red hatching) consists primarily of limestone pinnacles with depressions (typical geology for the island). One flat area exists within the Phase 2 extents that has been flattened and remediated following mining (labelled as area 4 in Figure 1.4).

Figure 1.3: Aerial view of site indicating Phase 1 (green hatch) and Phase 2 (red hatch) areas.

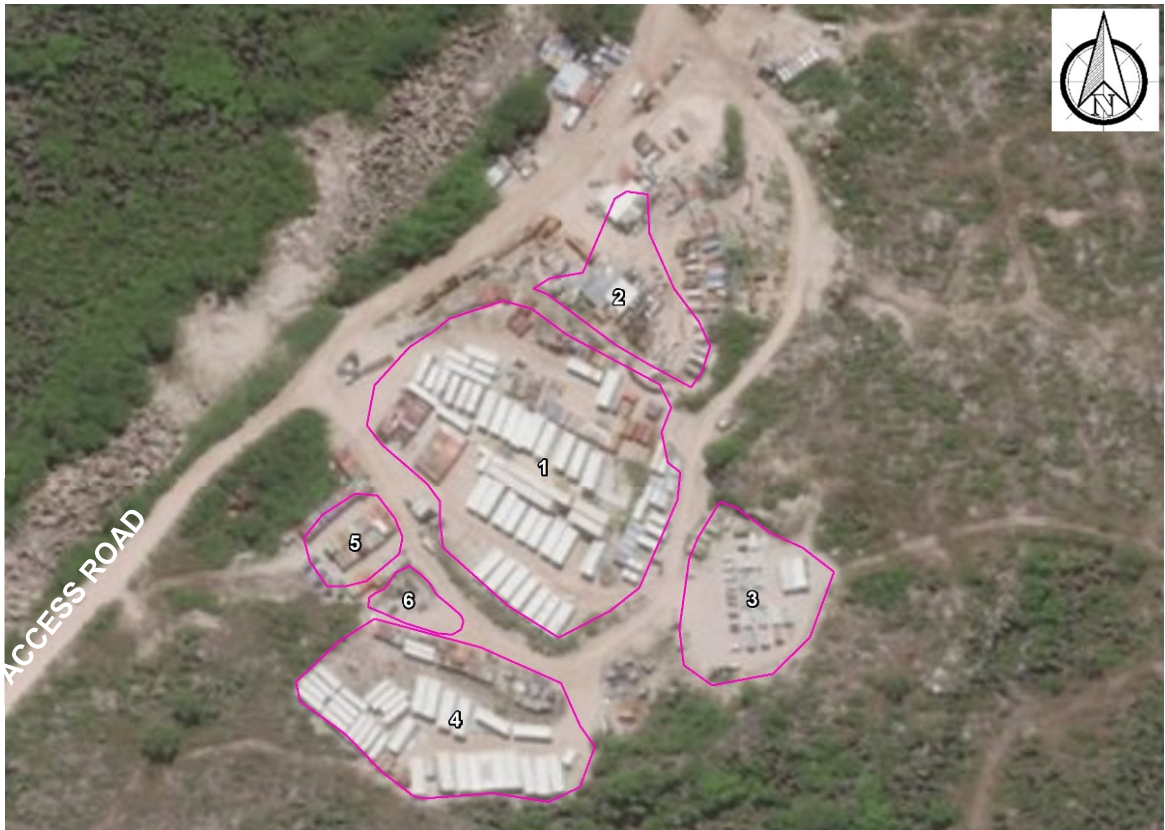
Figure 1.4: Aerial view of the site identifying indicative locations of the existing level pad areas on the site

Dynamic Cone Penetrometer (DCP's) (Scala) testing was attempted in a 10 m x 10 m grid over the full extents of Area 1 (location shown in Figure 1.4). The penetrometer reached refusal before penetrating 50 mm below existing ground level at all locations tested.

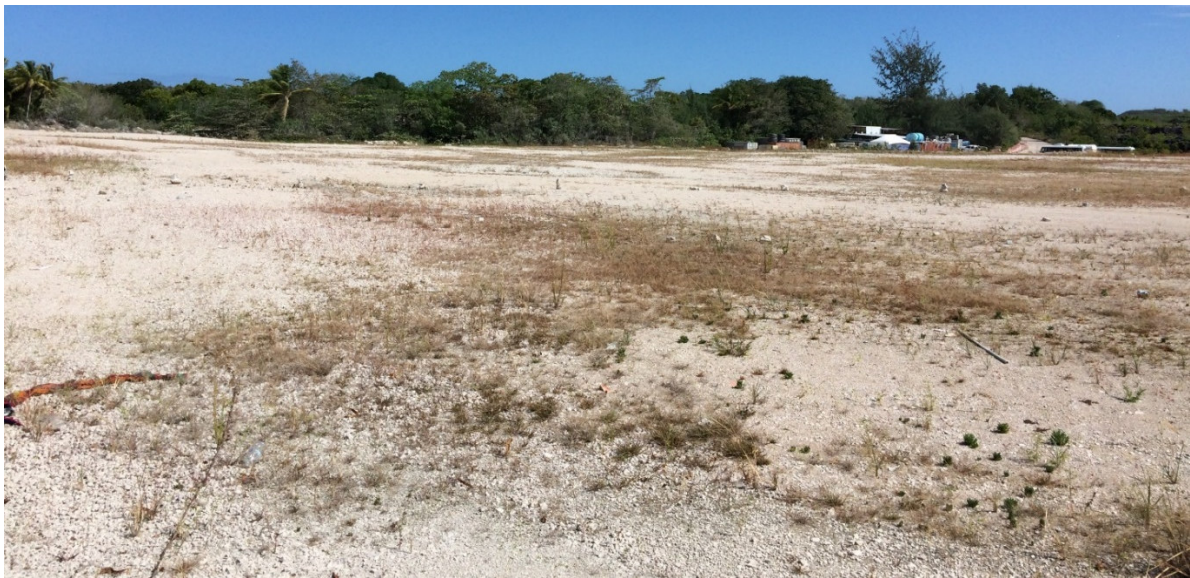
Figure 1.5: Photo of Area 1 (looking in the northern direction)

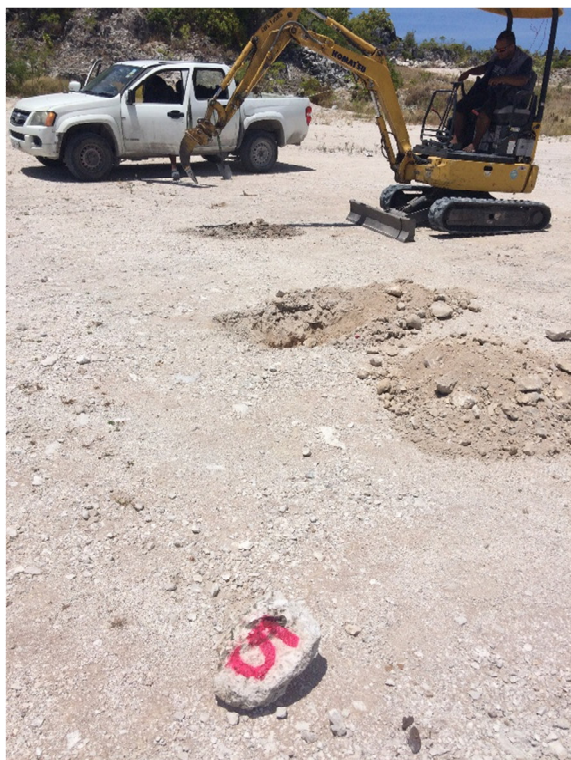
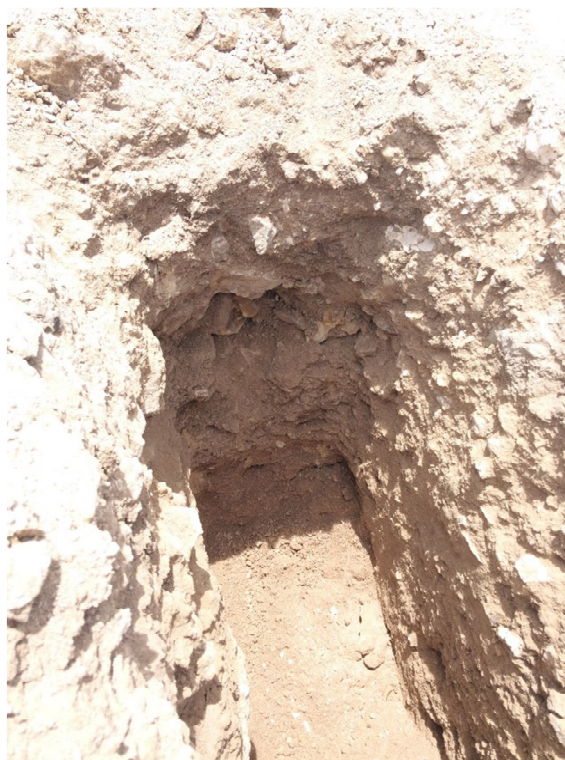
A small local excavator, estimated at 1.8 tonne (see Figure 2.2 ) was used to excavate the pits. A soil profile typical over the site is shown in the right-hand photo shown in Figure 2.2 .

Figure 2.2: Excavator used for test pits (left TL-E/A5). Typical soil profile of test pits across site (right Test pit TL-A:A1)

The site soil conditions of the flat areas at the site are typically hard, compact granular fill with large rock inclusions. Limestone pinnacles were exposed on occasion in the test pit excavations, and appeared that the flat areas have been created by breaking down the limestone pinnacles to pad level, and backfilling the depressions by compacting crushed rock and other granular fill (such as sand/gravel).

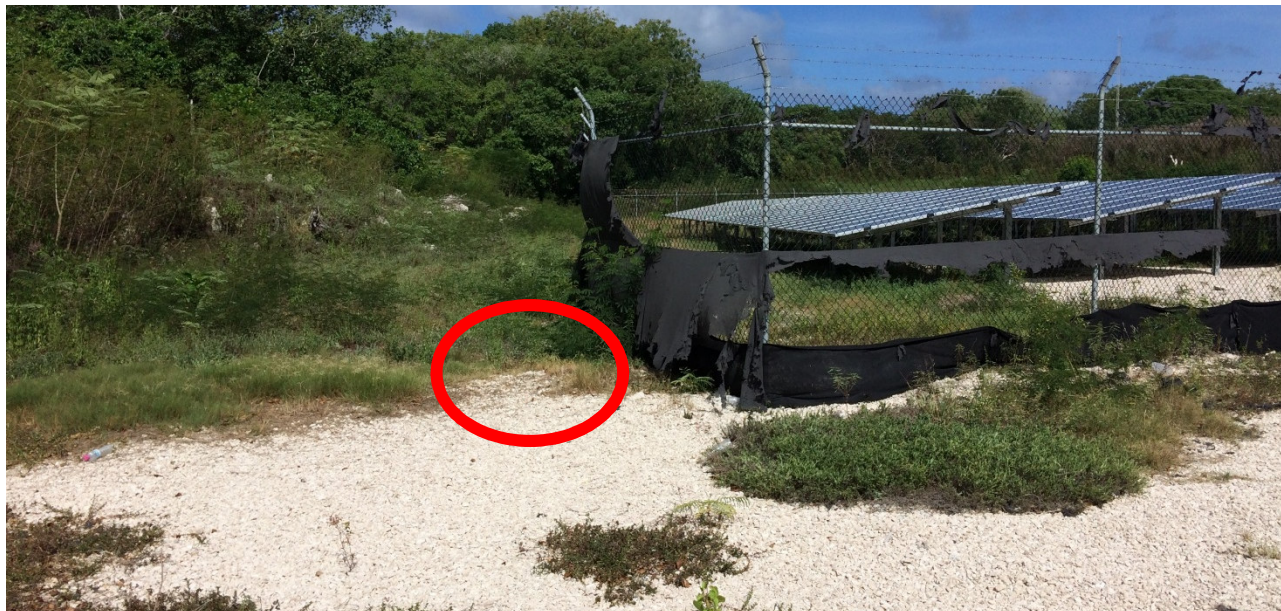
One DCP test was completed just outside the western perimeter fence of the existing solar panel development that has been constructed on the island (approximately 1.6 km west of the proposed solar panel site). Refer to Figure 2.1 for the penetrometer test location. The penetrometer did not meet refusal at this site, and was driven down to 1200 mm below existing ground level, averaging

approximately 10 mm / blow over the full soil profile tested (correlating to an indicative CBR of approximately 23).

Figure 2.3: Approximate location of the dynamic cone penetrometer test completed on the existing Nauru solar panel development (circled red)

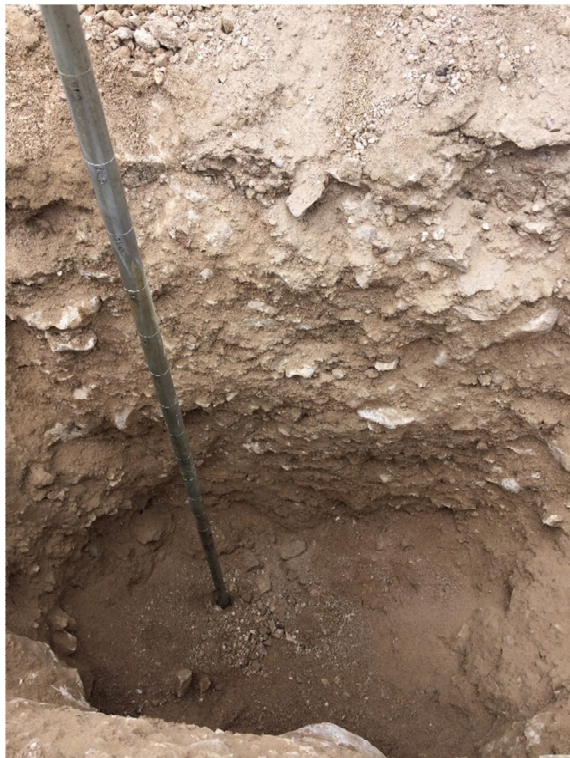
| Test Location<br>(Refer to Figure 2.1 for locations) | Depth below existing ground | Description |
|---|---|---|
| TL-A | 0 – 1000 | Compact grey/brown coloured gravel/sand with rock inclusions (200 mm maximum rock particle size). Very hard material to excavate. Minor silt inclusions creating a brown colouring to the sand. |

Test Pit 1 (Total Depth = 1000mm)

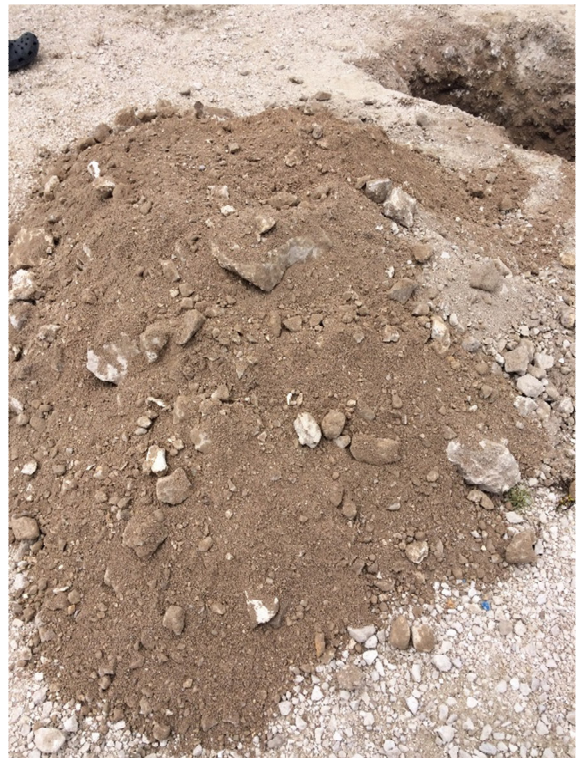
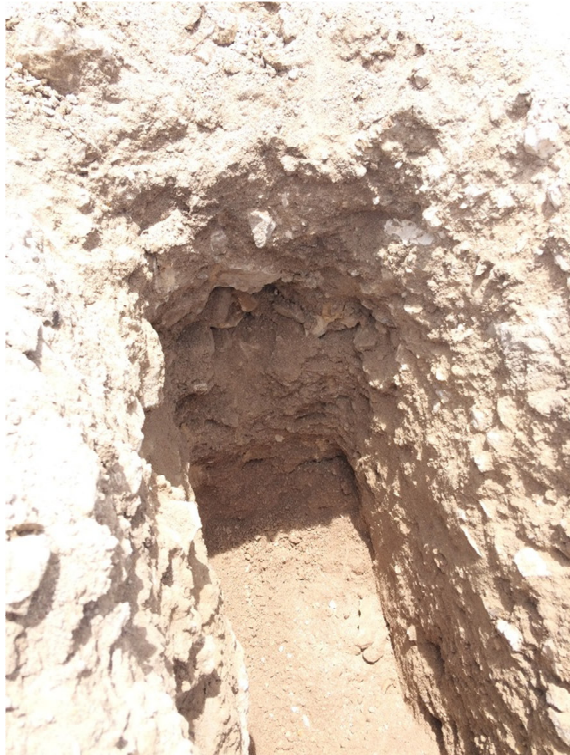
| Test Location<br>(Refer to Figure 2.1 for locations) | Depth below existing ground | Description |
|---|---|---|
| TL-B | 0 – 1100 | Compact grey gravel/sand with rock inclusions (200 mm maximum rock particle size). Very hard material to excavate. |

Test Pit 2 (Total Depth = 1100mm)

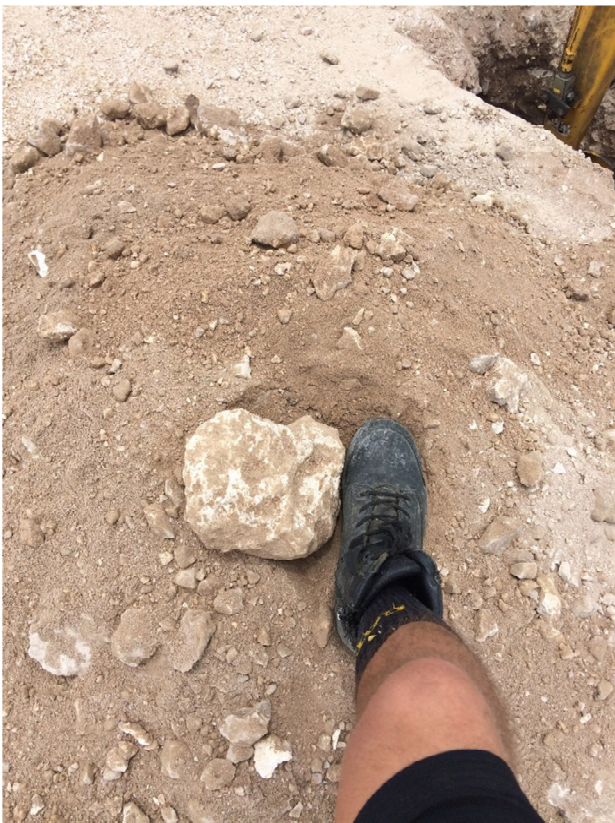
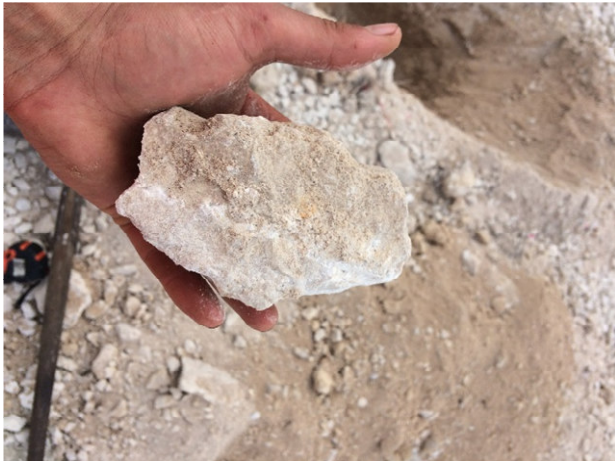
| Test Location<br>(Refer to Figure 2.1 for locations) | Depth below existing ground | Description |
|---|---|---|
| TL-C | 0 – 500 | Rock pinnacle with some compacted grey gravel/sand. Breaking rock to excavate to 500 mm depth – very hard material. |

Test Pit 3 (Total Depth = 500mm)

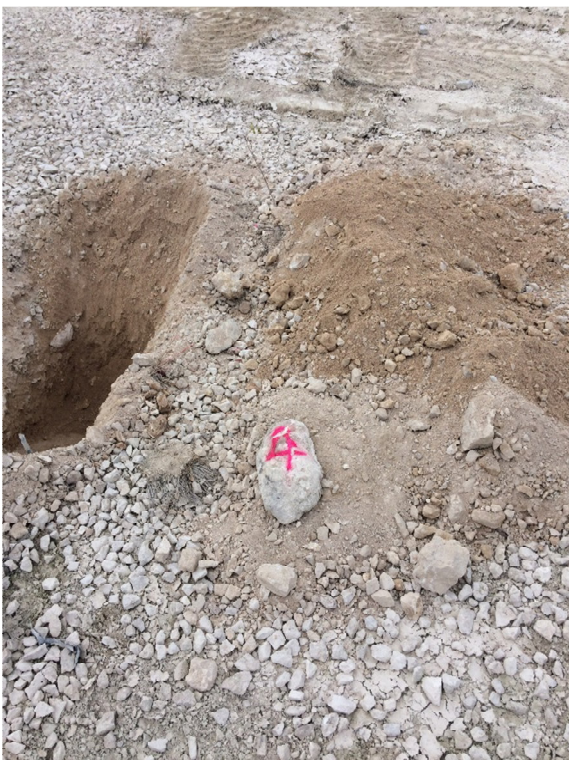
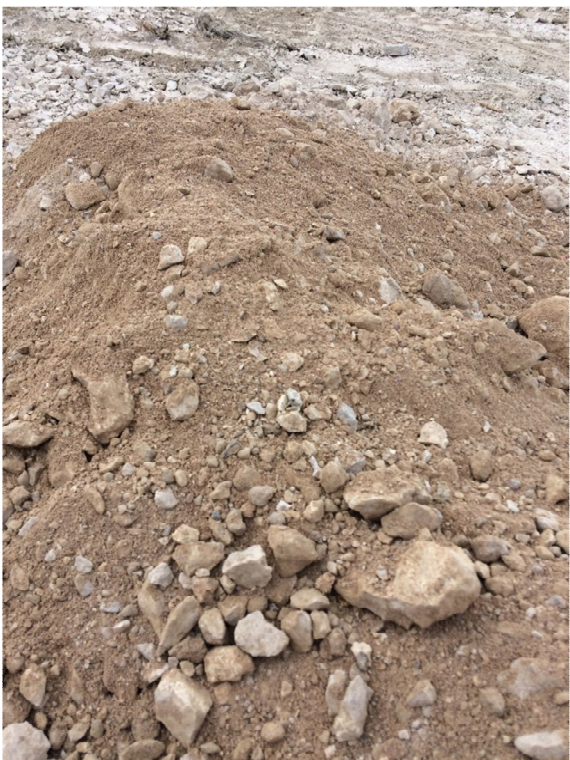
| Test Location<br>(Refer to Figure 2.1 for locations) | Depth below existing ground | Description |
|---|---|---|
| TL-D | 0 – 700 | Rock pinnacle with some compacted grey gravel/sand. Breaking rock to excavate to 500 mm depth – very hard material. |

Test Pit 4 (Total Depth = 700mm)

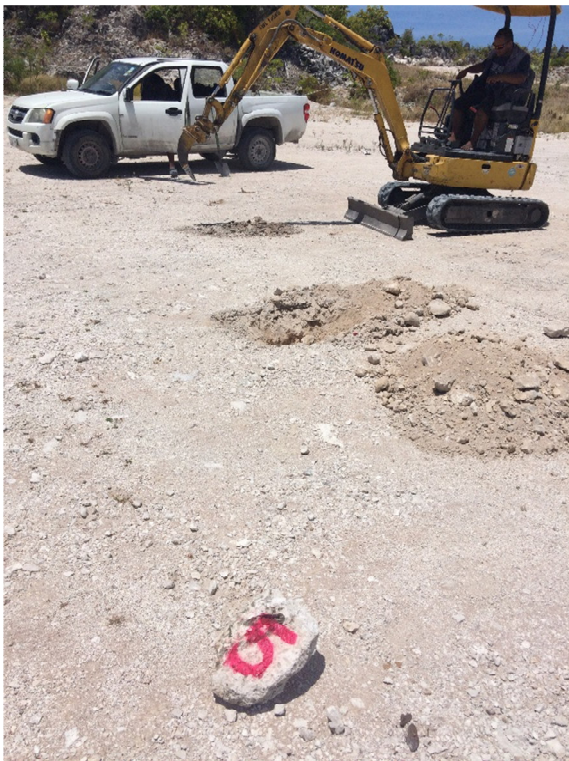
| Test Location<br>(Refer to Figure 2.1 for locations) | Depth below existing ground | Description |
|---|---|---|
| TL-E | 0 – 1500 | First excavation not possible to excavate (likely rock pinnacle). Offset test location 1500 mm and excavation successful on second location.<br>Compact grey/brown coloured gravel/sand with rock inclusions (100mm maximum rock particle size). Hard material to excavate. Minor silt inclusions creating a brown colouring to the sand.<br>Granular material surrounded by hard rock pinnacle (likely excavating natural depression). |

Test Pit 5 (Total Depth = 1500mm)

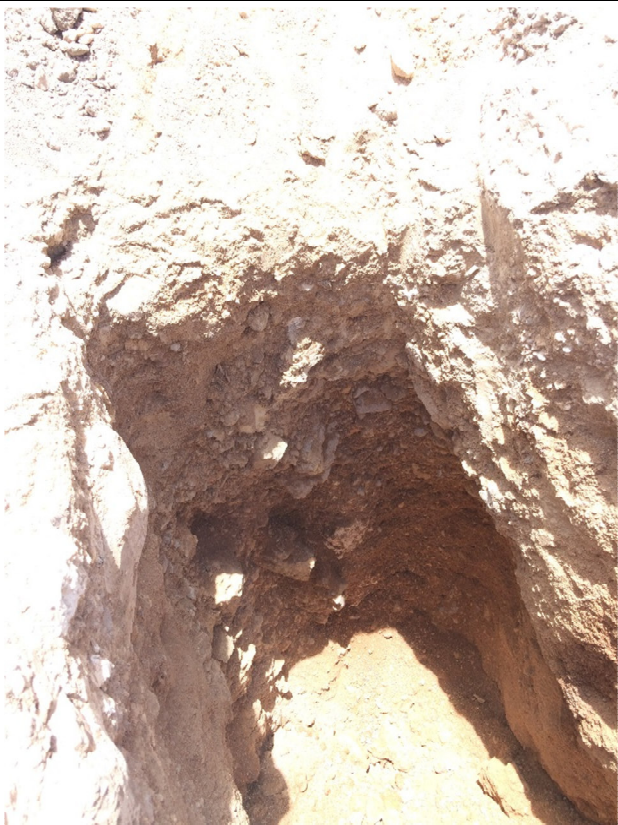
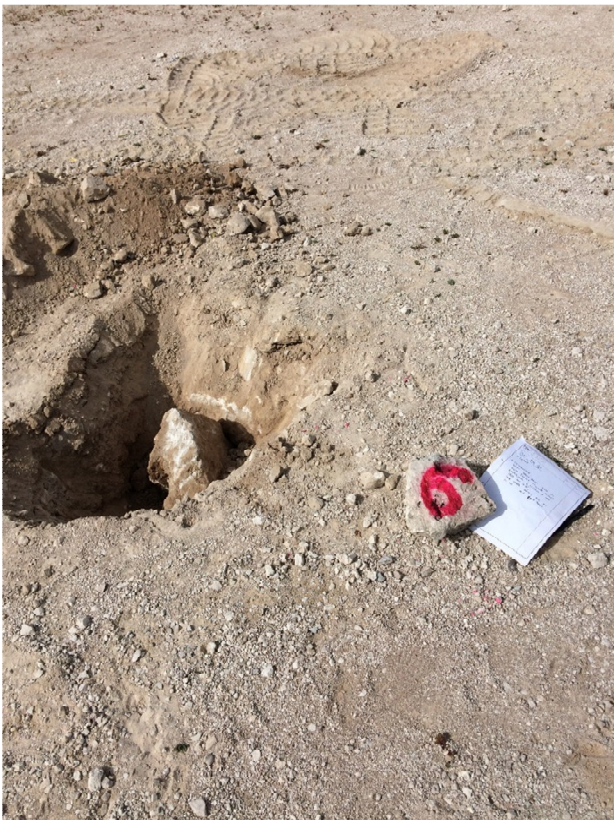
| Test Location<br>(Refer to Figure 2.1 for locations) | Depth below existing ground | Description |
|---|---|---|
| TL-F | 0 – 600 | Compact grey/brown coloured gravel/sand with rock inclusions (400 mm maximum rock particle size). Hard material to excavate. Minor silt inclusions creating a brown colouring to the sand. |

Test Pit 6 (Total Depth = 600mm)

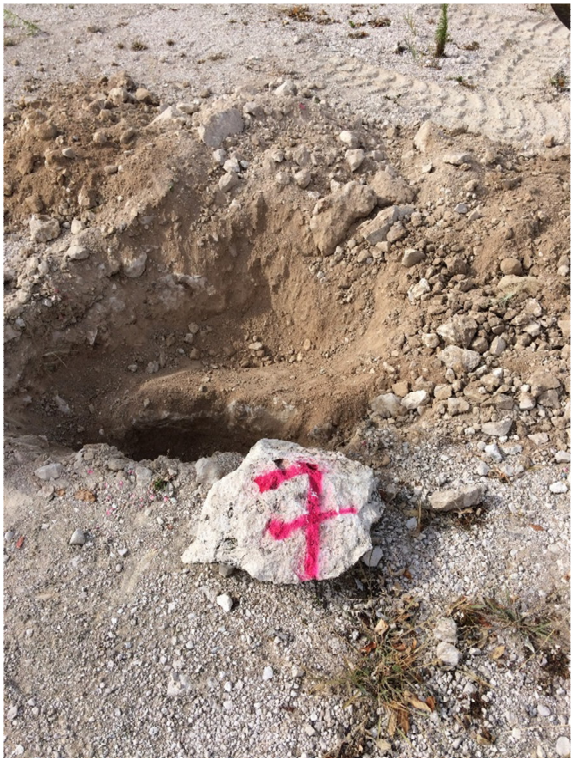
| Test Location<br>(Refer to Figure 2.1 for locations) | Depth below existing ground | Description |
|---|---|---|
| TL-G | 0 – 500 | Compact grey/brown coloured gravel/sand with rock inclusions (200 mm maximum rock particle size). Hard material to excavate. Minor silt inclusions creating a brown colouring to the sand.<br>Large pinnacle/rock at 500 mm depth that could not be excavated. |

Test Pit 7 (Total Depth = 500mm)

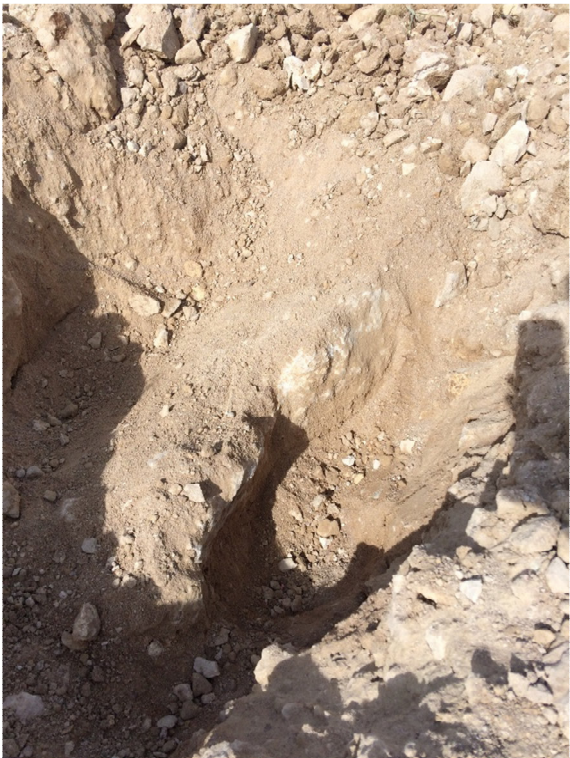
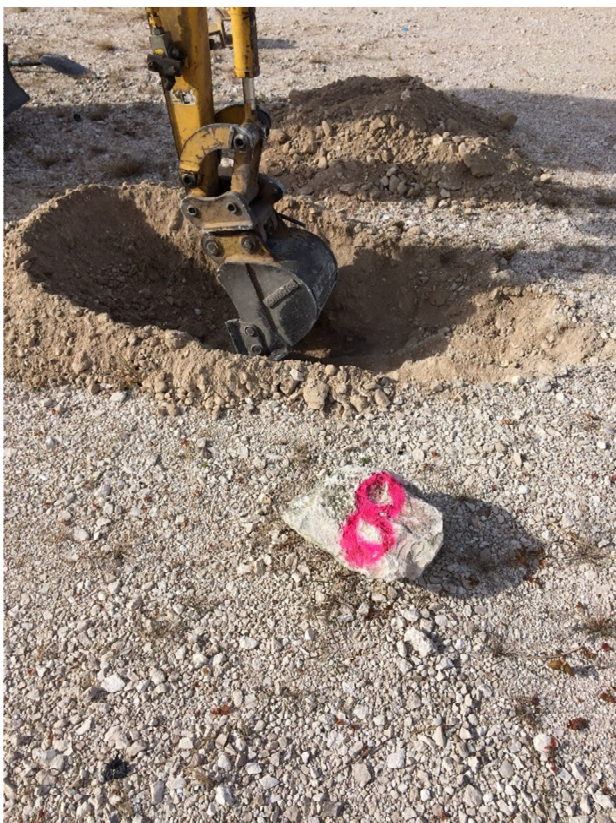
| Test Location<br>(Refer to Figure 2.1 for locations) | Depth below existing ground | Description |
|---|---|---|
| TL-H | 0 – 1600 | Grey/brown coloured gravel/sand with rock inclusions (400 mm maximum rock particle size) with minor silt inclusions creating a brown colouring to the sand. Granular material surrounded by rock pinnacle (presumably excavating through a natural depression that has been backfilled). Traces of pumice in the backfill.<br>Granular material was softer than typical for the site in this location. |

Test Pit 8 (Total Depth = 1600mm)

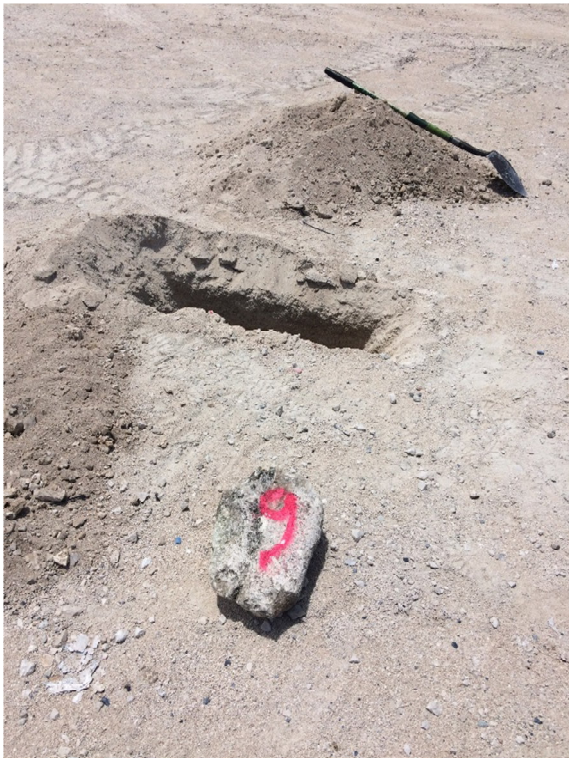
| Test Location<br>(Refer to Figure 2.1 for locations) | Depth below existing ground | Description |
|---|---|---|
| TL-I | 0 – 900 | Compact grey/brown coloured gravel/sand with rock inclusions (400 mm maximum rock particle size). Hard material to excavate. Minor silt inclusions creating a brown colouring to the sand. |

Test Pit 9 (Total Depth = 900mm)

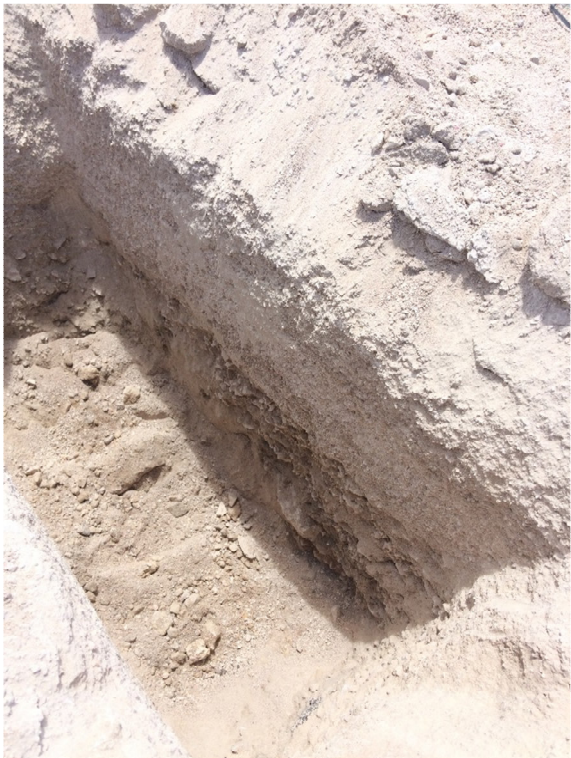
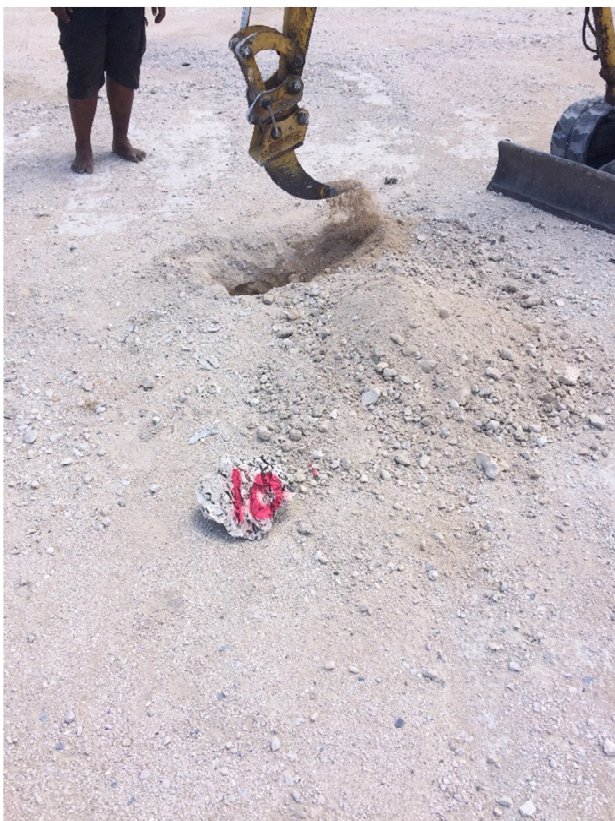
| Test Location<br>(Refer to Figure 2.1 for locations) | Depth below existing ground | Description |
|---|---|---|
| TL-J | 0 – 900 | Compact grey/brown coloured gravel/sand with rock inclusions (400 mm maximum rock particle size). Hard material to excavate. Minor silt inclusions creating a brown colouring to the sand. |

Test Pit 10 (Total Depth = 900mm)

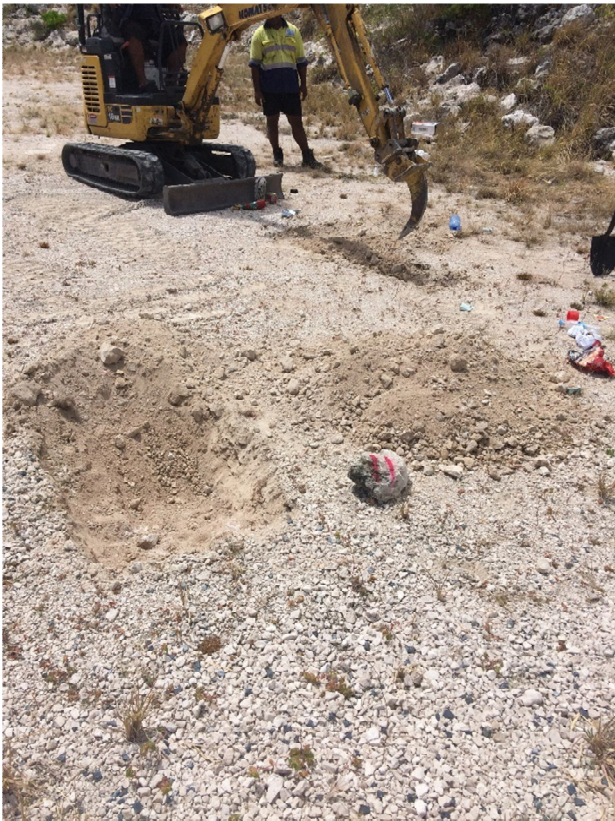
| Test Location<br>(Refer to Figure 2.1 for locations) | Depth below existing ground | Description |
|---|---|---|
| TL-K | 0 – 1500 | First excavation not possible to excavate (likely rock pinnacle). Offset test location 1500 mm and excavation successful on second location.<br>Grey/brown coloured gravel/sand with rock inclusions (100 mm maximum rock particle size) with minor silt inclusions creating a brown colouring to the sand. Granular material surrounded by rock pinnacle (presumably excavating through a natural depression that has been backfilled). Traces of pumice in the backfill. |

Test Pit 11 (Total Depth = 1500mm)
