# Quantification of the Power System Energy Losses in South Pacific Utilities

Public Utilities Board, Kiribati – Tarawa Atoll System

Prepared by KEMA International B.V.

Final report - May 15<sup>th</sup>, 2012

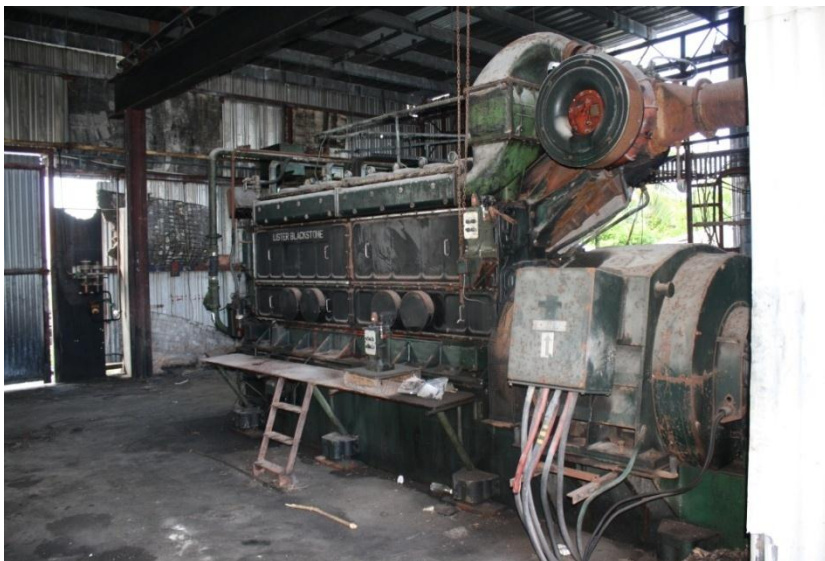
##### Major characteristics of the generating units

Unit 1: 750 kVA, 600 kW

0.415 kV, 50 Hz, 750 RPM

LOCATION: Bikenibeu

This unit and unit 2 were out of service during the time of KEMA's visit.

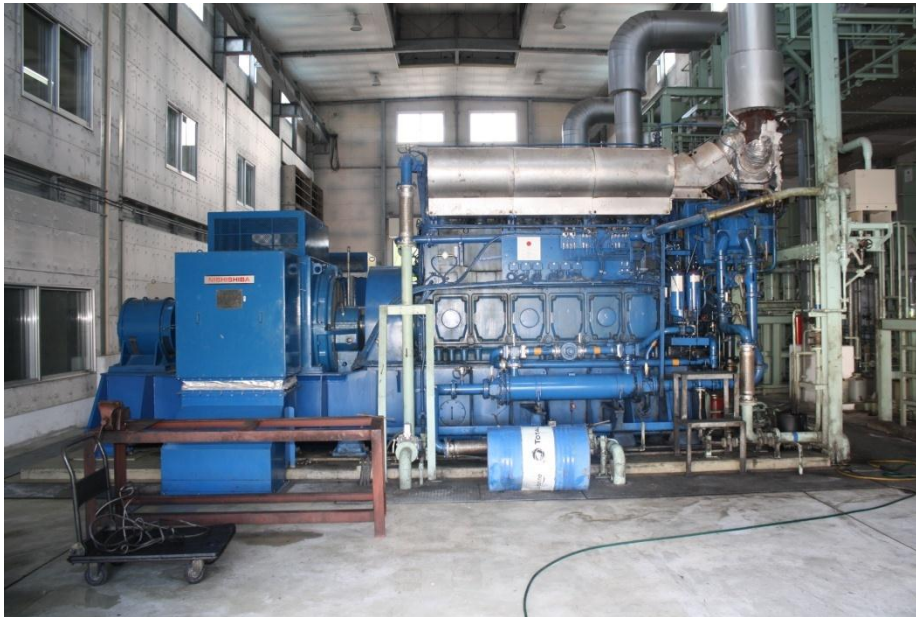
Unit 5: Daihatsu diesel generator  
1,750 kVA, 1,400 kW  
11 kV, 50 Hz, 750 RPM

LOCATION: Bikenibeu

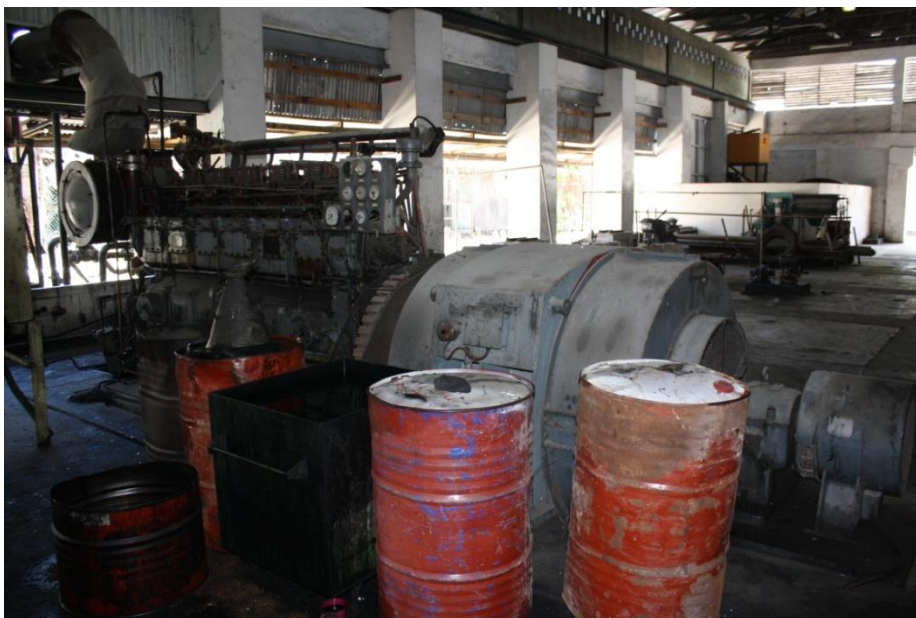
Unit 7: Unknown specifications

LOCATION: Betio

This unit and unit 6 were out of service at the time of KEMA's visit.

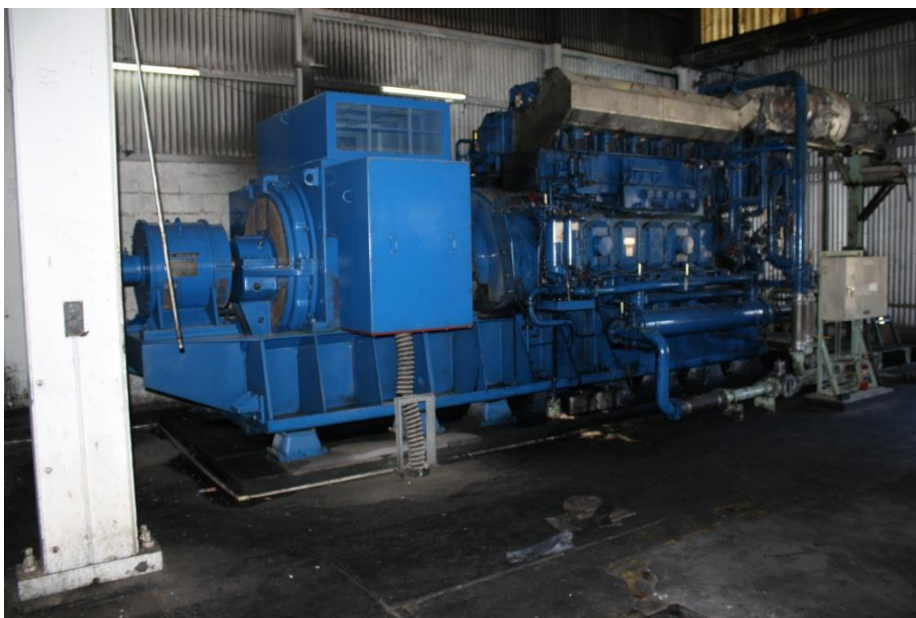
**Unit 8: Daihatsu diesel generator**

1,250 kVA, 1,000 kW

11 kV, 50 Hz, 750 RPM

LOCATION: Betio
