# Quantification of the Power System Energy Losses in South Pacific Utilities

Tuvalu Electric Corporation, Tuvalu

Prepared by KEMA International B.V.

Final Report , May 25<sup>th</sup>, 2012

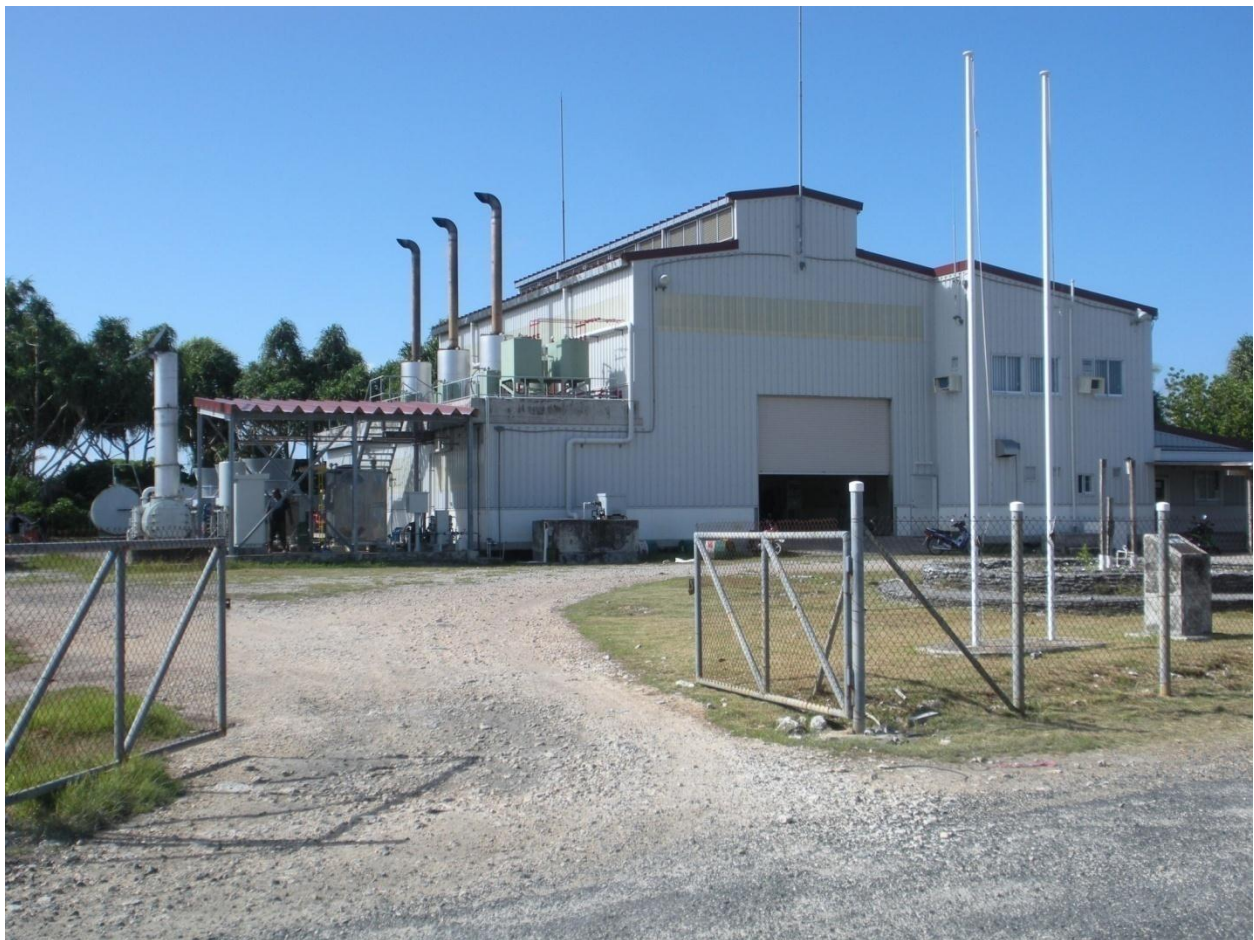
**Figure 1 - Power Station Building (as Viewed from Gate)**

The TEC Fogafale power station generation equipment is specified in the Generation Data Handbook. The following pictures show the excellent condition of the power station during the time of KEMA's visit.

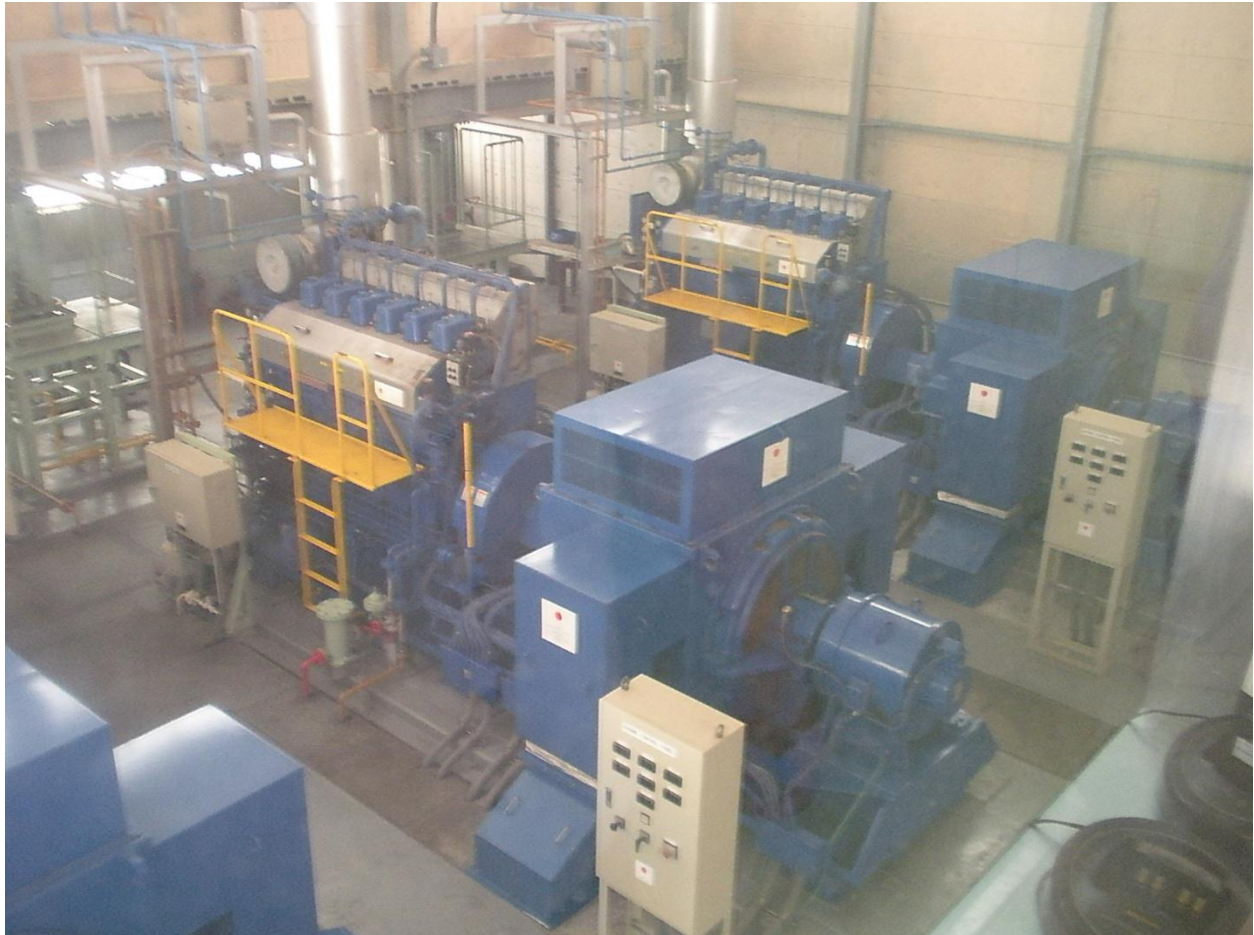
**Figure 2 - Generator Room**

At the time of KEMA's visit to Funafuti Atoll, the TEC Fogafale Power Station housed eight (8) diesel generators, all of which were well-maintained and available for service. Units 6, 7 and 8 were manufactured by Daihatsu in 2006 and are the units used the most for power generation.

KEMA's review of the Fogafale Power Station revealed that all of the units are all well maintained and in excellent condition. However, based on recorded generation fuel efficiency levels, TEC should consider looking into improvements to the economic dispatch methodology of the Fogafale units to improve generator fuel efficiency.

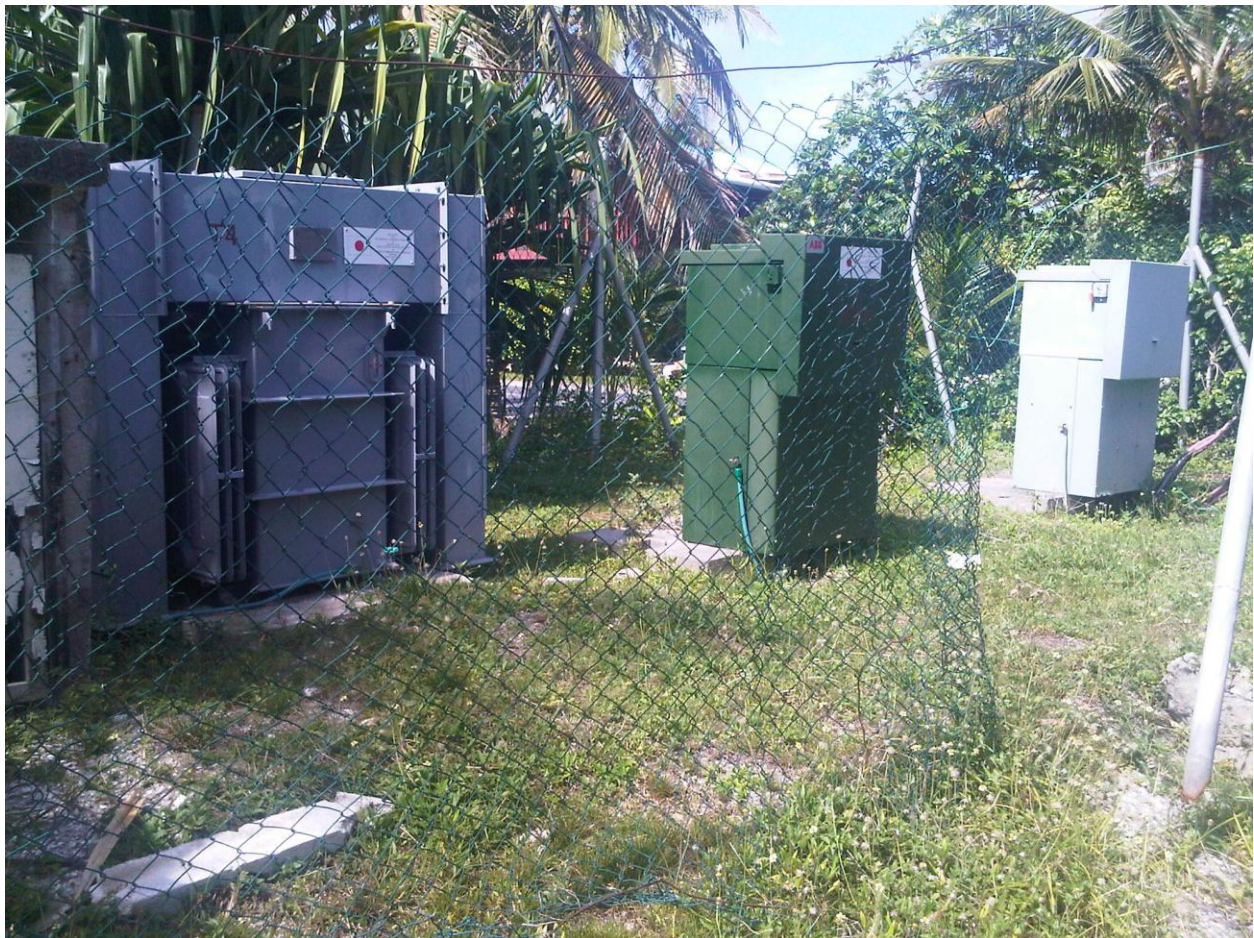
**Figure 3 – Typical RMU with switches**

A typical Ring Main Unit (RMU) transformer with switches is shown in Figure 3 below.

Feeder-1 goes directly to RMU-1, Feeder-2 goes to RMU-9 and Feeder-ES goes directly to RMU-ES. As indicated on the one-line diagram, all three feeders have an interconnection point at RMU-ES. Since no open points were identified on the one-line diagram provided, all 3 feeder tie switches were assumed to be normally closed.
