Quantification of the Power System Energy Losses in South Pacific Utilities

Tonga Power Limited, Tonga

Prepared by KEMA International B.V.

May 30, 2012

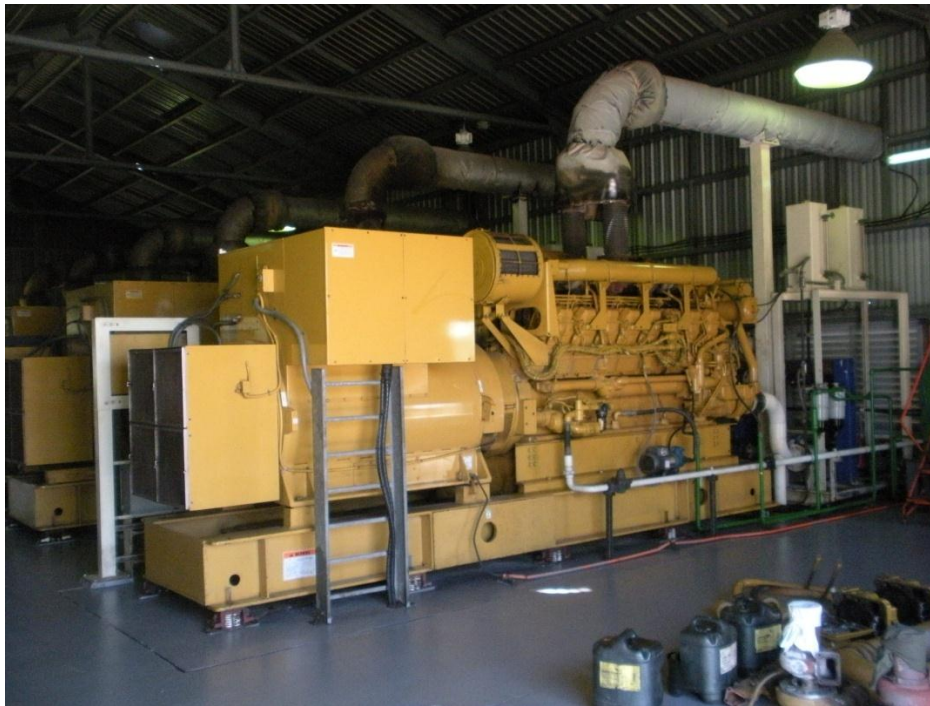
Figure 1 - 3516BDITA Generator

The TPL Popua power station generating equipment is listed in the Tonga Data Handbook. The following pictures show the good condition of the power station during the time of KEMA's visit. Units 1-6 are located in the CAT building, which is shown in figure 1.

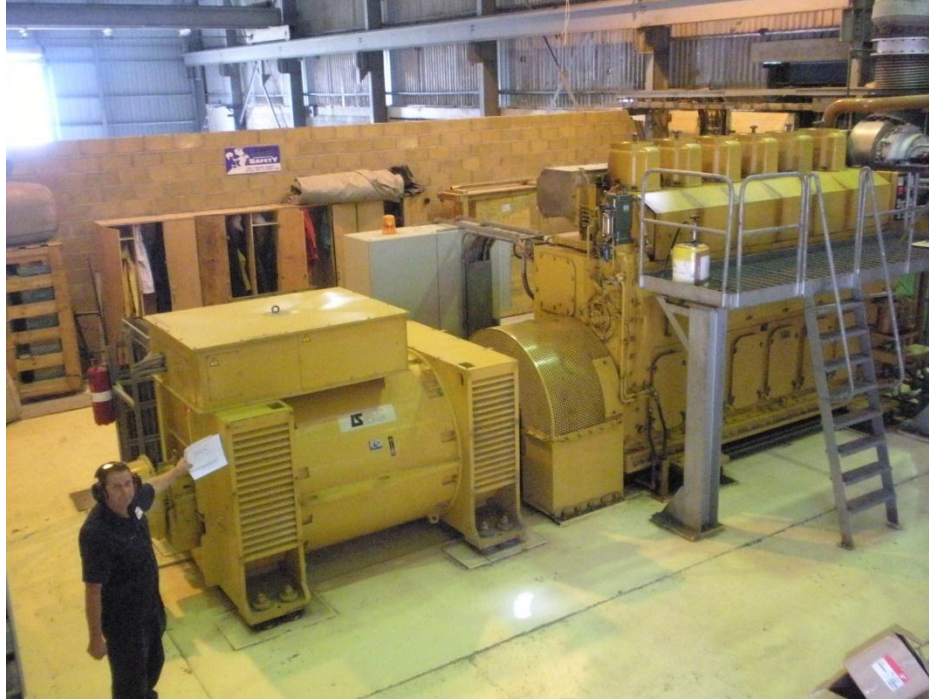
Figure 2 - CM32 Generator

Unit 7 is located in the TEPB building and is shown in figure 2.

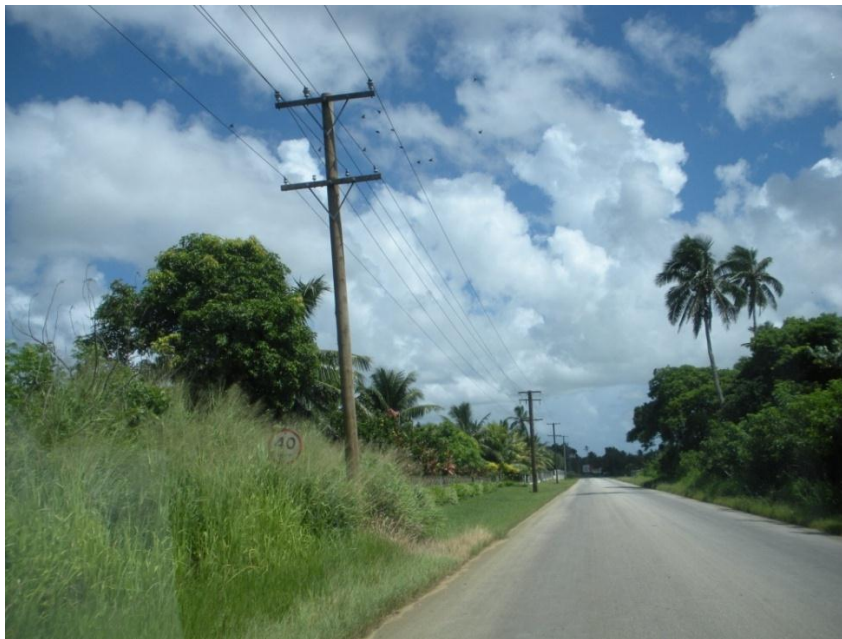
Figure 8 - Typical TPL 11 kV Distribution Line

Figures 8 and 9 show fairly typical 11 kV distribution equipment on the TPL system.

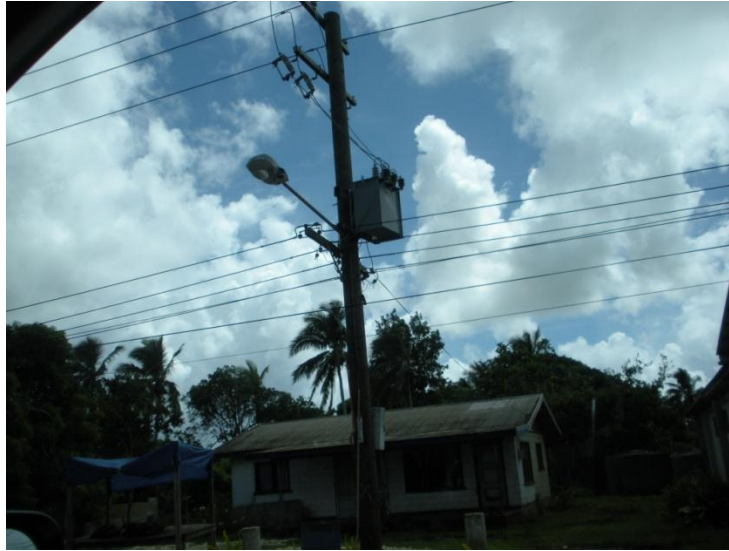
Figure 10 - Low Voltage Service Wires

Secondary service wire types and sizes were provided during KEMA's visit, and are listed in the Data Handbook. Typical secondary service wire configurations were used in the calculation of LV wire losses. A distribution pole showing the low voltage service wires is shown below.
