Ord River power station
Planned Outage case study

PPA Annual Conference, July/August 2018

PROJECT DETAILS

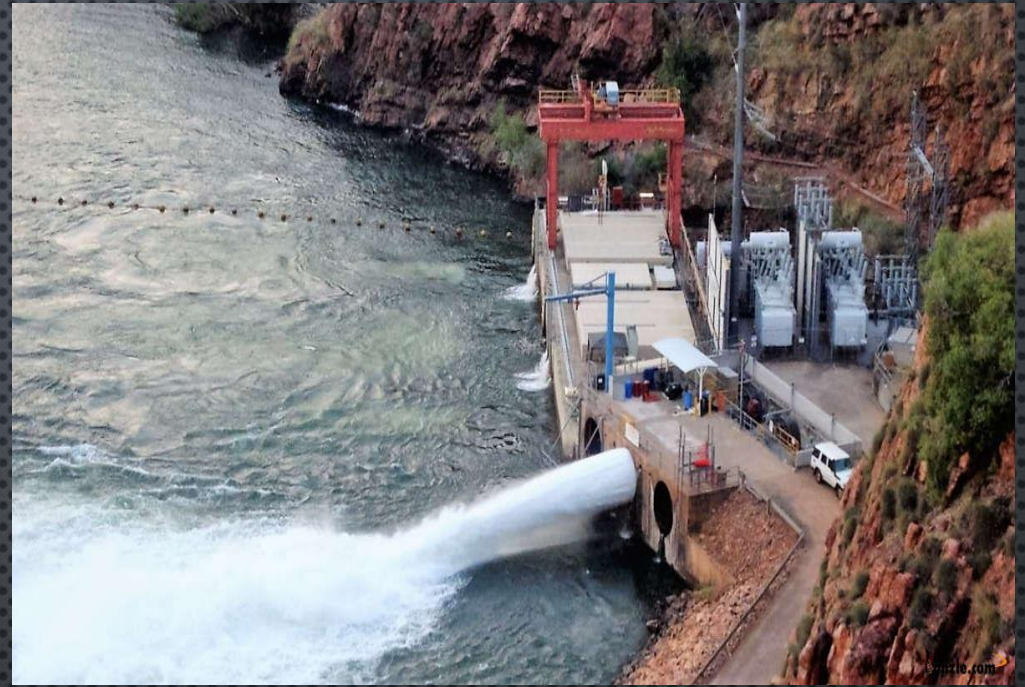
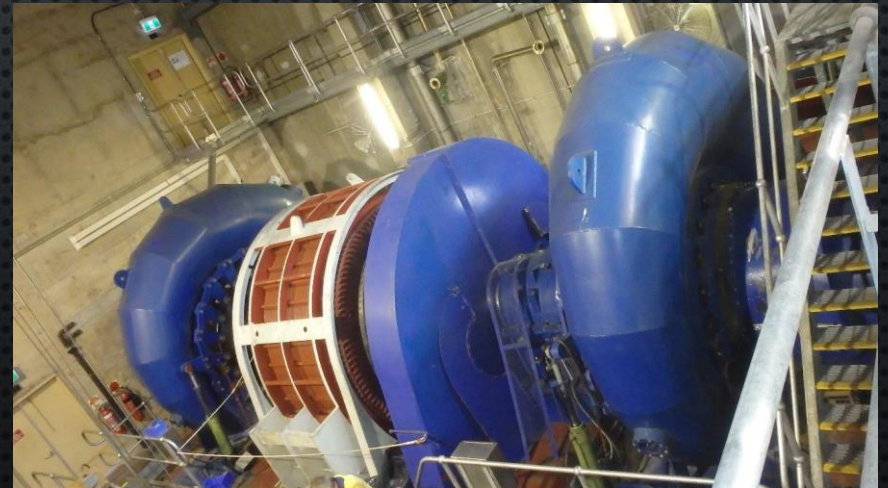
- ACEC (BELGIUM) GENERATOR
- COMMISSIONED 1996
- 19.5 MVA, 11 KV
- HORIZONTAL SHAFT TWIN FRANCIS TURBINES
- PLANNED 26 DAY OUTAGE
- REFURBISH GENERATOR TO ENABLE CONTINUING RELIABLE PERFORMANCE
- HISTORICAL INSULATION PROBLEMS ON STATOR WINDINGS
- ROTOR WAS OK

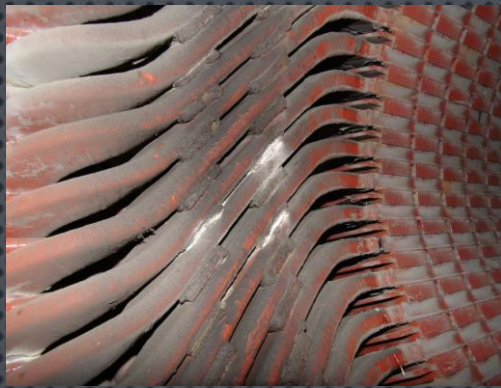
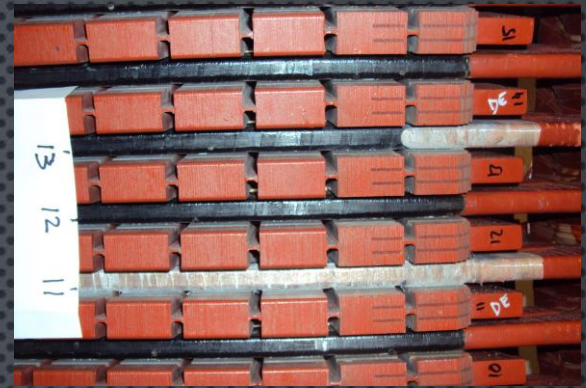
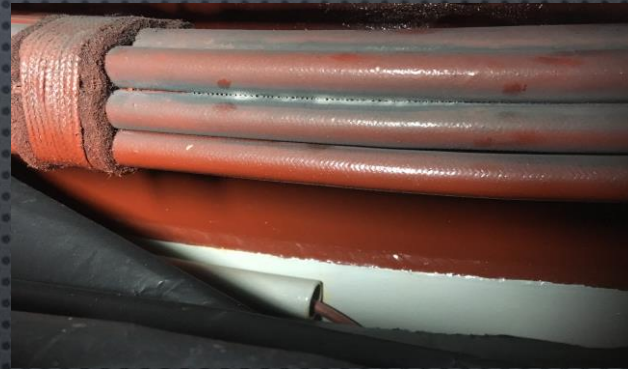
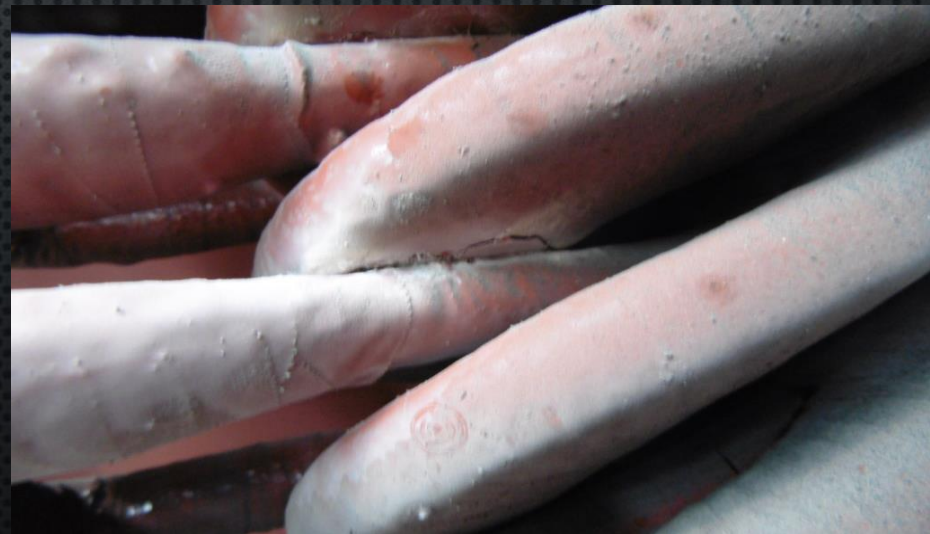
- IN AIR COOLED HYDRO GENERATOR WINDINGS PARTIAL DISCHARGES (CORONA) OCCUR WHEN DIELECTRIC BREAKDOWN OF AIR IS EXCEEDED (APPROX 3 KV/MM).
- HEAT GENERATED BY IONIZED AIR PARTICLES CONTRIBUTE TO THERMAL DEGRADATION AND EROSION OF INSULATION.
- A SIDE EFFECT OF THE PROCESS IS THE CONVERSION OF OXYGEN INTO OZONE AND THE FORMATION OF NITROGEN OXIDES IN INSULATION VOIDS.
- THIS PHENOMENON IS TERMED “PARTIAL DISCHARGE” (PD), BECAUSE IT INVOLVES PARTIAL BREAKDOWN OF AN AIR SPACE, RATHER THAN COMPLETE BREAKDOWN OF INSULATION.

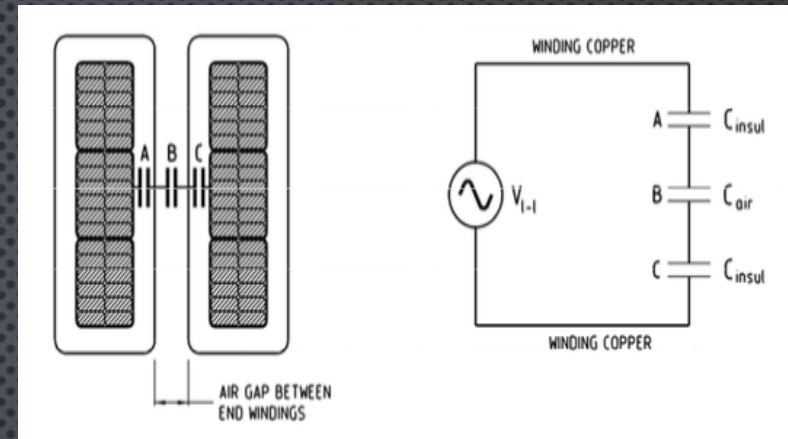
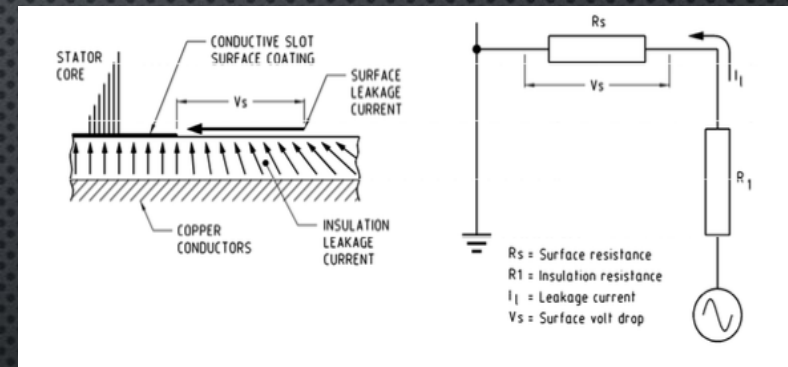
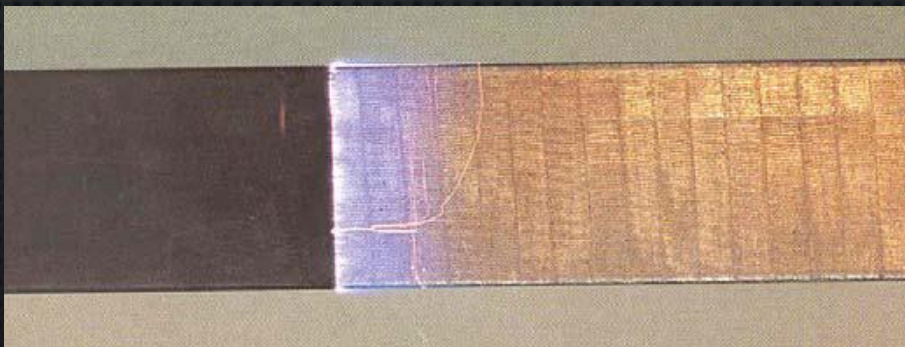
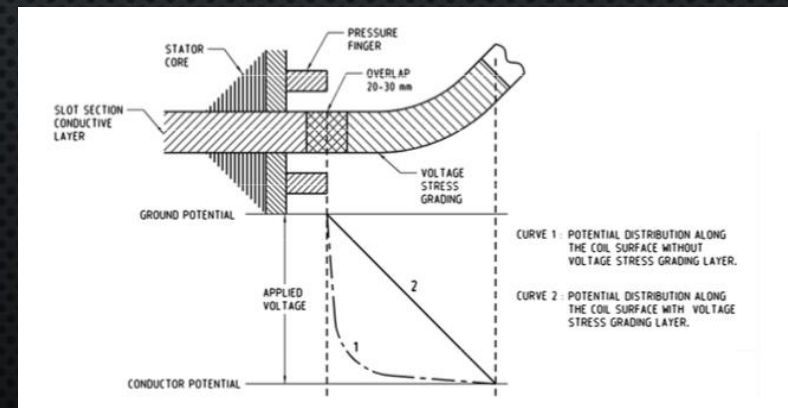
- PD CAN OCCUR IN THE INSULATION VOIDS OR ON THE WINDING SURFACES.
- REFERRING TO THE DRAWING HERE, TWO END WINDINGS AND AN AIR GAP BETWEEN THEM CAN BE REPRESENTED BY AN EQUIVALENT SERIES CIRCUIT OF THREE CAPACITANCES, CAPACITANCE OF GROUND INSULATION OF COIL A, CAPACITANCE OF AIR GAP B, AND CAPACITANCE OF GROUND INSULATION OF COIL C.
- THE TYPICAL "RING OF FIRE" IS FORMED AT THE END OF THE SLOT SECTION CONDUCTIVE COATING. TO PREVENT THESE PARTIAL DISCHARGES THE SPECIAL VOLTAGE GRADING SEMI CONDUCTIVE LAYER IS FITTED, OVERLAPPING THE SLOT SECTION CONDUCTIVE LAYER, AND EXTENDING AROUND THE FIRST COIL SLOT SECTION BEND
