Wailoa- Vuda

WAI-VUD A Paint Towers 19/20		DRG. SIZE	SCALE	FOLDER	
				7/07/2023				A3	N/A	CAP18365			
LandOwner	Refer To Efl	Inspector-Tower	Karl Formo		LATITUDE	17°42'38.52"S		Work Scope Assessment Report - Jun-2023	WID	MR57-2021	SHEET	REVISION	
TowerAccess	Second Turen Left After Fulton College Off Sabeto Rd	Inspector-Ground	Karl Formo		LONGITUDE	177°30'38.52"E					1	2	
ContactName	Refer To Efl	Draft Report	R. Glover	24/04/2023					WAI-VUD-A0023				
ContactPhone	Refer To Efl	Report Review

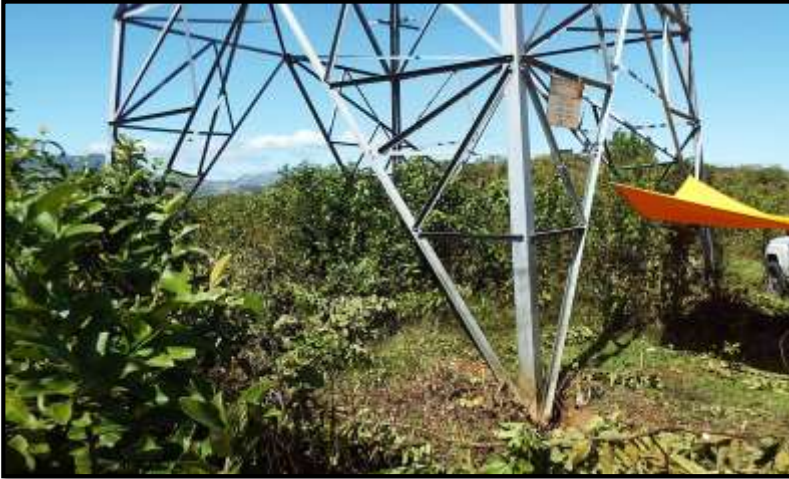
Structure looking towards CD Face

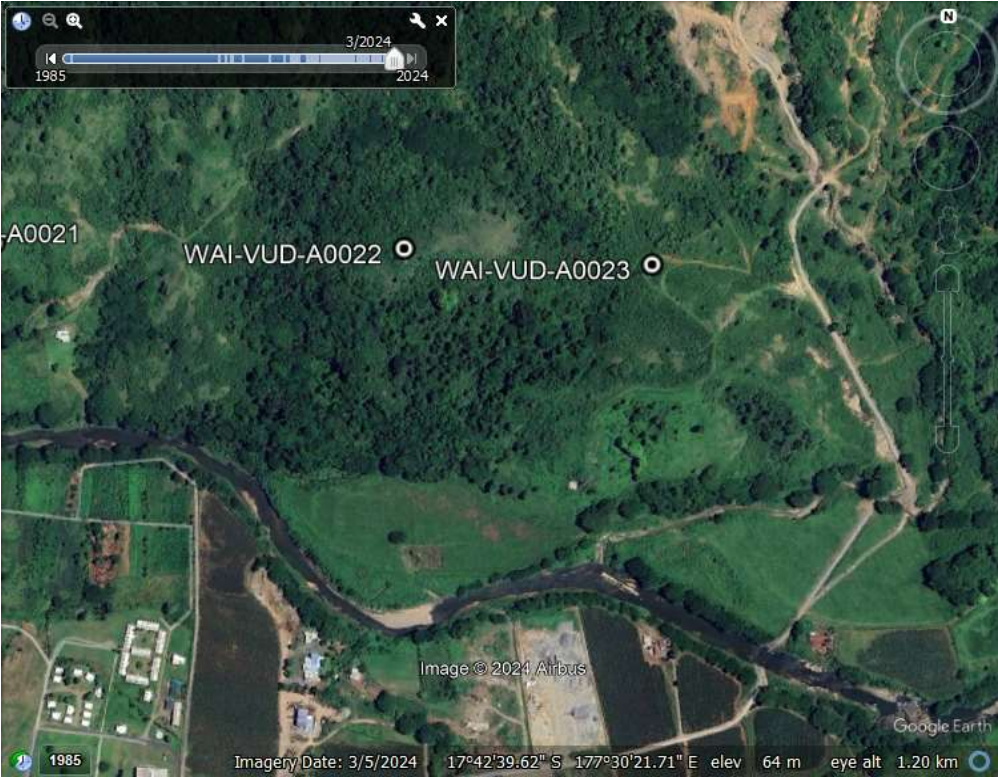
Comments
Track access maintenance required prior to entry
LSD - faded
no CPI - Fiji
Minor vegetation managennt needed around base of structure
Coal tar epoxy painted 1m up each leg
Light ZCP throughout structure
Dross throughout structure steel
There is a River ford on the way to the structure, exercise caution during wet season
Bird excrement on members throughout structure
2 x aerial id's on tower
Minor bend on A-Leg K-brace DA phase
