WAI-VUD-A0021

_			
WAI-VUD A Paint Towers 19/20		SCALE FO		LDER			
WAI-VOD A Paint Towers 19/20	A3	N/A	CAP18365				
	WID	MR57-2021	SHEET	REVISION			
Mark Carra Assessment Daniel Ive 2002	WID	IVIN 37-202 I	1	2			
Work Scope Assessment Report - Jun-2023		WAI-VUD-A0021

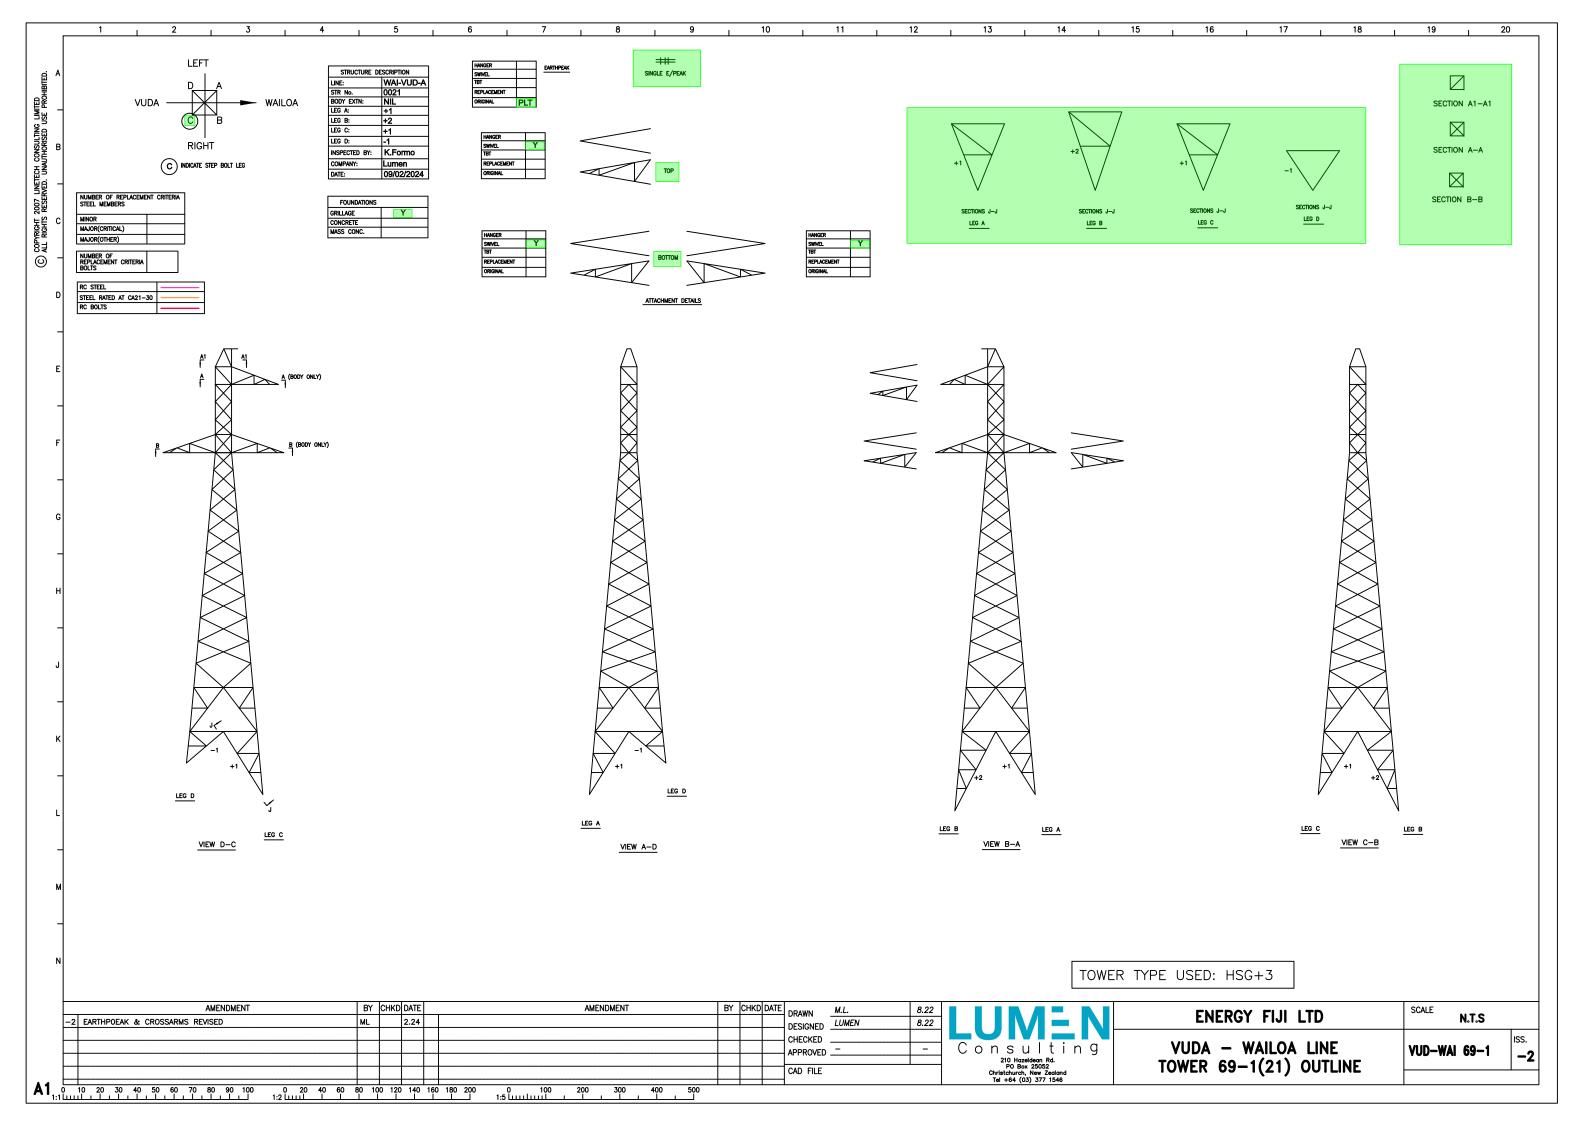
Tower base needs clearing Legs painted with CTE about 400mm above ground level

Minor construction damage to steel member main horizontal coming of B-Leg

Light ZCP through out tower

Dross noted throughout tower

Top chord coming off B-Leg minor construction damage, top cross arm.
