| Device Position Description | WAI-VUD-A0026 | |

Wailoa- Vuda

| LANDOWNER DETAILS | | INSPECTION TEAM<br>LUMEN | | Date | GPS COORDINATES (WGS84) | | | WAI-VUD A Paint Towers 19/20 | | | | | | | | |
|---|---|---|---|---|---|---|---|---|---|---|---|---|---|---|---|---|
| ContactName | Refer To Efl | Draft Report | R. Glover | 24/04/2023 | | | Work Scope Assessment Report - Jun-2023 | | | | | | | | | |

VUDA - WALOIA LINE  
TOWER 67-2(26) OUTLINE

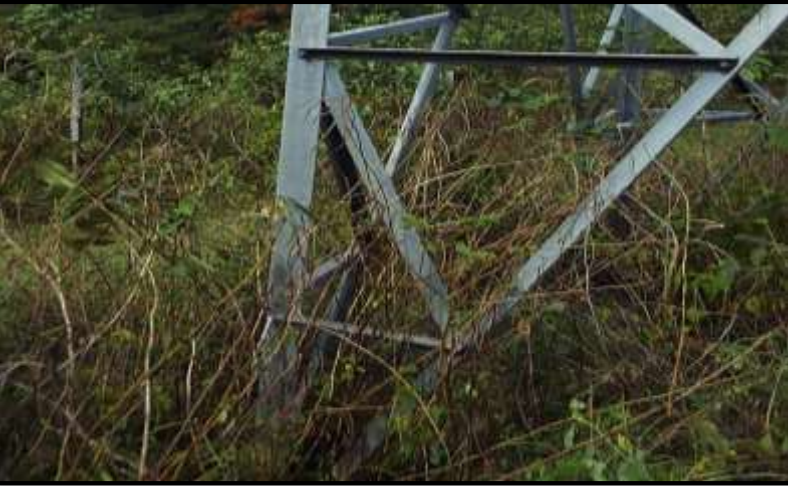
Structure looking towards CD Face
