| Device Position Description | WAI-VUD-A0027 | |

Wailoa- Vuda

| LANDOWNER DETAILS | | INSPECTION TEAM<br>LUMEN | | Date | GPS COORDINATES (WGS84) | | | WAI-VUD A Paint Towers 19/20 | | DRG. SIZE | SCALE | FOLDER | |
|---|---|---|---|---|---|---|---|---|---|---|---|---|--|
| LandOwner | Refer To Efl | Inspector-Tower | Karl Formo | | LATITUDE | 17°42'39.24"S | | Work Scope Assessment Report - Jun-2023 | WID | MR57-2021 | SHEET | REVISION | |

VUDA - WAILOA LINE  
TOWER 67-1(27) OUTLINE

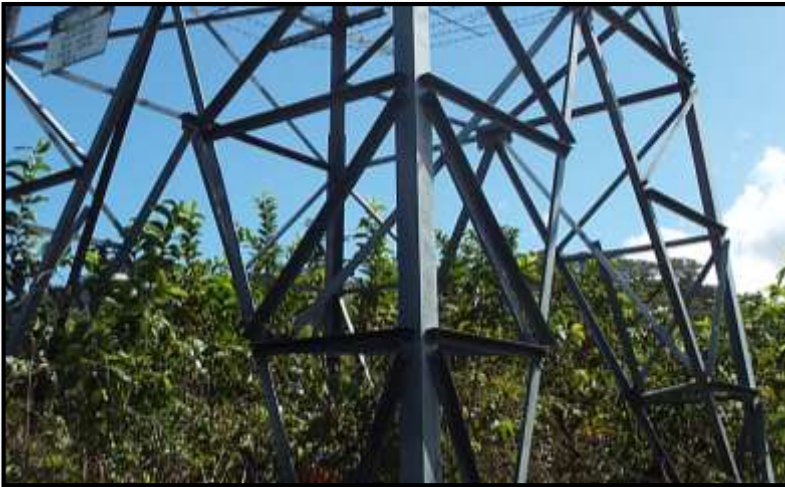
Structure looking towards CD Face

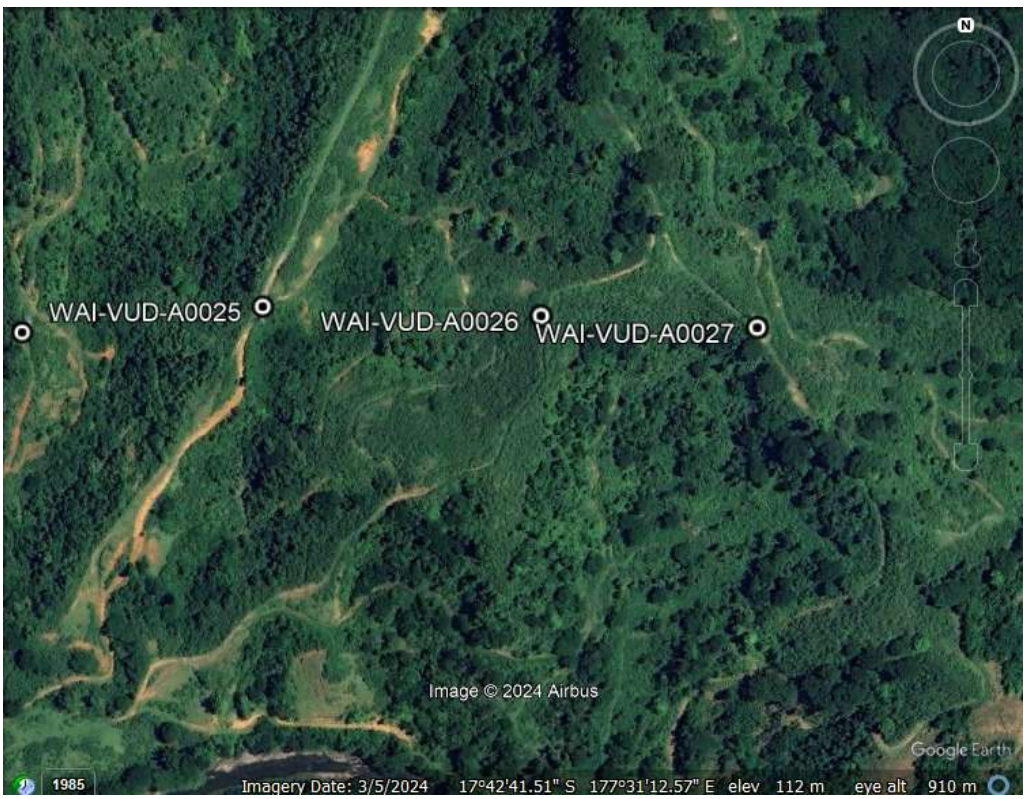
| Track access maintenance required prior to entry | | |
| Major vegetation management needed around base of structure. | | |
| CTE painted 1m up each Leg | | |
| Light ZCP through out structure | | |
| Dross throughout structure on steel | | |
| Bird excrement on members throughout structure | | |
| LSD - faded | | |
| TVHZ, 4 wire fence withing 5m of C-Leg | | |
