Tower ID	WAI-VUD-A0045		
Contract number	\$2G+6		
Final No.	60-2		
Insulator Type/ Condition	COMPOSITE		
Туре	0		
Body Extn - size	0		
Legs - size	+1, -1, +/-0, +2		
Earth Wire	YES		
Tower Area m ²	122		
Rust m ²	11 9%		
Sweep m ²	89 74%

Work Scope Assessment Report - May-2025	WAI-VUD-A0045				
Work Coops Assessment Depart May 2025		U	1	2	
	WID	0	SHEET	REVISION	
WAI-VUD-A		N/A	CAP20477		
WAI-VUD-A		DRG. SIZE		TOLDER

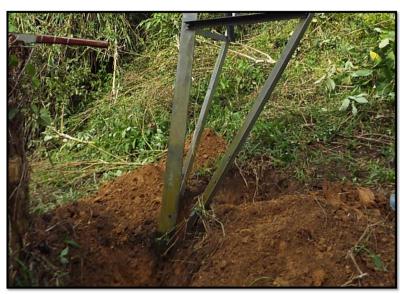
LSD - faded LSD - raded
no cpi - Fiji
CTE painted 1m up each leg
Light ZCP through out structure
Galv dross throughout structure
Structure situated in a gold mine
Heavy machinery moving round site, caution required
Site induction maybe required prior to entry, once site is up and running properly
Rird excrement throughout tower

Bird excrement throughout tower

CDG wires to be replaced
Green mould on bottom part of tower.

Clear creeper off structure
Glod mine entrance and buildings 200m from Structure
