# WORLD BANK EXPERIENCE ON ENHANCING ENERGY RESILIENCE FOR CLIMATE ADAPTATION

Hua Du, Ph.D  
Energy Specialist Consultant  
September 28, 2018

# Belize: Energy Resilience for Climate Adaptation project

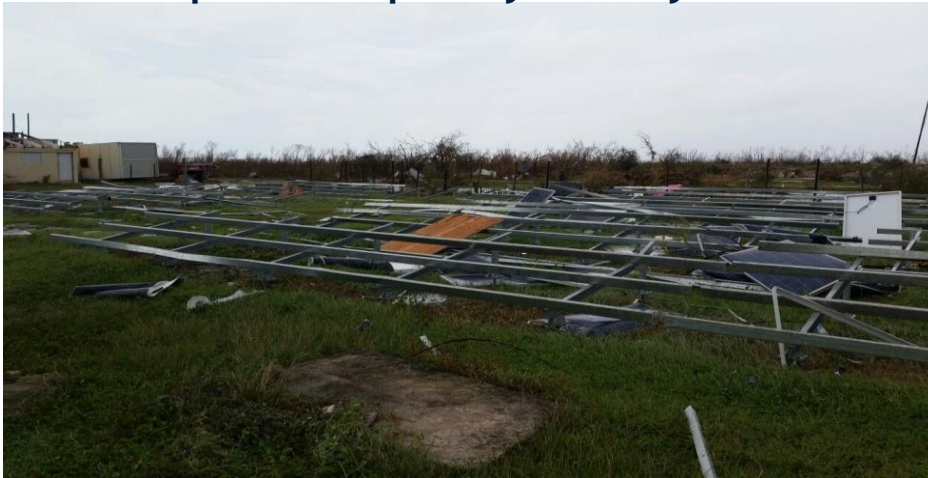
Solar plant completely destroyed

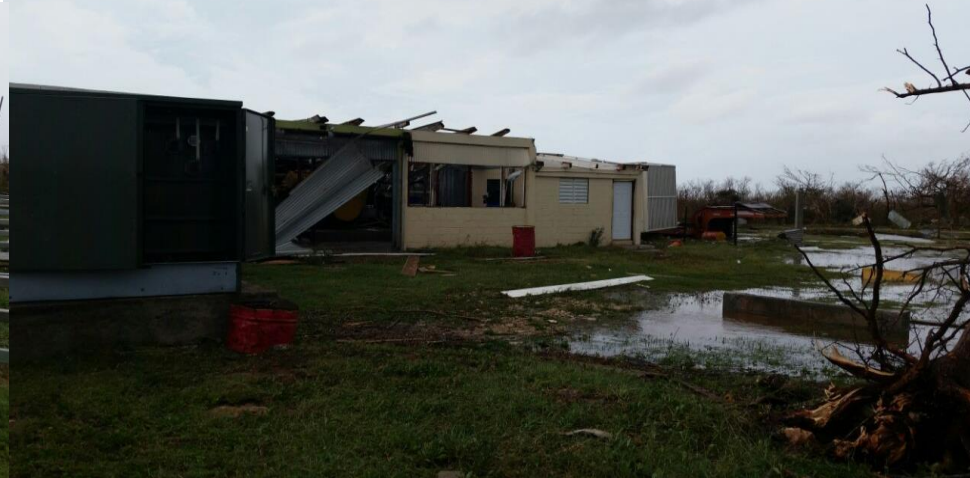
Damaged roof of power plant that houses the Generators

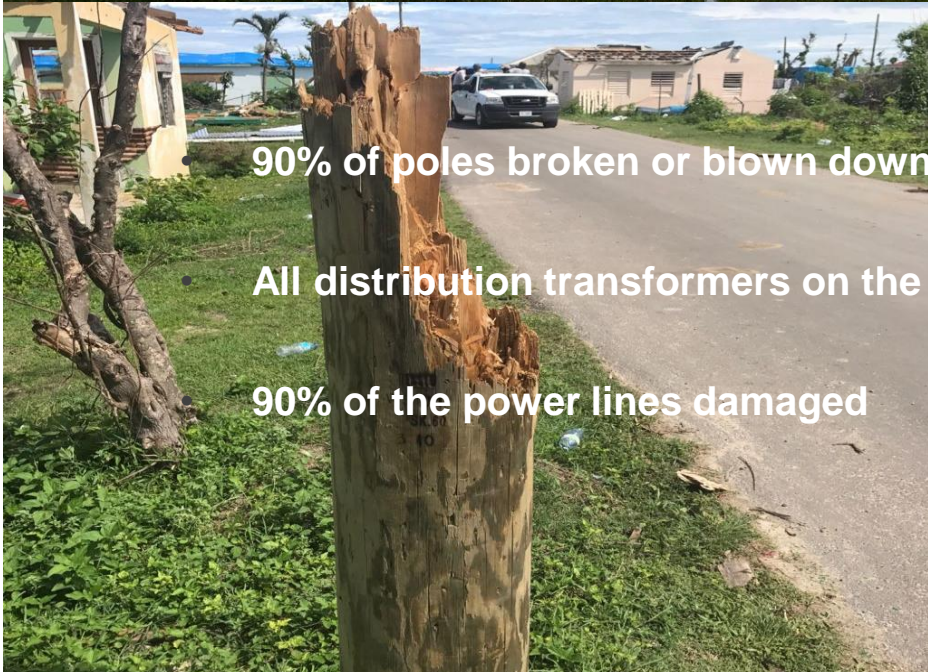
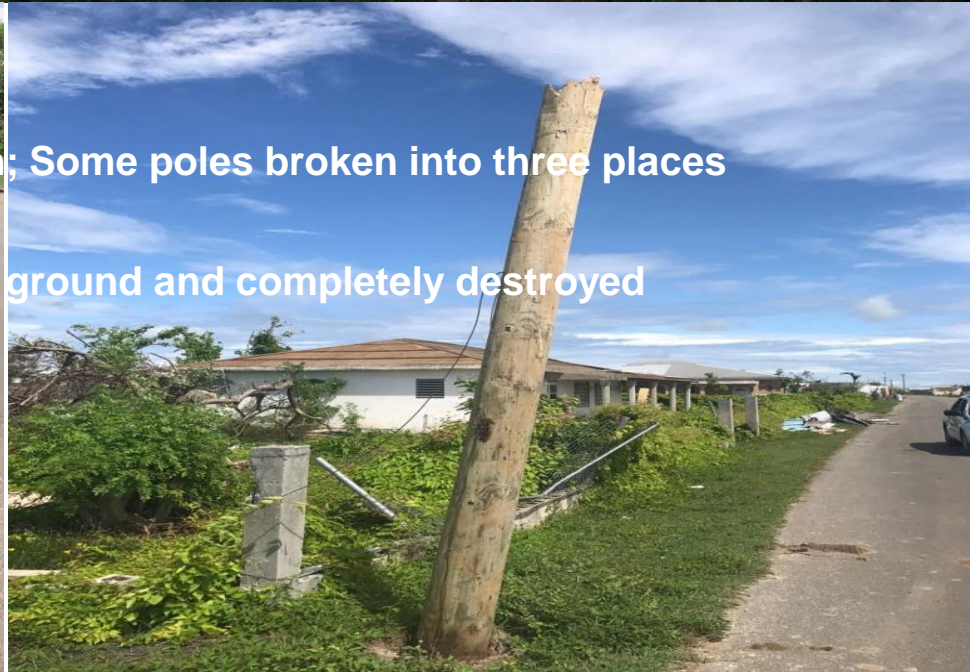
90% of poles broken or blown down; Some poles broken into three places

All distribution transformers on the ground and completely destroyed

90% of the power lines damaged

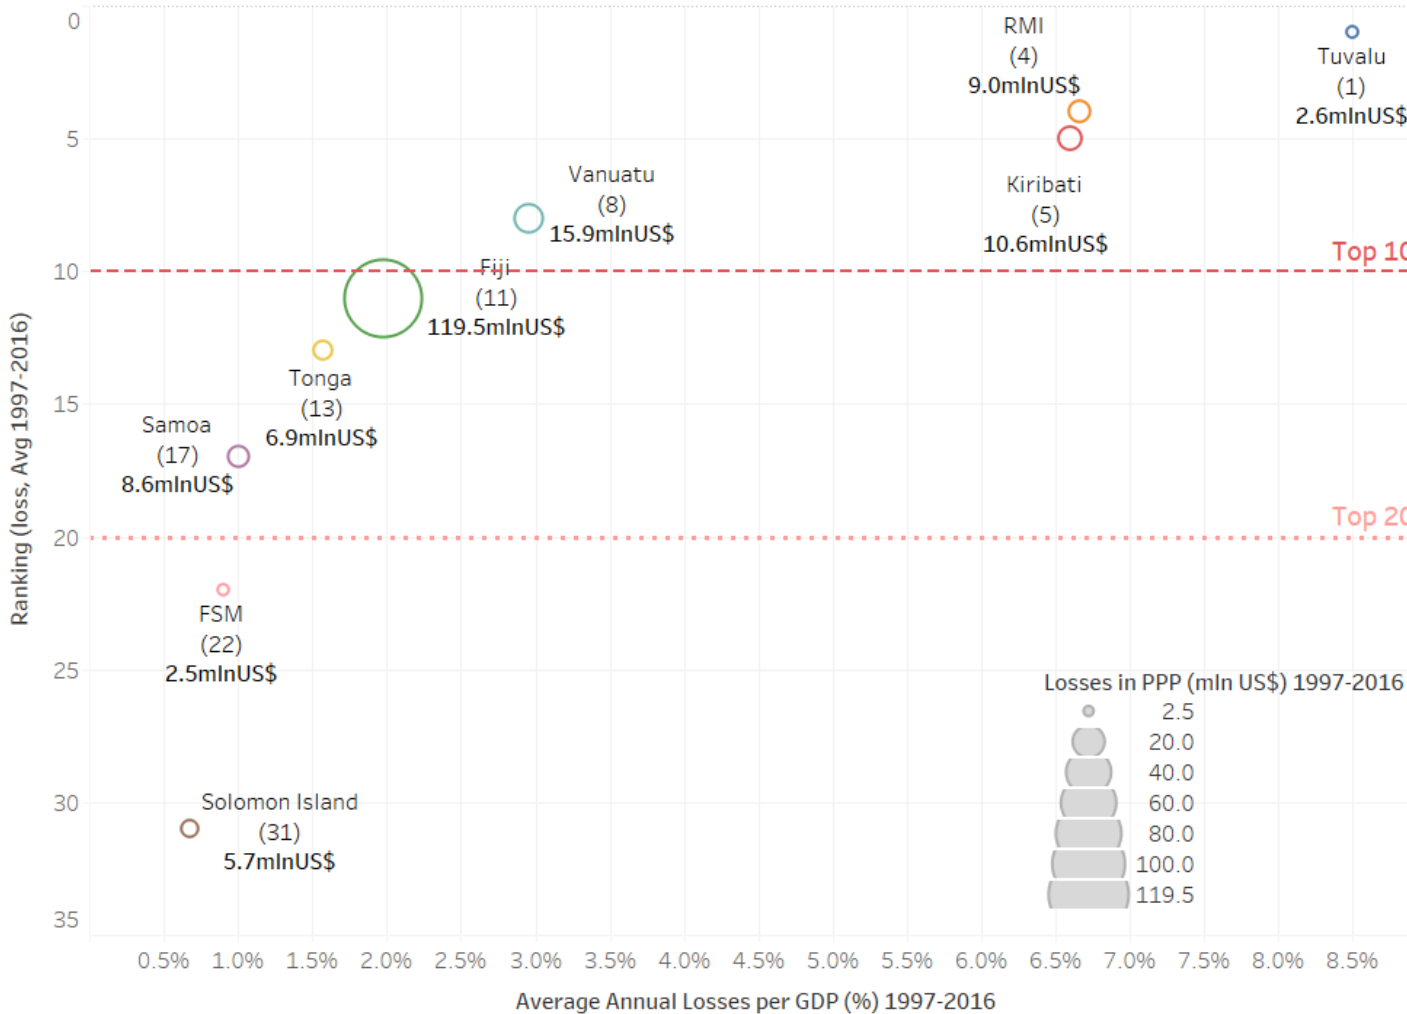
## Climate Risks Ranking of Pacific Island Countries (1997-2016)

based on average annual losses per GDP (%) from this time period

**4 PICs are within Global Top 10 most affected countries**

**7 PICs are within Global Top 20**

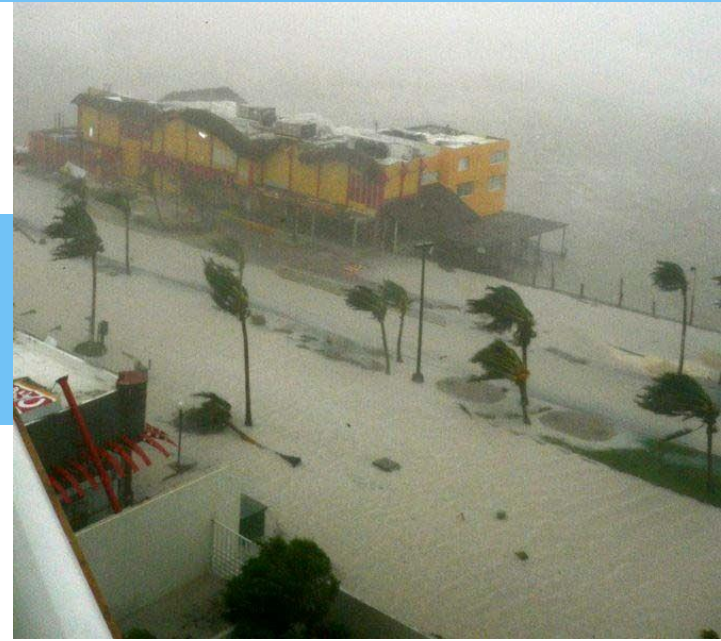
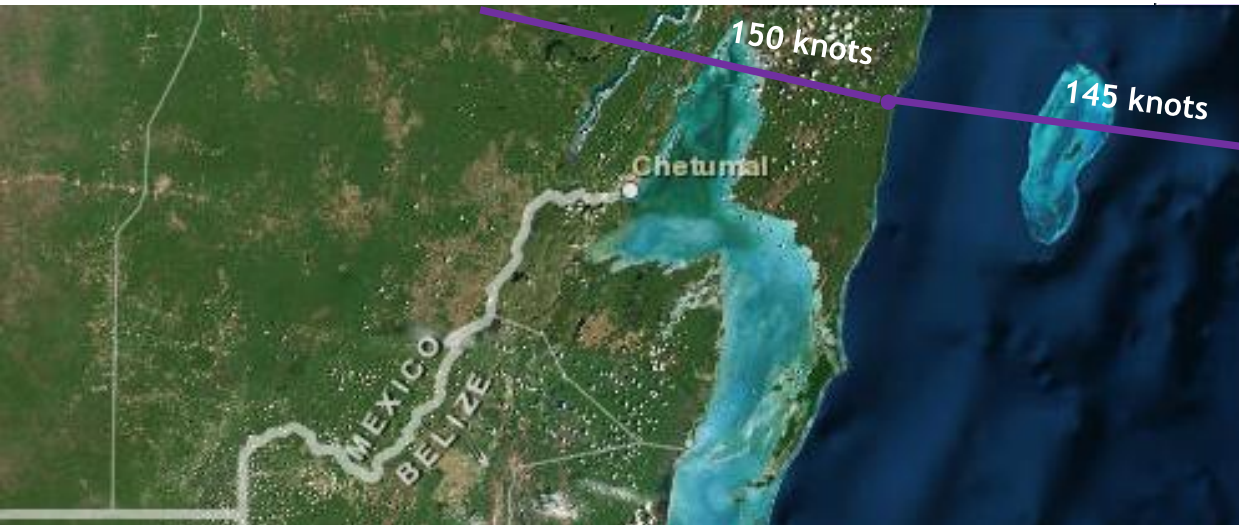
**Hurricane Dean (2007)**

# Mapping the Storms to Evaluate Impacts & Identify Vulnerabilities in Power System

## HURRICANE DEAN
