Quantification of the Power System Energy Losses in South Pacific Utilities

Nauru Utilities Corporation

Prepared by KEMA International B.V. May 30, 2012

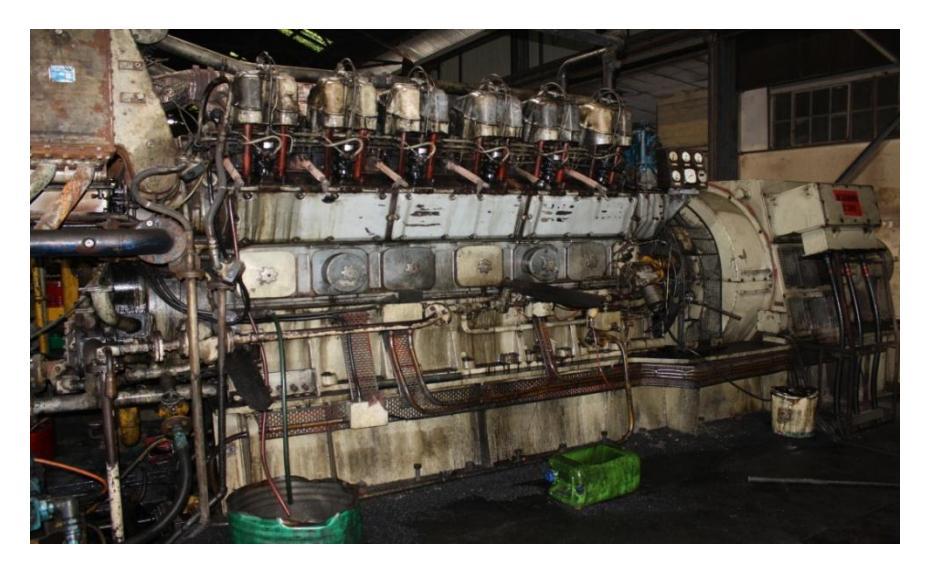
Figure 1 - Unit 1

Unit 1: Ruston model 12RK270 diesel generator 2500 kVA, 1900 kW 3.3 kV, 50 Hz, 750 RPM STATUS: Operational

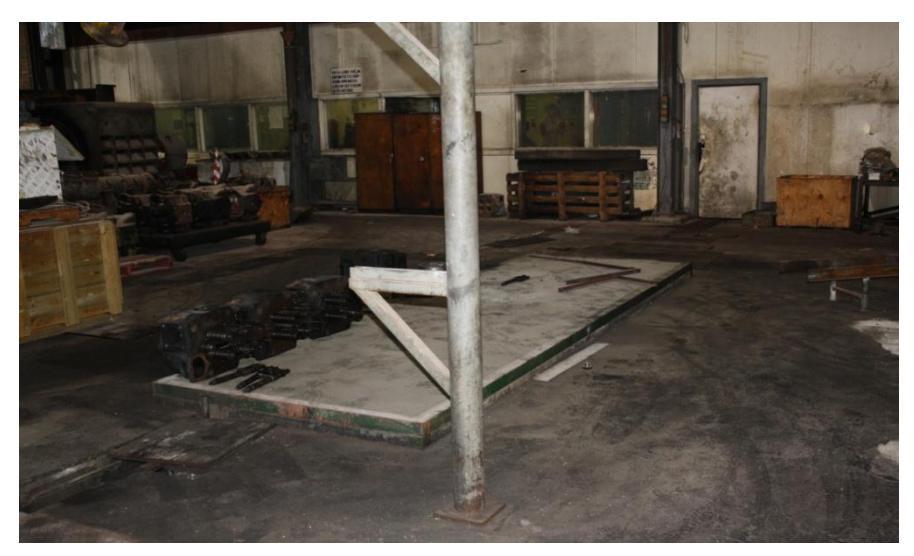
Figure 2 - Unit 2

Unit 2: Paxman model 12VP185 diesel generator 2000 kVA, 1600 kW 3.3 kV, 50 Hz, 1500 RPM STAT

STATUS: Decommissioned

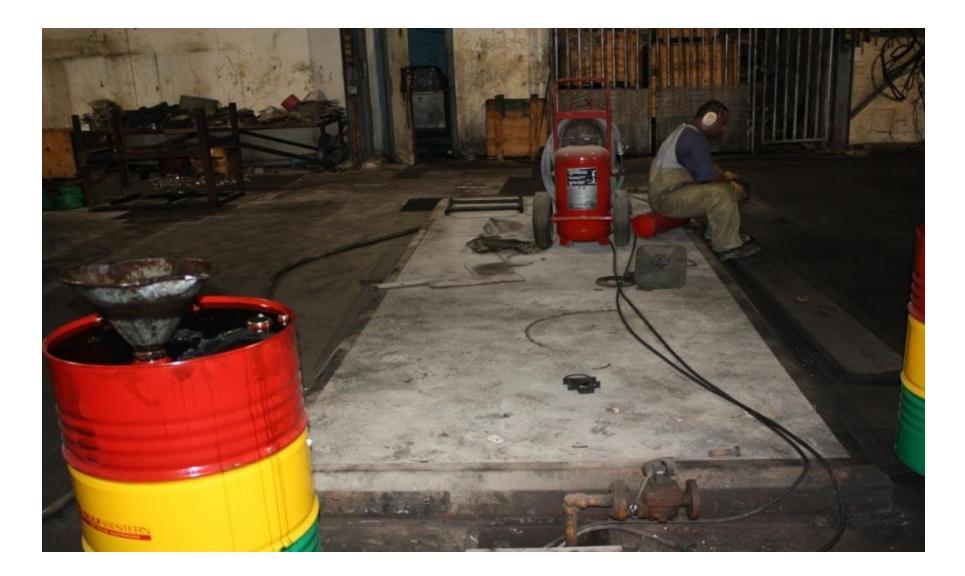
Figure 3 - Unit 3

Unit 3: Caterpillar model 3516B diesel generator 1600 kVA, 1250 kW 3.3 kV, 50 Hz, 1500 RPM STATUS: Decommissioned

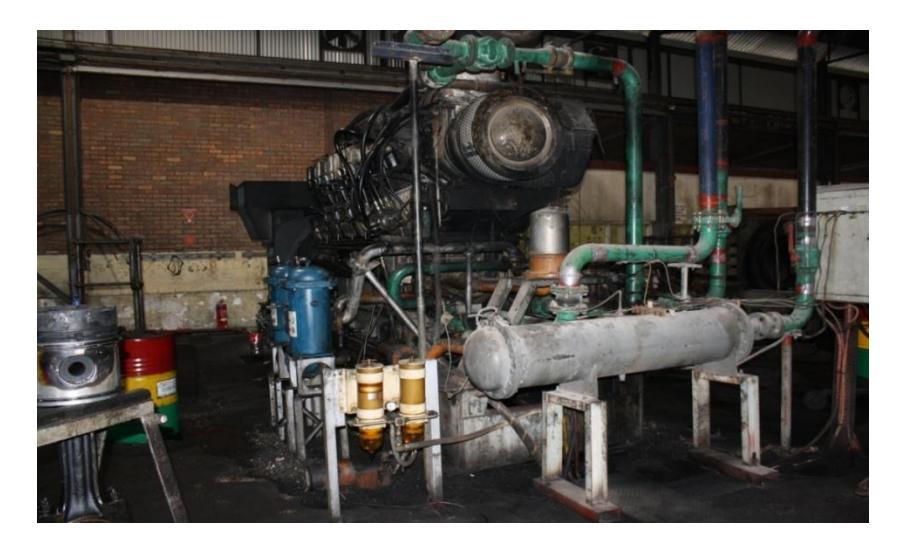
Figure 4 - Unit 4

Unit 4: Ruston model 16RK3C diesel generator 2000 kVA, 1600 kW 3.3 kV, 50 Hz, 750 RPM STA

STATUS: Operational

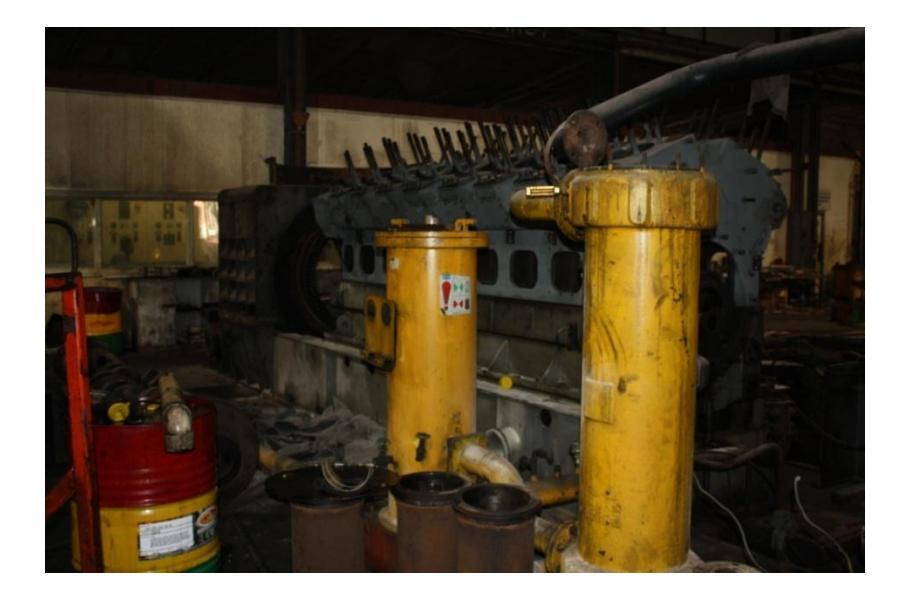
Figure 5 - Unit 5

Unit 5: Ruston model 16RK3C diesel generator 2000 kVA 1600 kW 3.3 kV, 50 Hz, 750 RPM STATU

STATUS: Under Repair

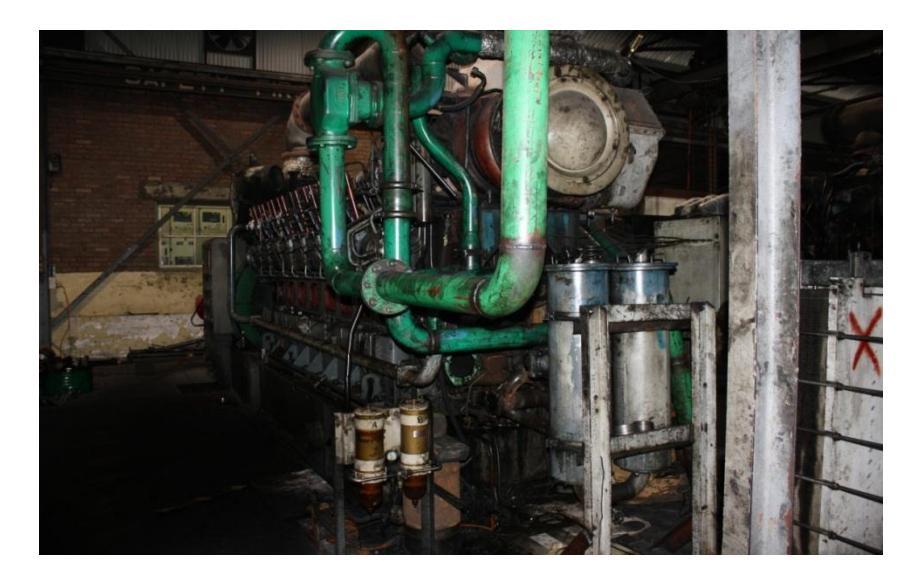
Figure 6 - Unit 6

Unit 6: Ruston model 16RK3C diesel generator 2000 kVA 1600 kW 3.3 kV, 50 Hz, 750 RPM STA

STATUS: Under Repair

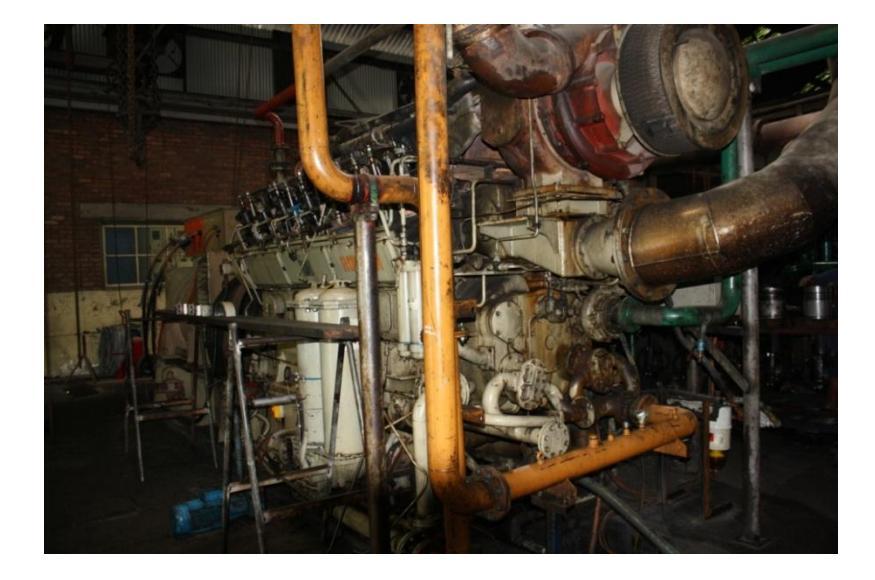
Figure 7 - Unit 7

Unit 7: Paxman model 12VP185 diesel generator 2000 kVA 1600 kW 3.3 kV, 50 Hz, 1500 RPM STATU

STATUS: Under Repair

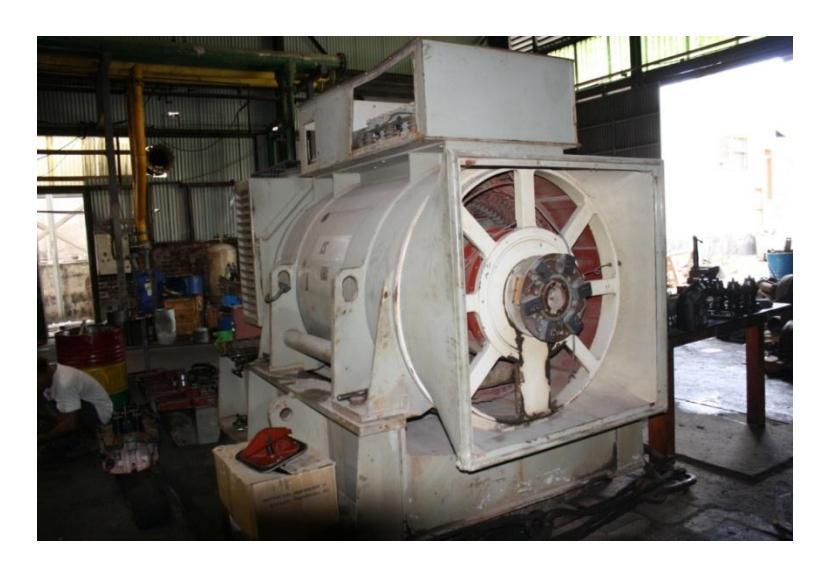
Unit 8: Caterpillar model 3516B diesel generator 1600 kVA, 1250 kW 3.3 kV, 50 Hz, 1500 RPM STAT

STATUS: Decommissioned

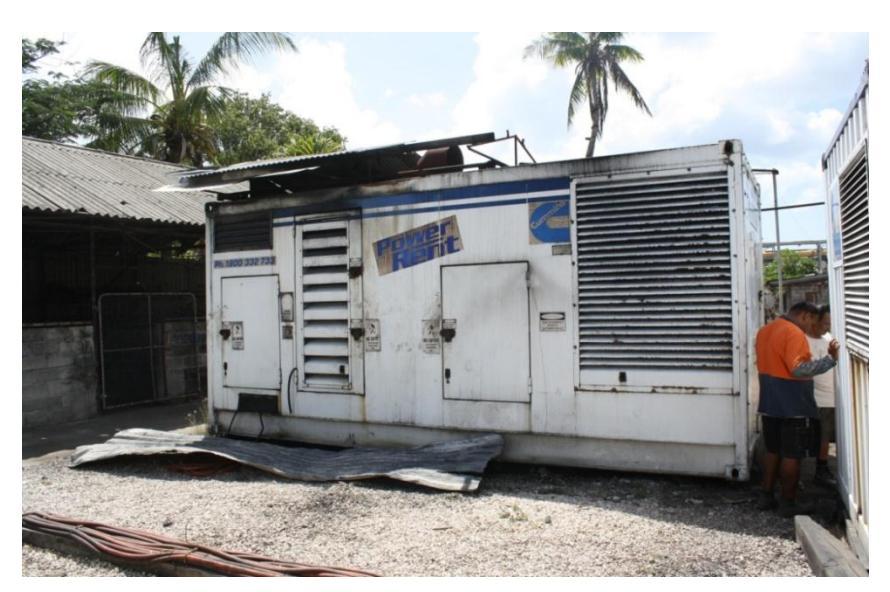
Figure 9 - Caterpillar Diesel Units

Caterpillar has also delivered 4 lease-package high-speed diesel units. Model 1120-DFLC-7158B 1500 kVA, 1200 kW 3.3 kV, 50 Hz, 1500 RPM STATUS: 2 of 4 Operational

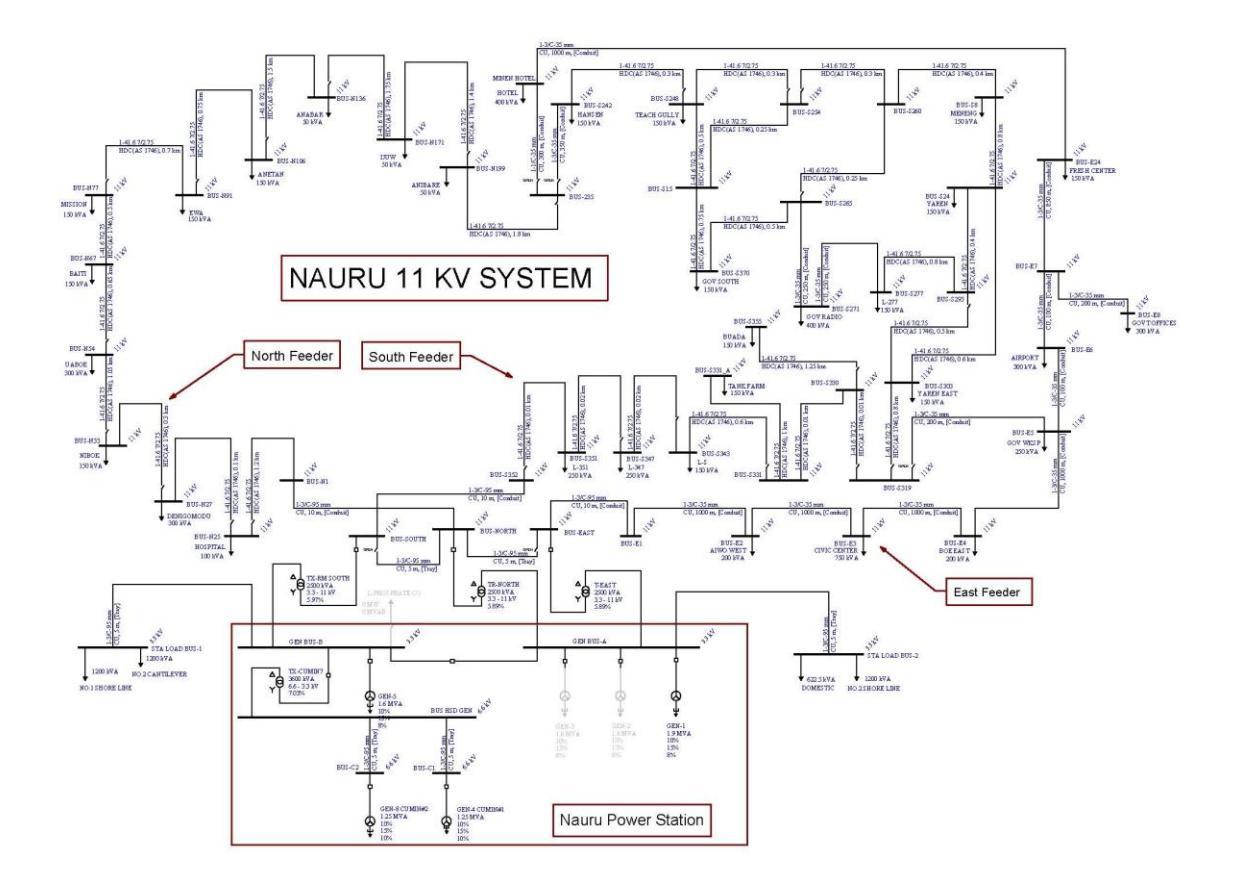
Figure 10 - NUC 11kV System One-Line Diagram

The one line diagram of the EasyPower model is provided in the following figure. Larger versions of this diagram, along with an Excel spreadsheet file of the loss calculations, are included with this report in Appendix C.

The power flow results did not show any overloaded facilities or unacceptable voltage drops under the peak load condition studied.

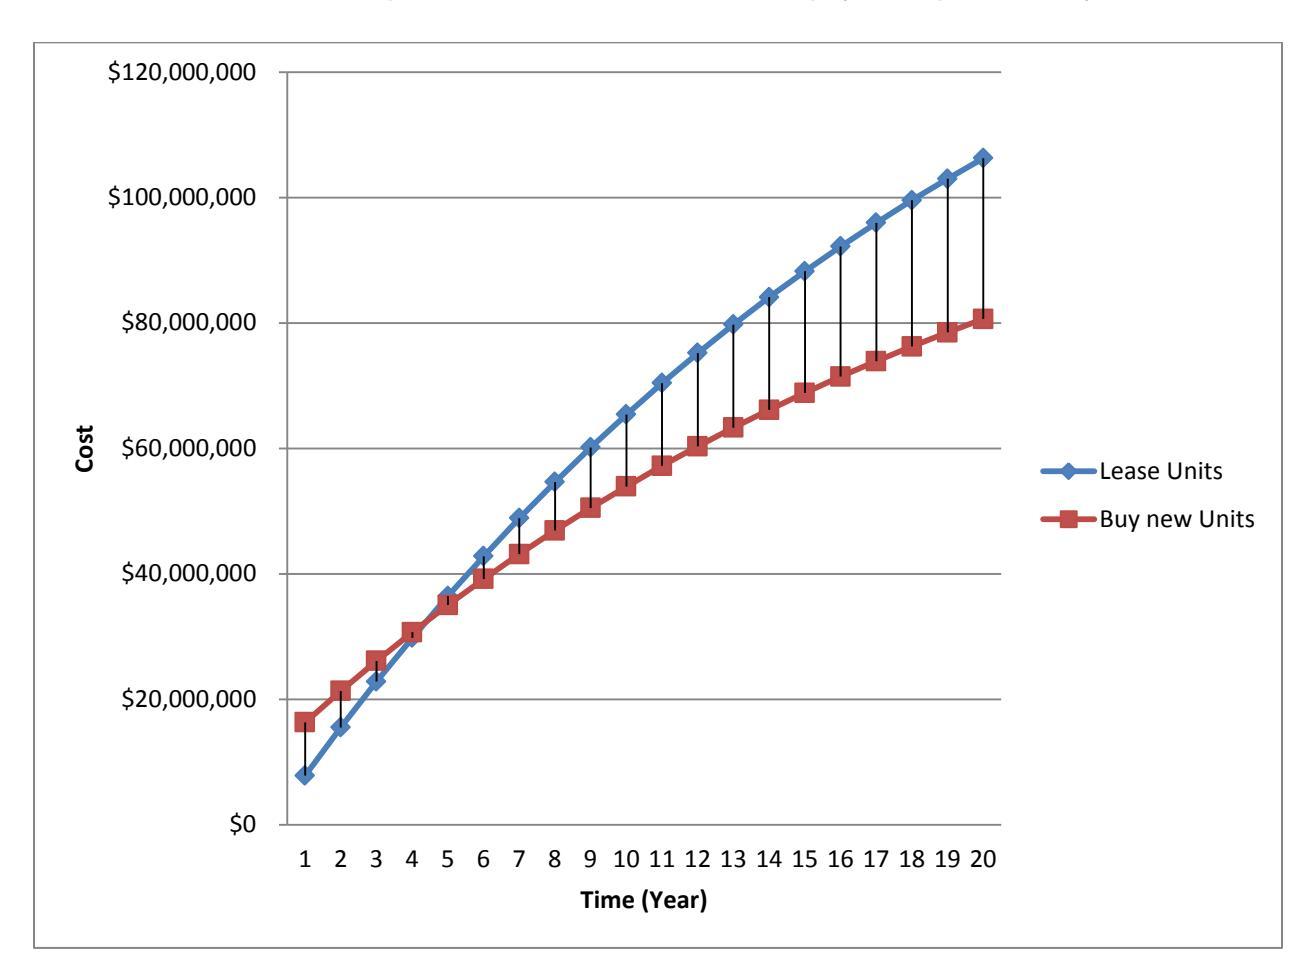
Figure 11 - NPV Results

Since generator maintenance has also been a continuing issue at NUC, those costs have been included in the above NPV calculation. The results of the NPV calculation are shown in figure 11 below, and indicate that purchase of new units has a net pay-back period of 5 years.

The conclusion of this process is that NUC generator replacement appears to be the greatest need. Six of the eight units owned by NUC were not operable during the time of KEMA's visit. To meet an n-2 reliability criteria (e.g., loss of any single unit with one unit out for maintenance), KEMA recommends that NUC consider installing four new, high-efficiency diesel units, rated at 2 MW (2.5 MVA) each. This would provide enough generating reserve to meet a 4 MW peak load under any n-2 generator condition. This should be done as soon as financing can be secured for the capital investment.
